**Geologic and Engineering Services
Hillslope Area Between Schuster
Parkway and Stadium Way
Tacoma, Washington**

December 29, 2000

**For
City of Tacoma**

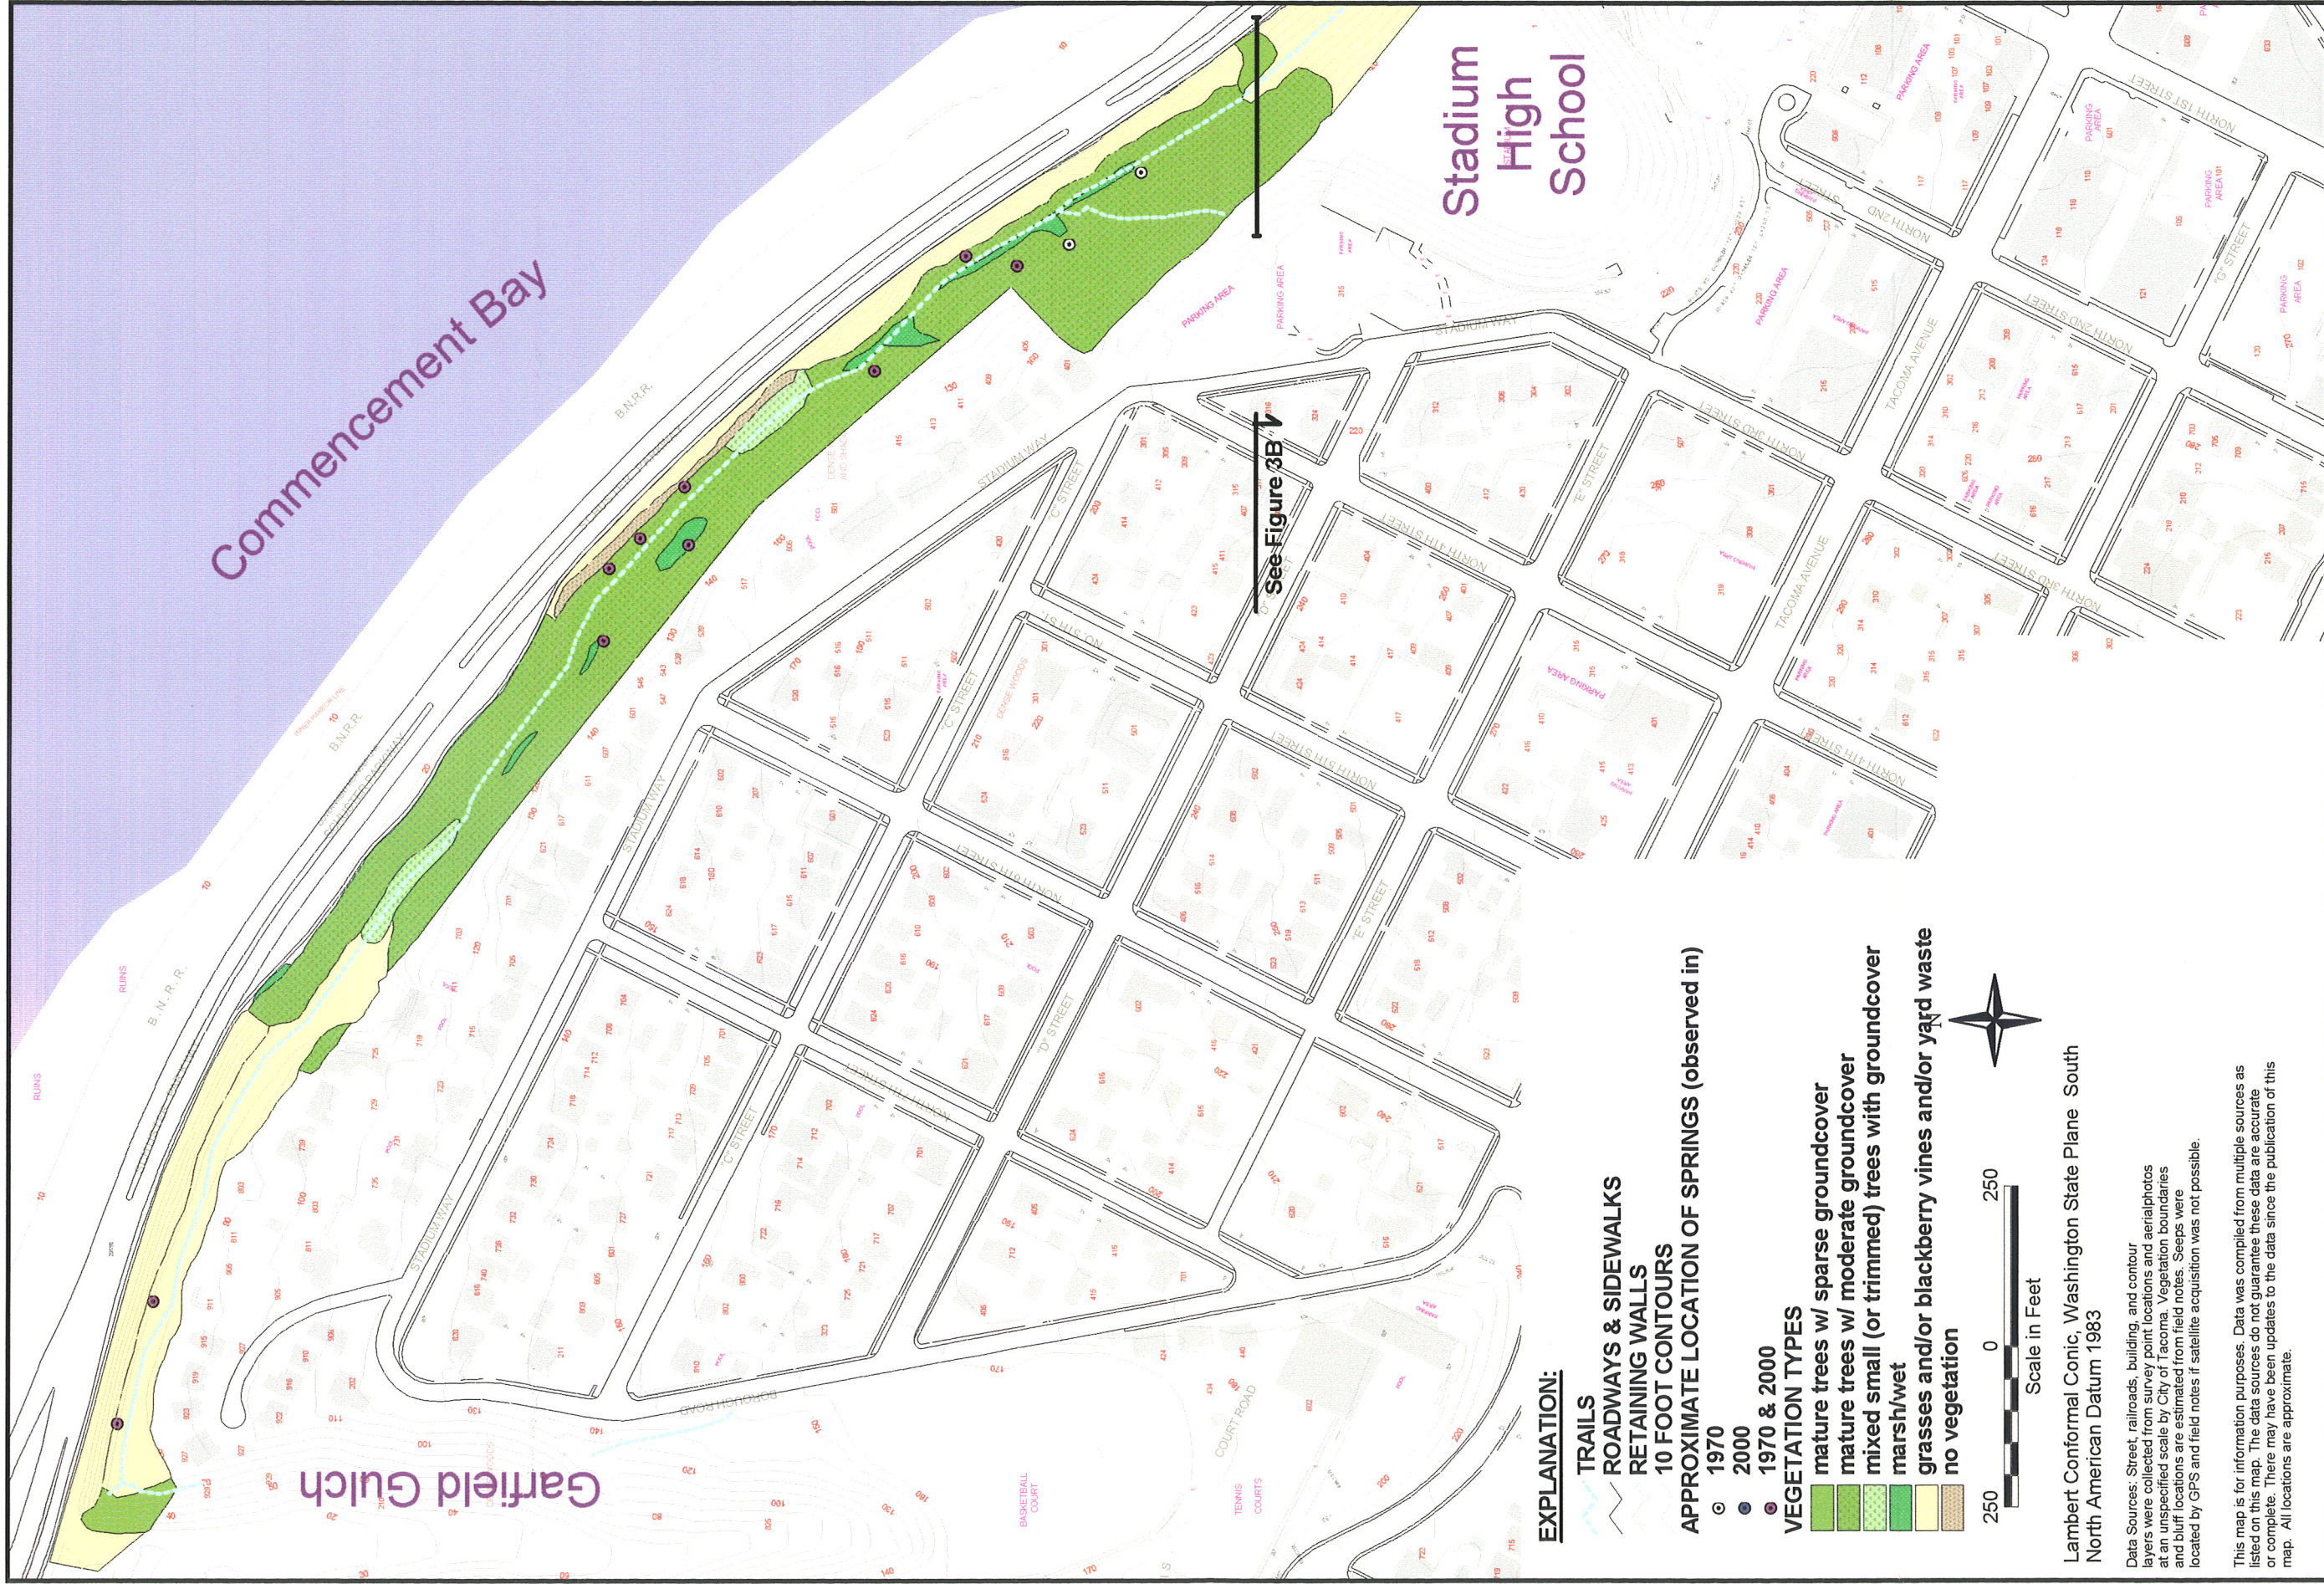
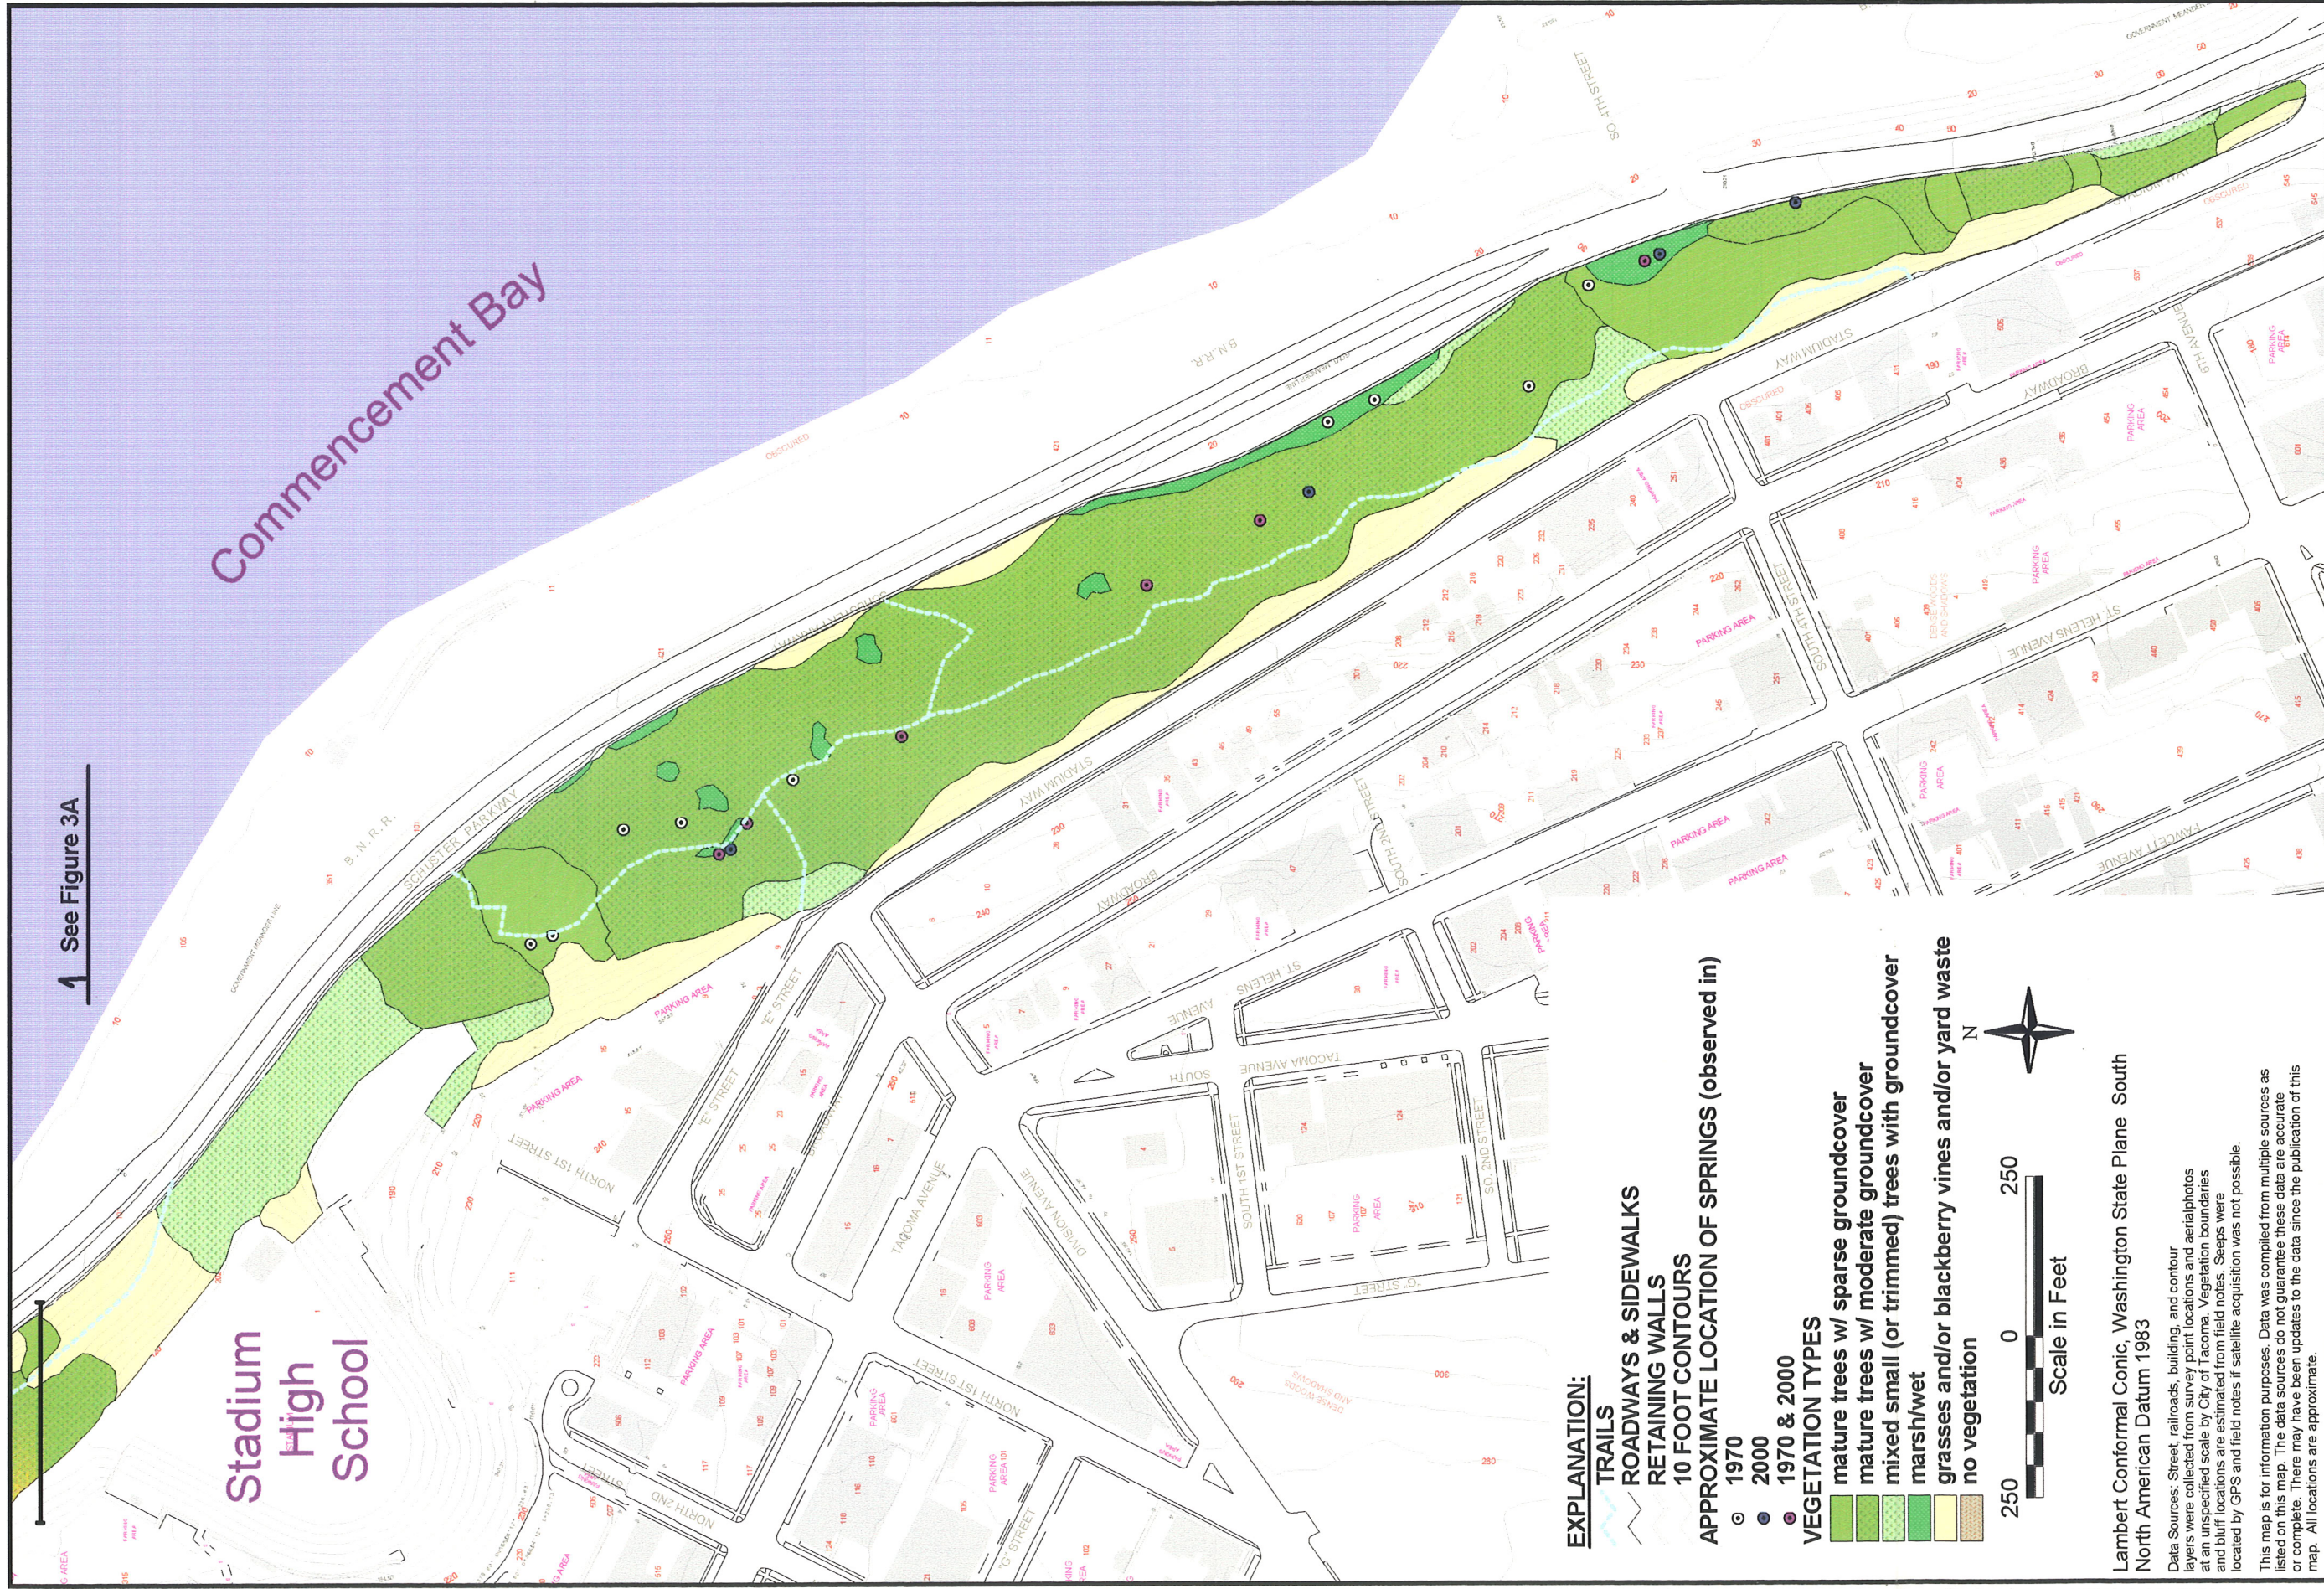
FIGURE 3B

The vegetation we observed in the study area includes a comprehensive canopy of mature deciduous trees with some areas of small (recently trimmed) trees, some open grass and brush areas and a very limited area with essentially no vegetation. The character and distribution of vegetation in the study area is indicated on Figures 3A/3B.

We observed and mapped about 20 springs during our site reconnaissance in September 2000. Dames & Moore identified 27 springs at the project site in 1970. Most of the springs identified by Dames & Moore were observed during our site reconnaissance. The approximate locations of the springs are shown in Figures 3A/3B.

We recommend that dense, low vegetation growth at the site be encouraged, especially in areas where existing ground cover is sparse or absent. The ground cover vegetation can consist of shrubs and low trees and particularly evergreen brush. The vegetation will improve slope stability by limiting erosion and by increasing evapotranspiration of surface and ground water. We recommend that an arborist be consulted to:

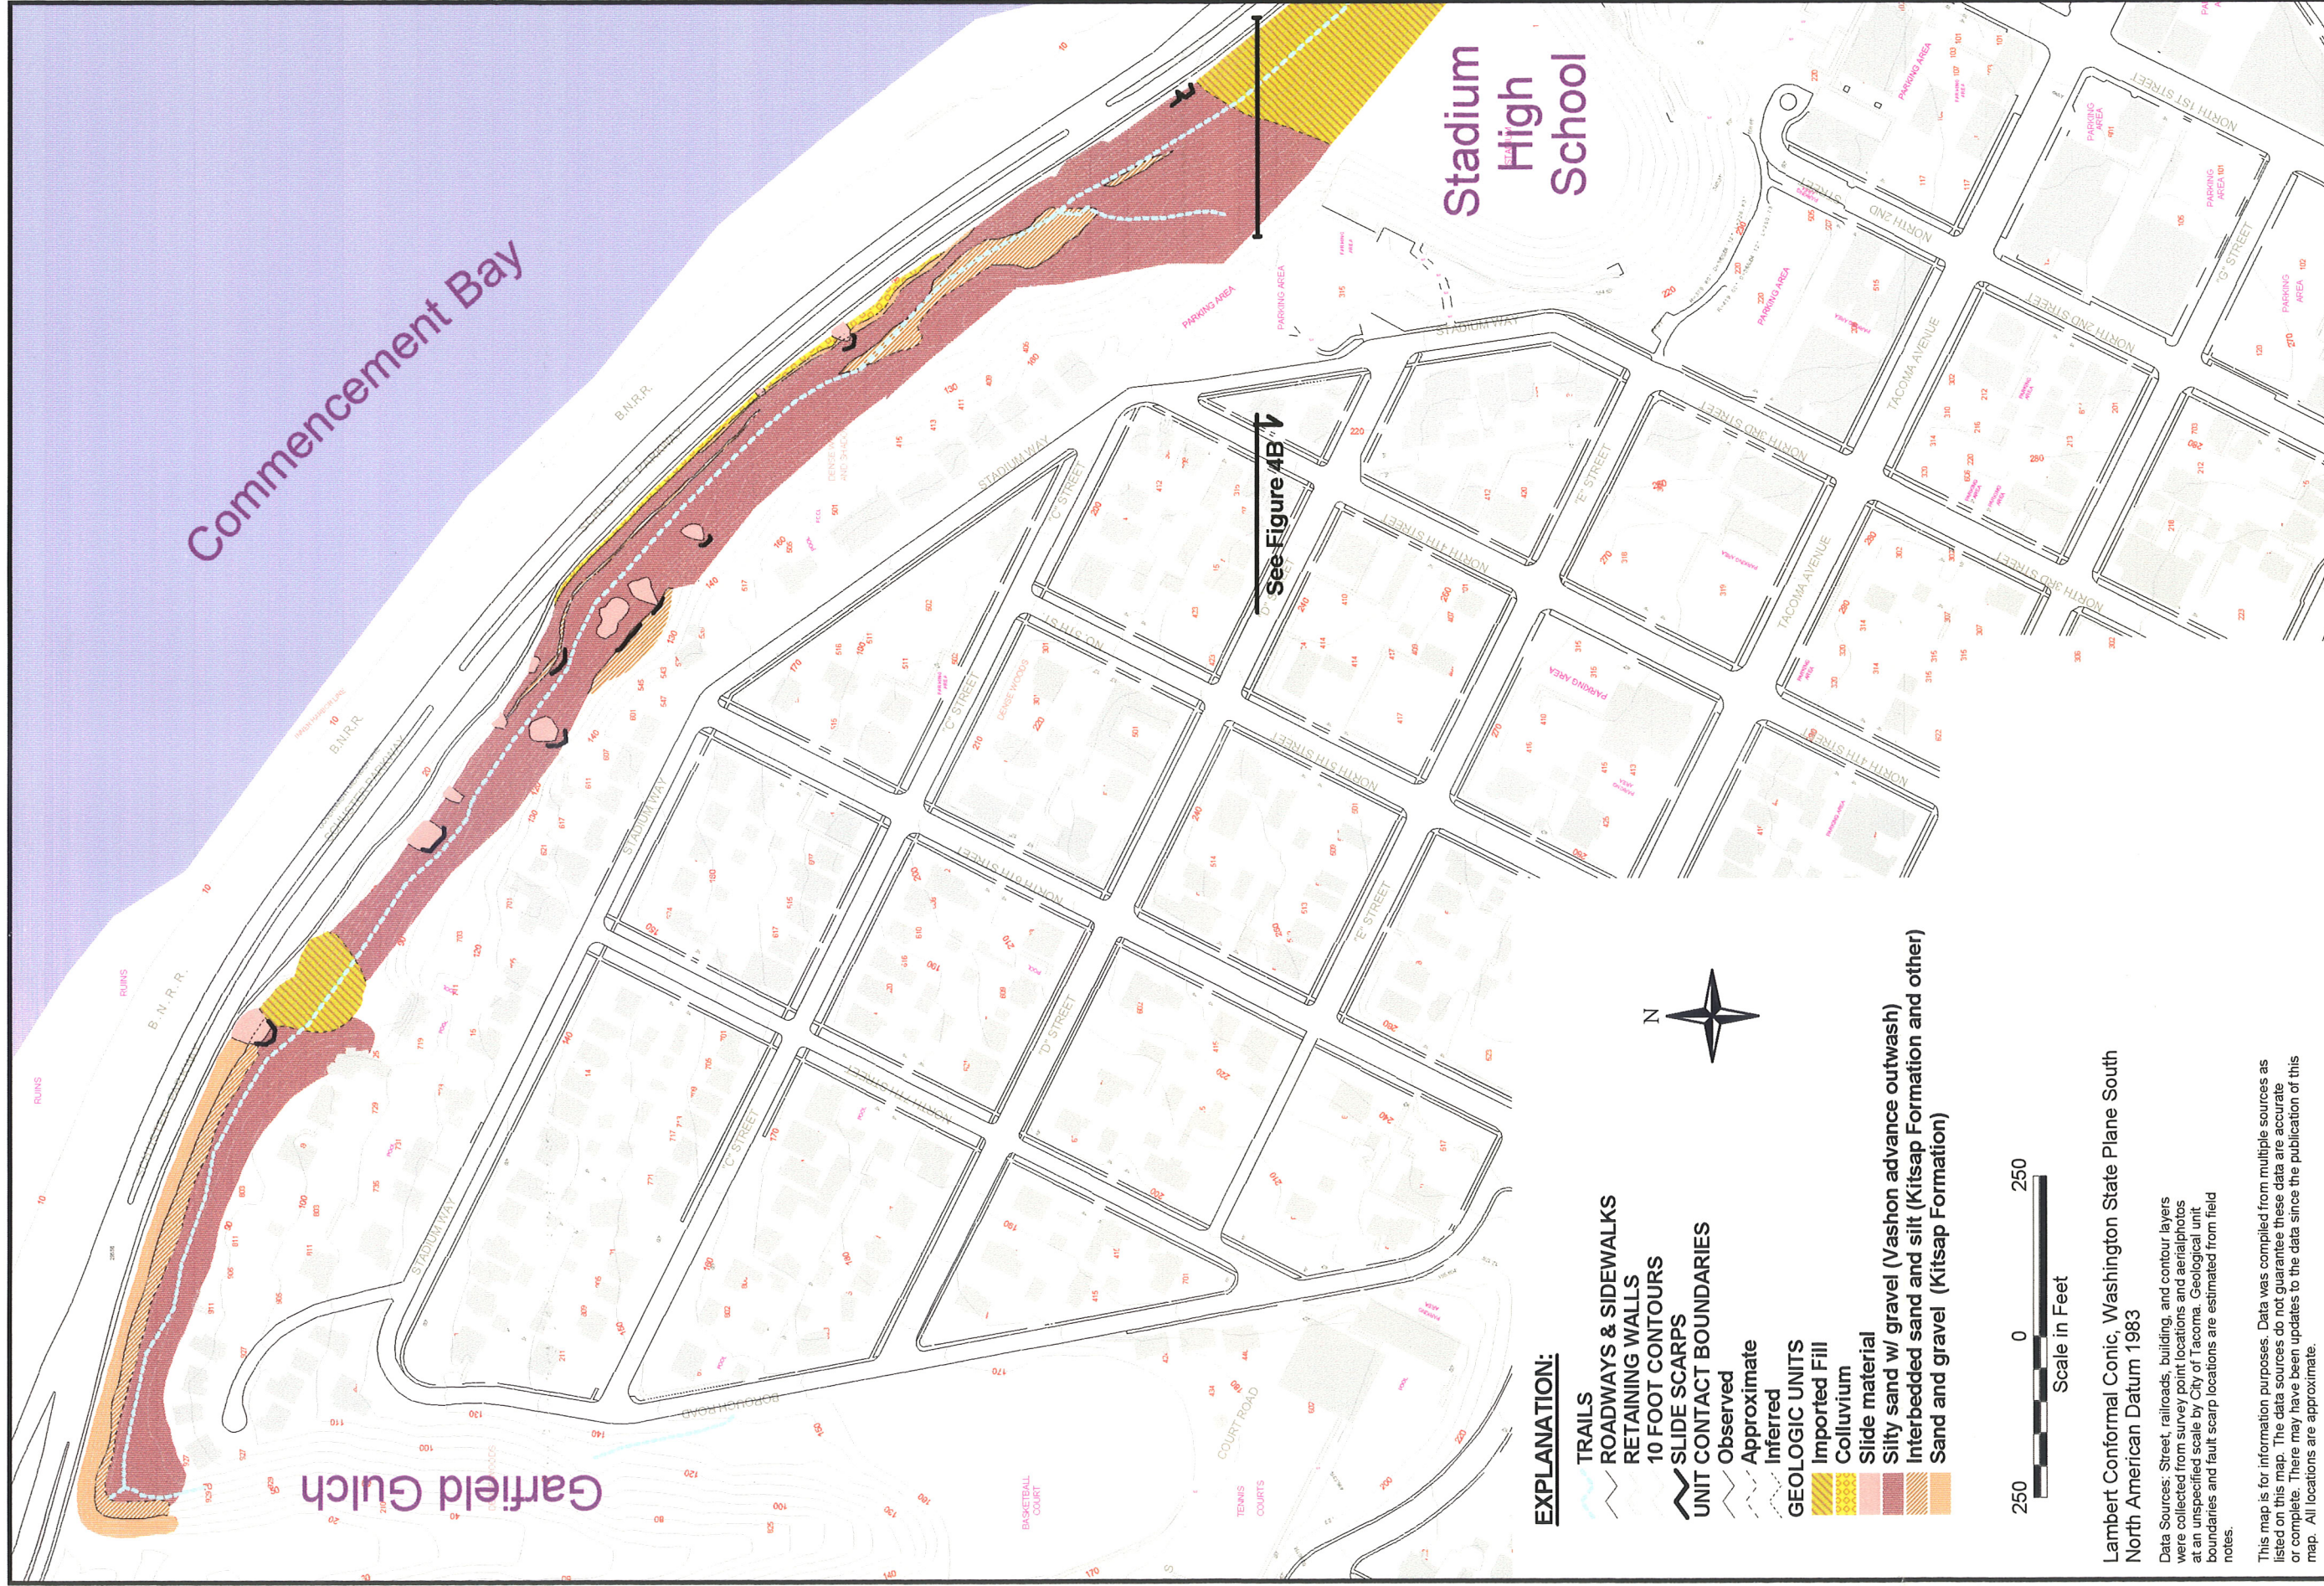
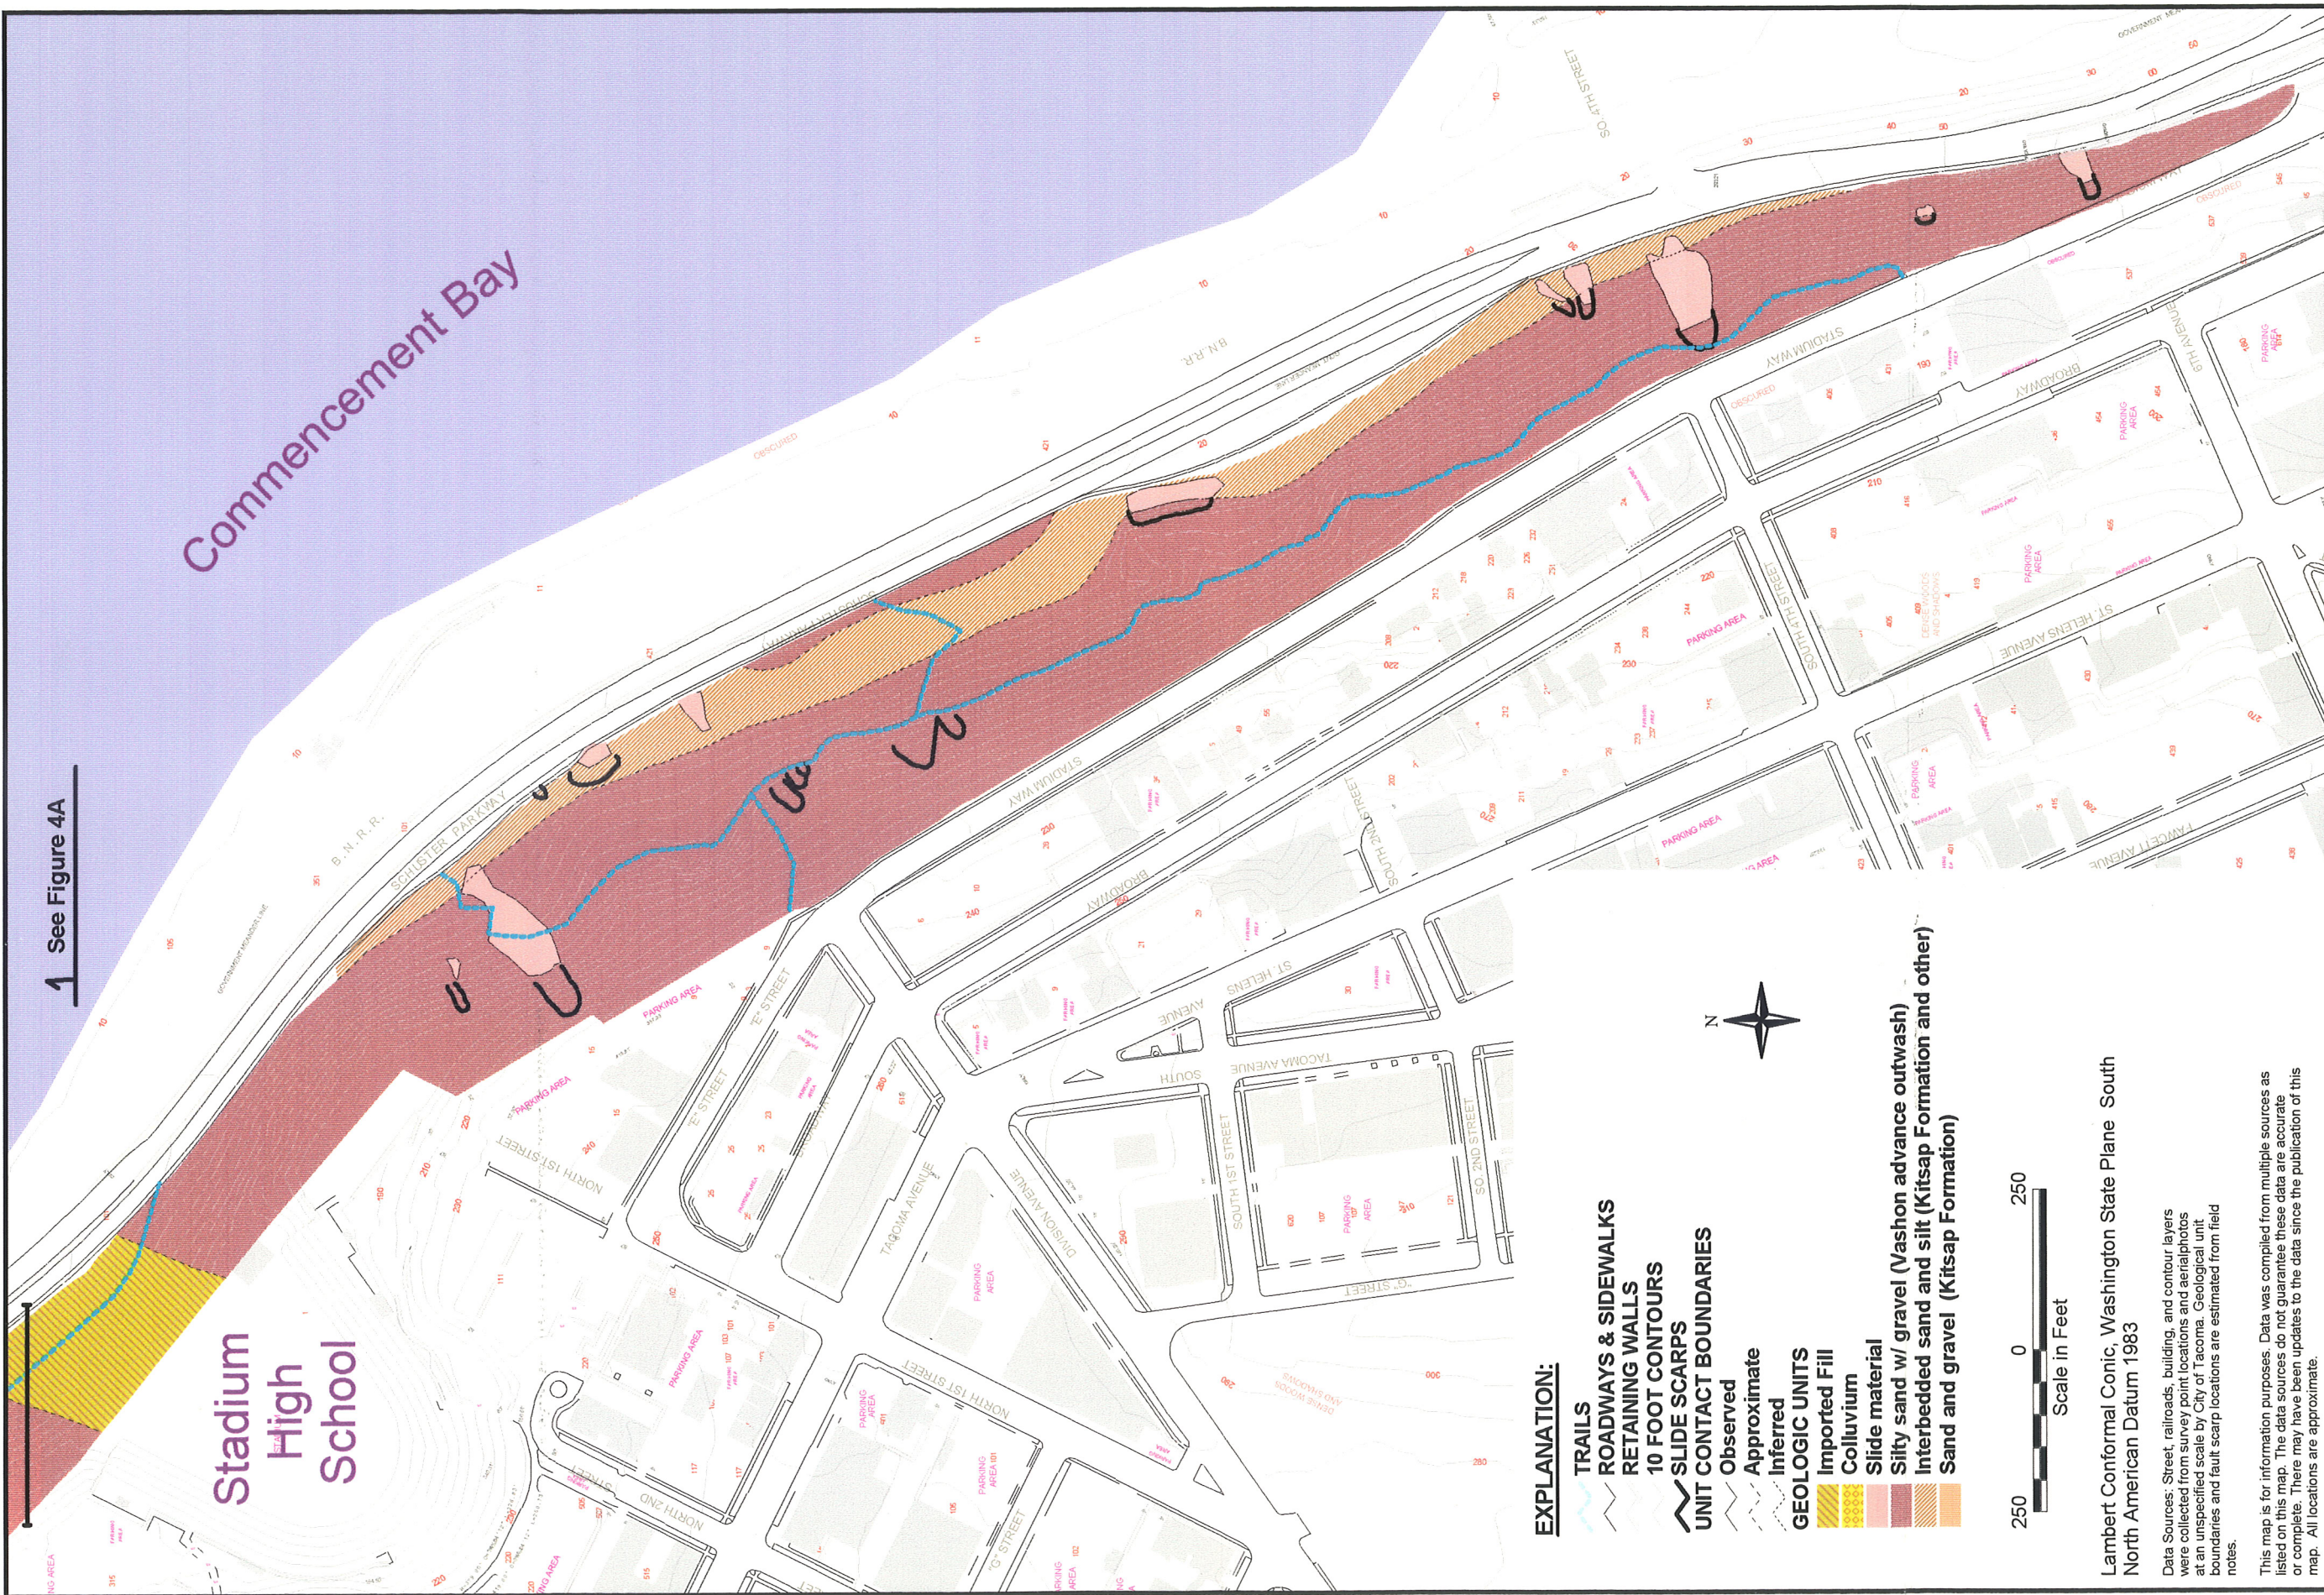
FIGURE 4A

Our understanding of geologic conditions within the site area is based on a geologic reconnaissance performed at the site from September 14 to September 18, 2000, our review of published and unpublished reports and our experience. The approximate distribution of geologic materials at the site is shown in Figures 4A/4B.

Recent slide material and colluvium consists of a mixture of native material in a loose to medium dense condition. Landslide-deposited material is generally found at the base of bluffs or at the base of slide scarps within the site area. A blanket of loose colluvium covers most of the hillslope in the study area, where the dense glacial and interglacial soils are obscured. All of the hillslope vegetation is rooted in colluvium or fill soils. The colluvium blanket is especially loose in the South Half of the study area where no ground cover of underbrush occurs.

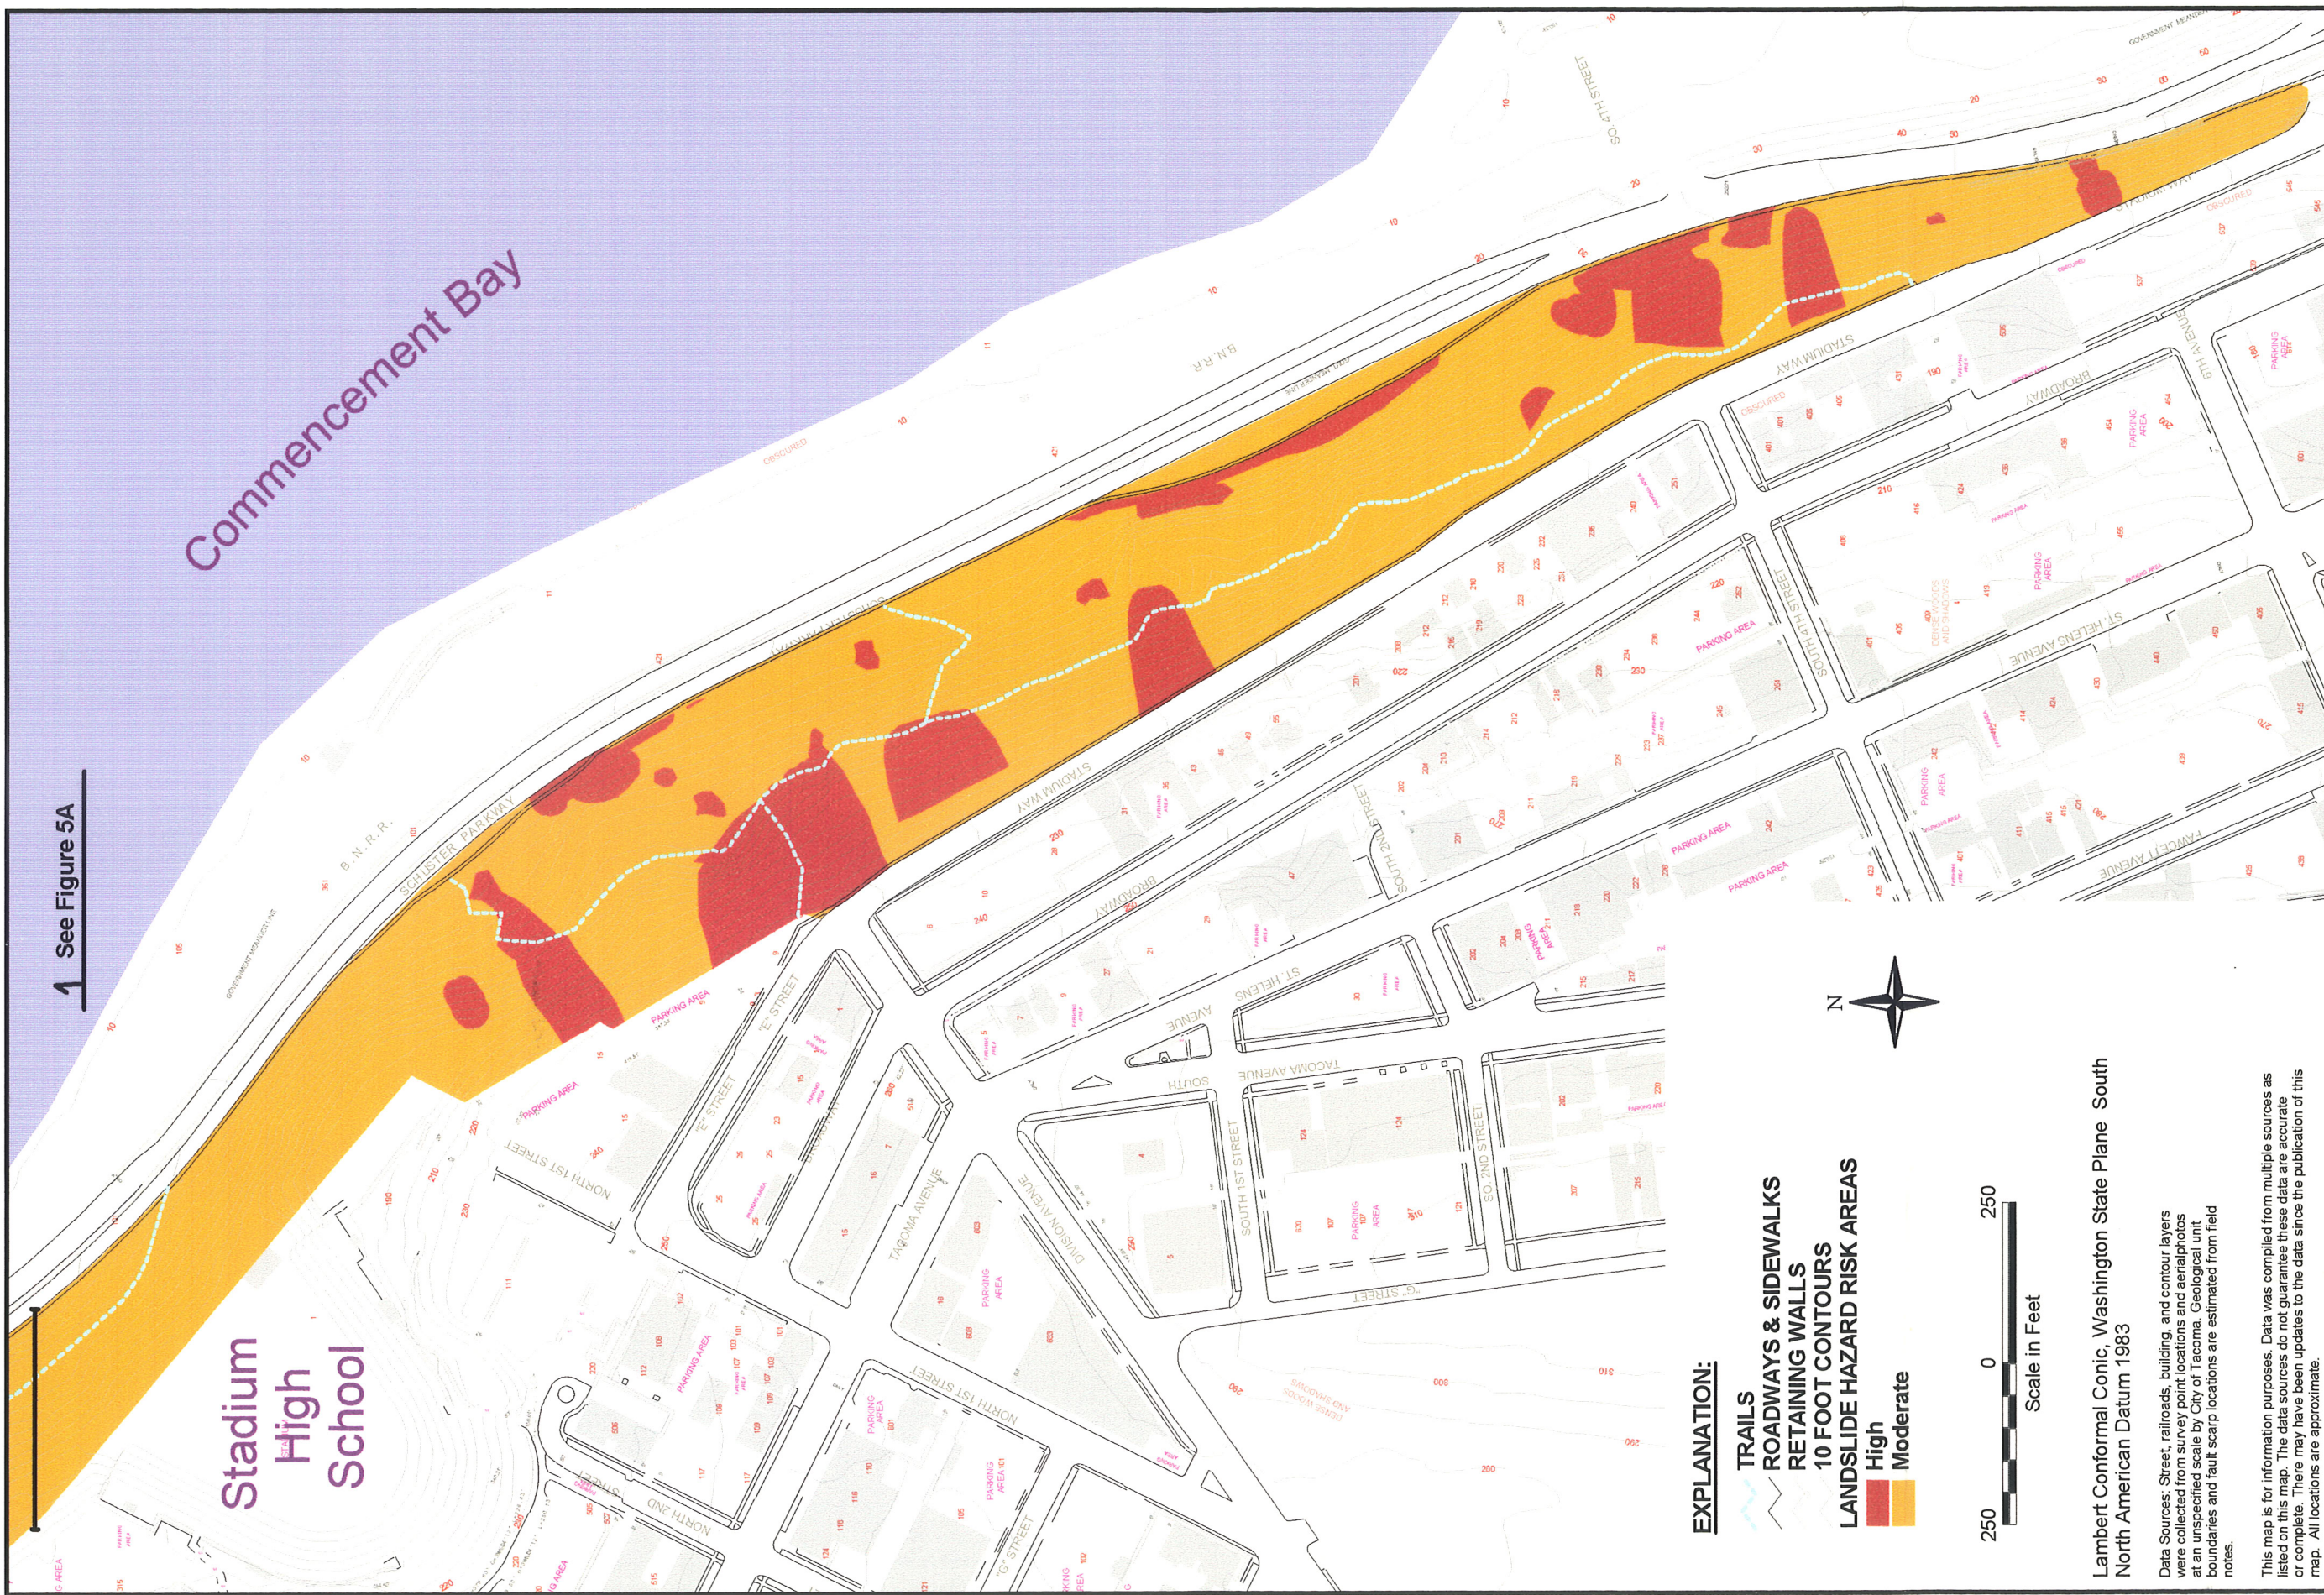
FIGURE 5A

All of the project area is mapped as High Risk to Moderate Risk landslide hazard area. The highest risk areas generally consist of the steepest slopes, poor or no stabilizing vegetation, water-softened areas, advance outwash over Kitsap formation silt and existing or historic slide areas. Several of the mapped High Risk landslide hazard areas occur near the end of streets up-slope of the study area. This may indicate active or historical disposal of surface water runoff in these areas. The disposal of storm runoff from private property was not investigated a part of this study, but that source of water is a likely contributory cause of hillslope instability. Many other past or active landslide areas are directly related to springs or seeps.

In our opinion "Moderate Risk" areas as those that appear to be relatively stable in their present configuration. "High Risk Areas" are those which are marginally stable (or unstable) in their present configuration, typically because of a number of interrelated factors as listed below.

Removal of most, or all, vegetation in either of these areas would have a decided negative impact on slope stability in the immediate and adjacent areas. As noted below we recommend activities to encourage more vegetation development throughout the hillslope. The approximate distribution of the Moderate Risk and High Risk landslide hazard areas are shown in Figures 5A/5B. The criteria we considered to define the risk areas are as follows:

- All slopes steeper than 15 percent.
- Within 20 feet of active and historic landslide areas.
- Hillslope areas above springs or seeps and water-softened or marshy areas down-slope of seepage areas.
- Hillslopes with observed surficial instability (creep).

We recommend that the City of Tacoma investigate surface water runoff patterns in the area immediately up-slope of the project area. As previously stated, High Risk landslide areas were mapped down-slope of the intersections of North 6th and Stadium Way, North 4th and Stadium Way, Division Avenue and Stadium Way, and South 4th and Stadium Way. The existence of these features relative to the roadway intersections may indicate discharge of surface water runoff to the hillslope in these areas.

We recommend drainage improvements be accomplished to reduce the area and extent of saturated surface soils caused by water emerging from seeps and springs. The measures will reduce the potential for massive ground movement as well as the potential for erosion/sedimentation in the presently saturated areas. The details of the drainage recommendation are not a part of this consultation, but we would be please to assist the City in such an effort.
