FIRE FACILITIES MASTER PLAN

CITY OF TACOMA

FEBRUARY 2024

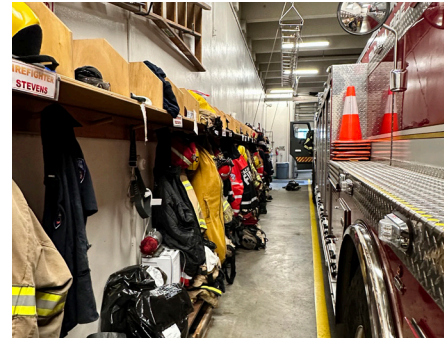
Figure 37. Turnout storage is in Station 1 apparatus bay

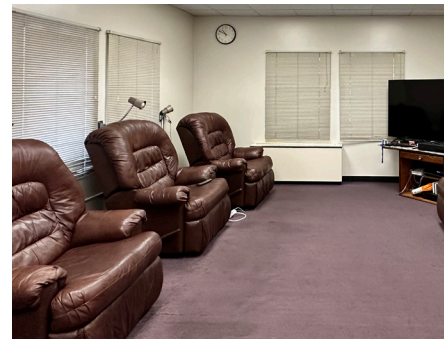
Figure 38. Carpet in Station 1's day room is dated and stained

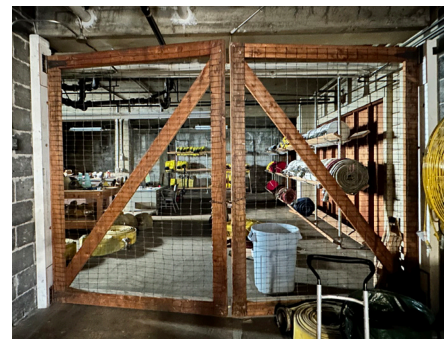
Figure 39. Security gate in Station 2 basement storage

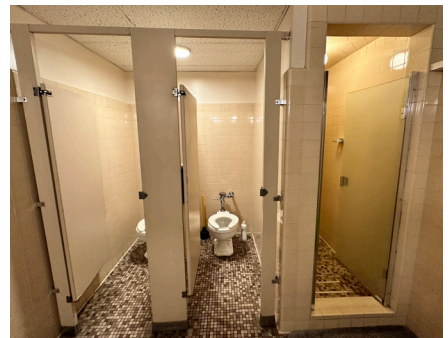
Figure 44. Station 6 has insufficient restroom facilities

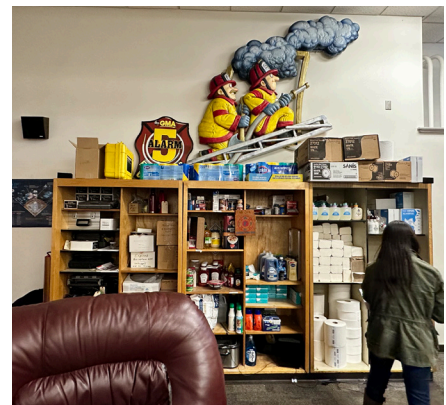
Figure 59. Hygiene storage located in Station 12 day room

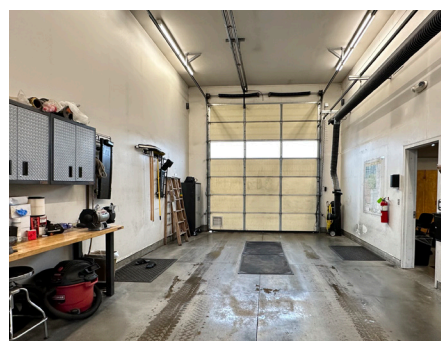
Figure 77. Temporary apparatus bay at Station 15

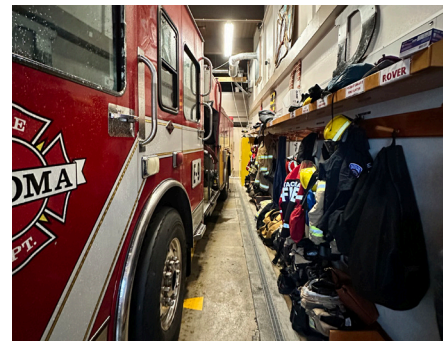
Figure 91. Turnout storage is stored in Station 9's apparatus bay

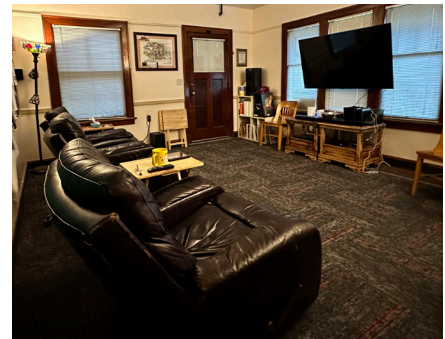
Figure 96. Station 14 day room doubles as a dining room and public lobby for blood pressure checks

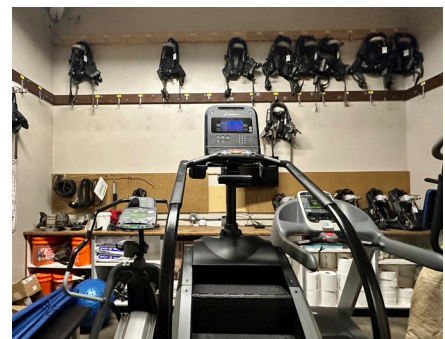
Figure 98. Station 17 fitness room doubles as SCBA storage

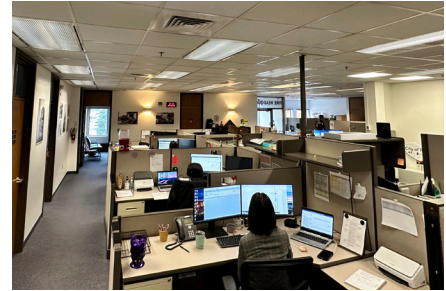
Figure 111. Staff share assigned workstations at Fire HQ

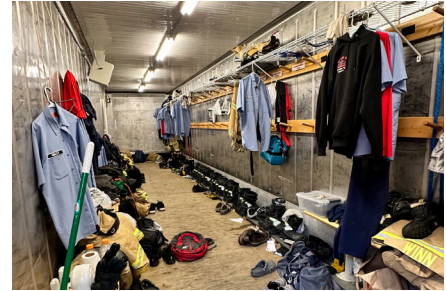
Figure 119. Shipping container doubles as Training locker room

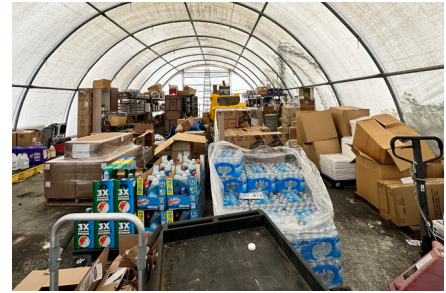
Figure 124. Fire Garage storage has little protection from the elements

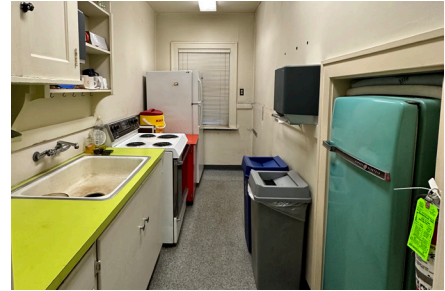
Figure 129. The Electrical Shop's kitchen is outdated and cramped

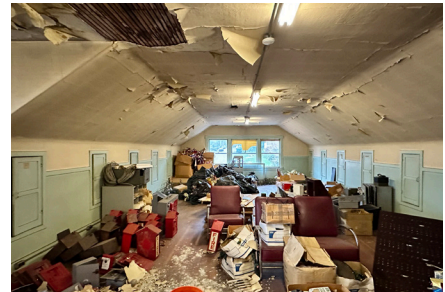
Figure 130. EMB's attic storage area is in poor condition
