Agenda

Landmarks Preservation Commission Planning and Development Services Department

STAFF REPORT

SPECIAL TAX VALUATION

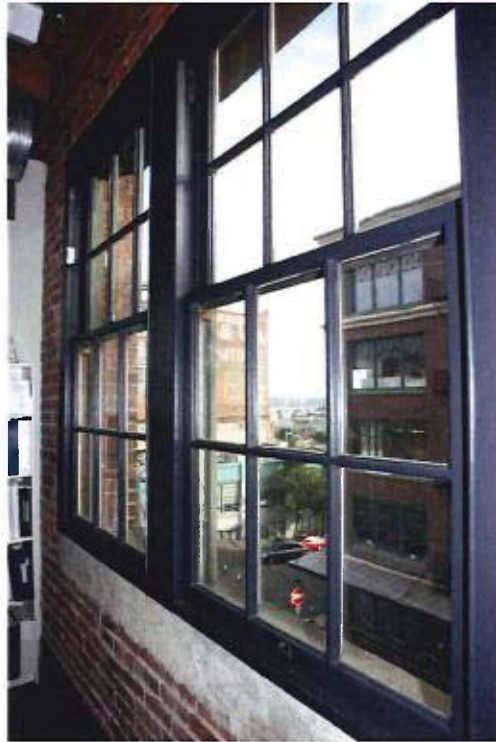
Window repair detail, looking northeast. September 2019.

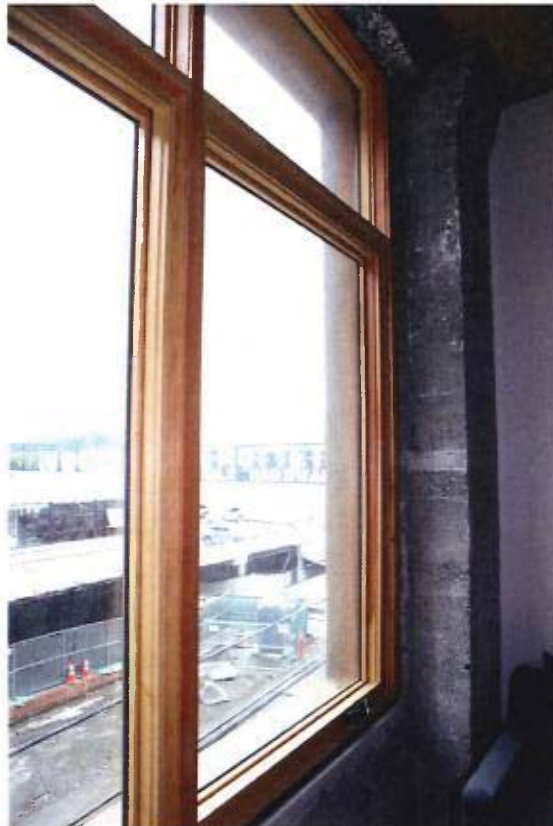
Replacement window detail, looking southeast. 2019.

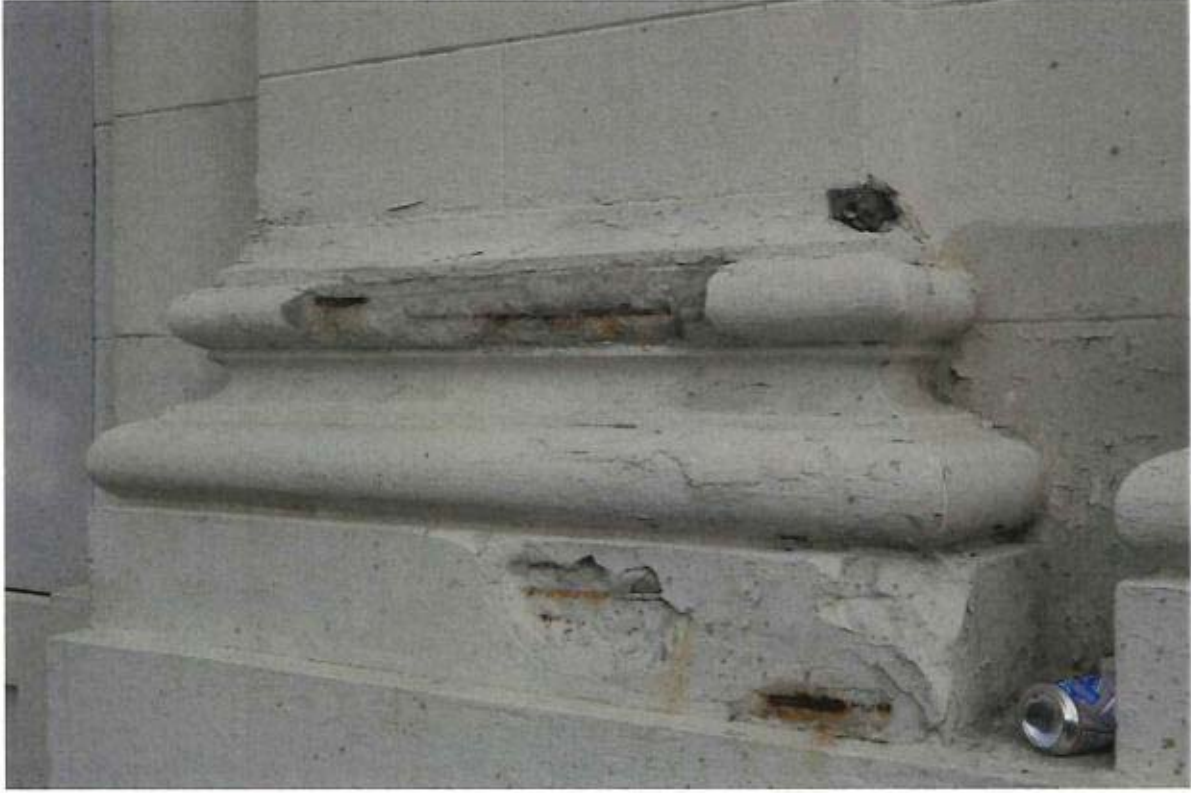
West facade detail, showing typical concrete deterioration on exterior. 2016.

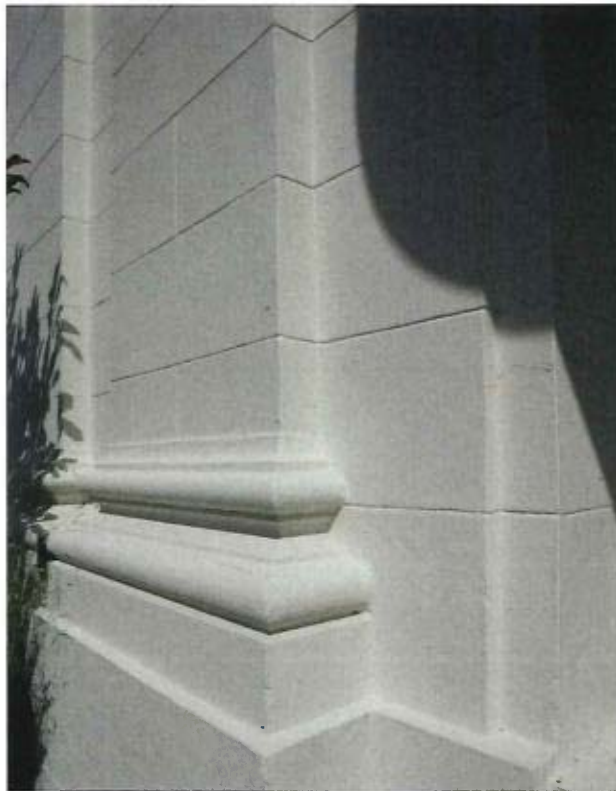
West facade detail, showing exterior walls repaired. 2019.

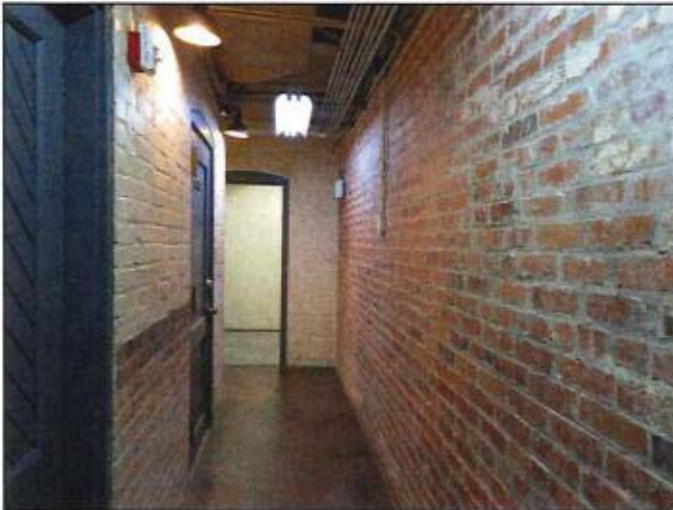
Figure 12. Basement corridors with original brick and wood doors (2019).

After: During the rehabilitation, sensitive features like painted brick were cleaned and repaired, as were wood doors, and original light fixtures. Additional lighting and fresh paint was added as needed.

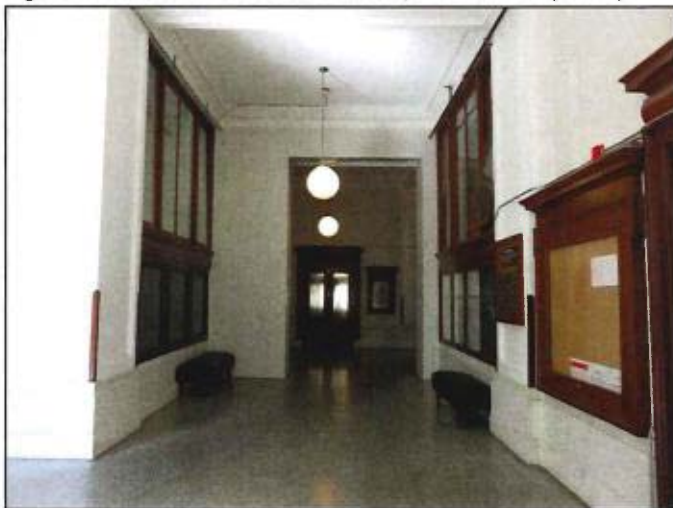
Figure 28. Corridor leading to the north exit, main floor (2019).

After: One of the most challenging elements of the rehabilitation was adding fire doors on the first floor while retaining the open volumes that characterize the corridor. After consultation with local, state, and federal regulators, the owners added "pocket" fire doors behind a new half-wall, thereby retaining the wide corridor while meeting code requirements (compare to photo 16).

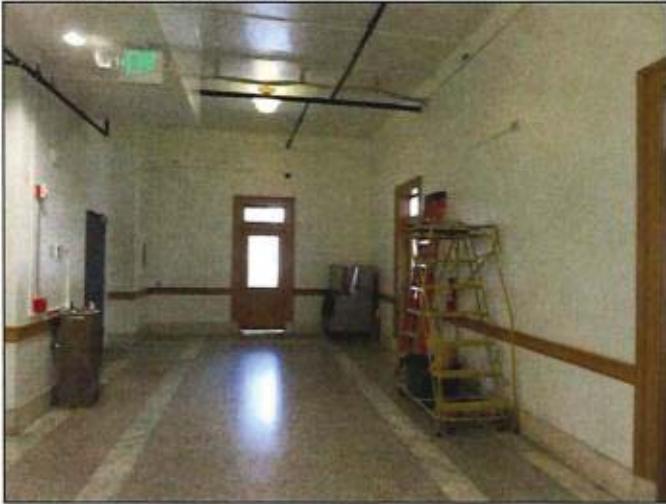
Figure 32. Third-floor corridor with restored features (2019).

After: Original corridor floors and baseboards were cleaned and repaired, as needed. Sprinkler systems were added to meet code, lighting was repaired or replaced in-kind, and wood doors, trim, picture rails, and windows were repaired and restored.

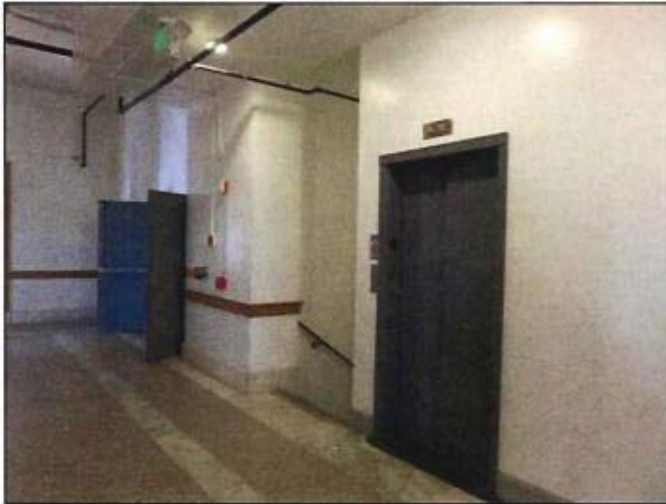
Figure 33. Third floor elevator and stairs with added fire doors (2019).

After: To meet fire and safety code, the building owners installed fire doors at the north and south ends of the corridor, where original stairs and elevators were retained in place.

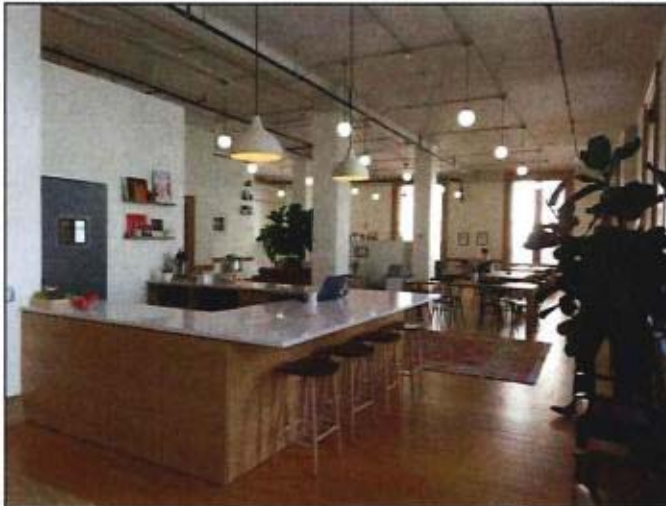
Figure 34. Rehabilitated office space, third floor (2019).

After: The rehabilitation removed incompatible carpet, repaired or replaced wood flooring, upgraded lighting, and constructed tenant improvements to prepare the former office spaces for new uses. All original windows were retained and repaired, as needed.

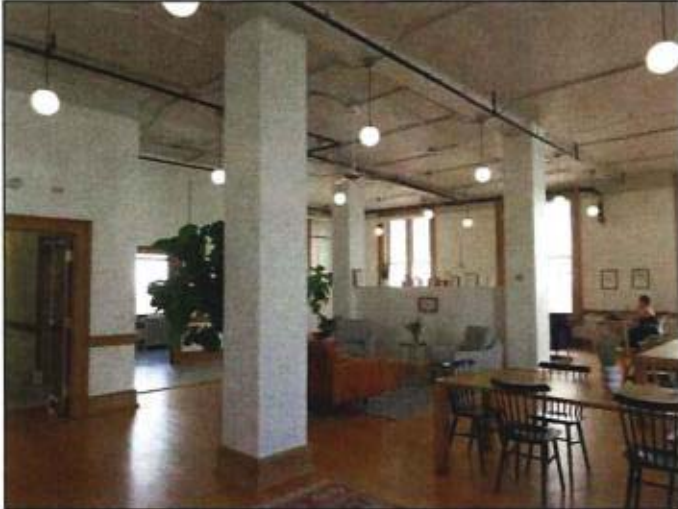
Figure 35. Rehabilitated office space, third floor (2019).

After: Tenant improvements have been designed to retain and enhance historic features. Additions generally consist of reversible additions like mobile furniture. Added pendant lights and exposed sprinkler systems are in character with the original building’s design.

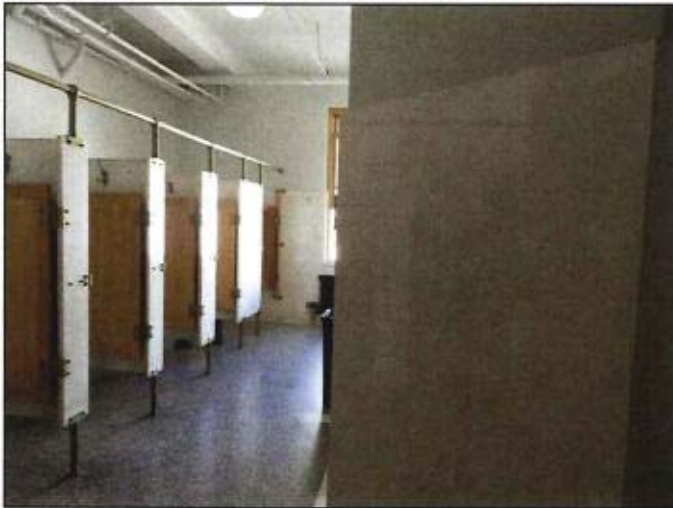
Figure 49. Original restroom, restored, fourth floor (2019).

After: Original restrooms on the fourth floor were in good condition, and all materials, including original marble and wood, were cleaned and repaired by the gentlest means possible.

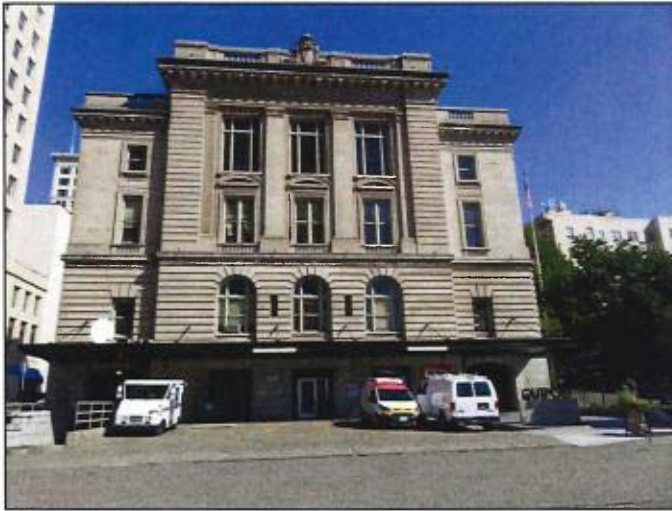
Figure 59. South elevation with new signage, repaired driveway (2019).

After: At the building’s south end, the driveway was repaired and a new, freestanding monument sign was installed the building’s southeast corner (lower right corner).

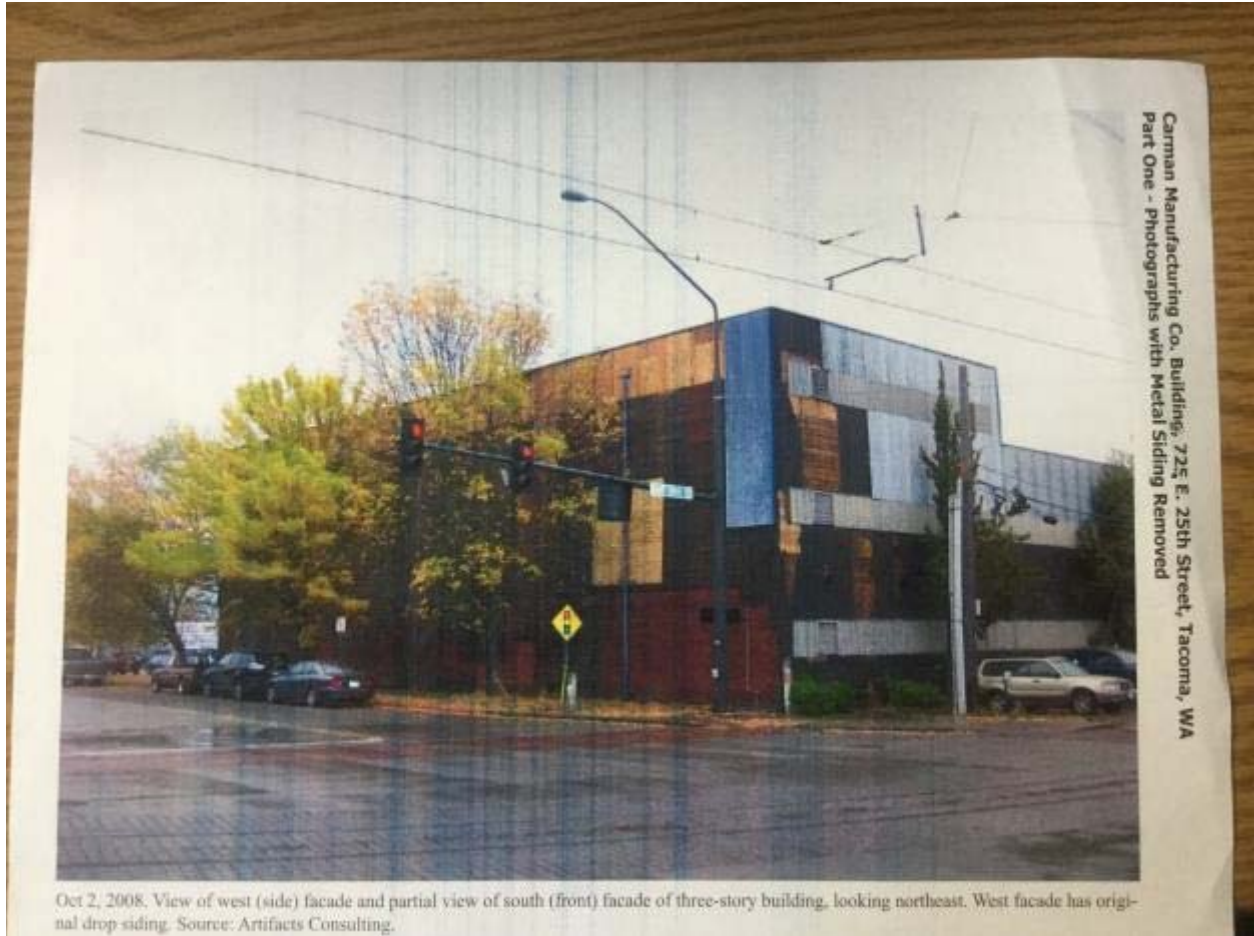
Oct 2, 2008. View of west (side) facade and partial view of south (front) facade of three-story building, looking northeast. West facade has original drop-siding. Source: Artifacts Consulting.
