Landmarks Preservation Commission Planning and Development Services Department

Date: July 8, 2020
Time: 5:30 p.m.
Location: Virtual (see below)

STAFF REPORT

NOMINATIONS TO THE TACOMA REGISTER OF HISTORIC PLACES – PRELIMINARY REVIEW

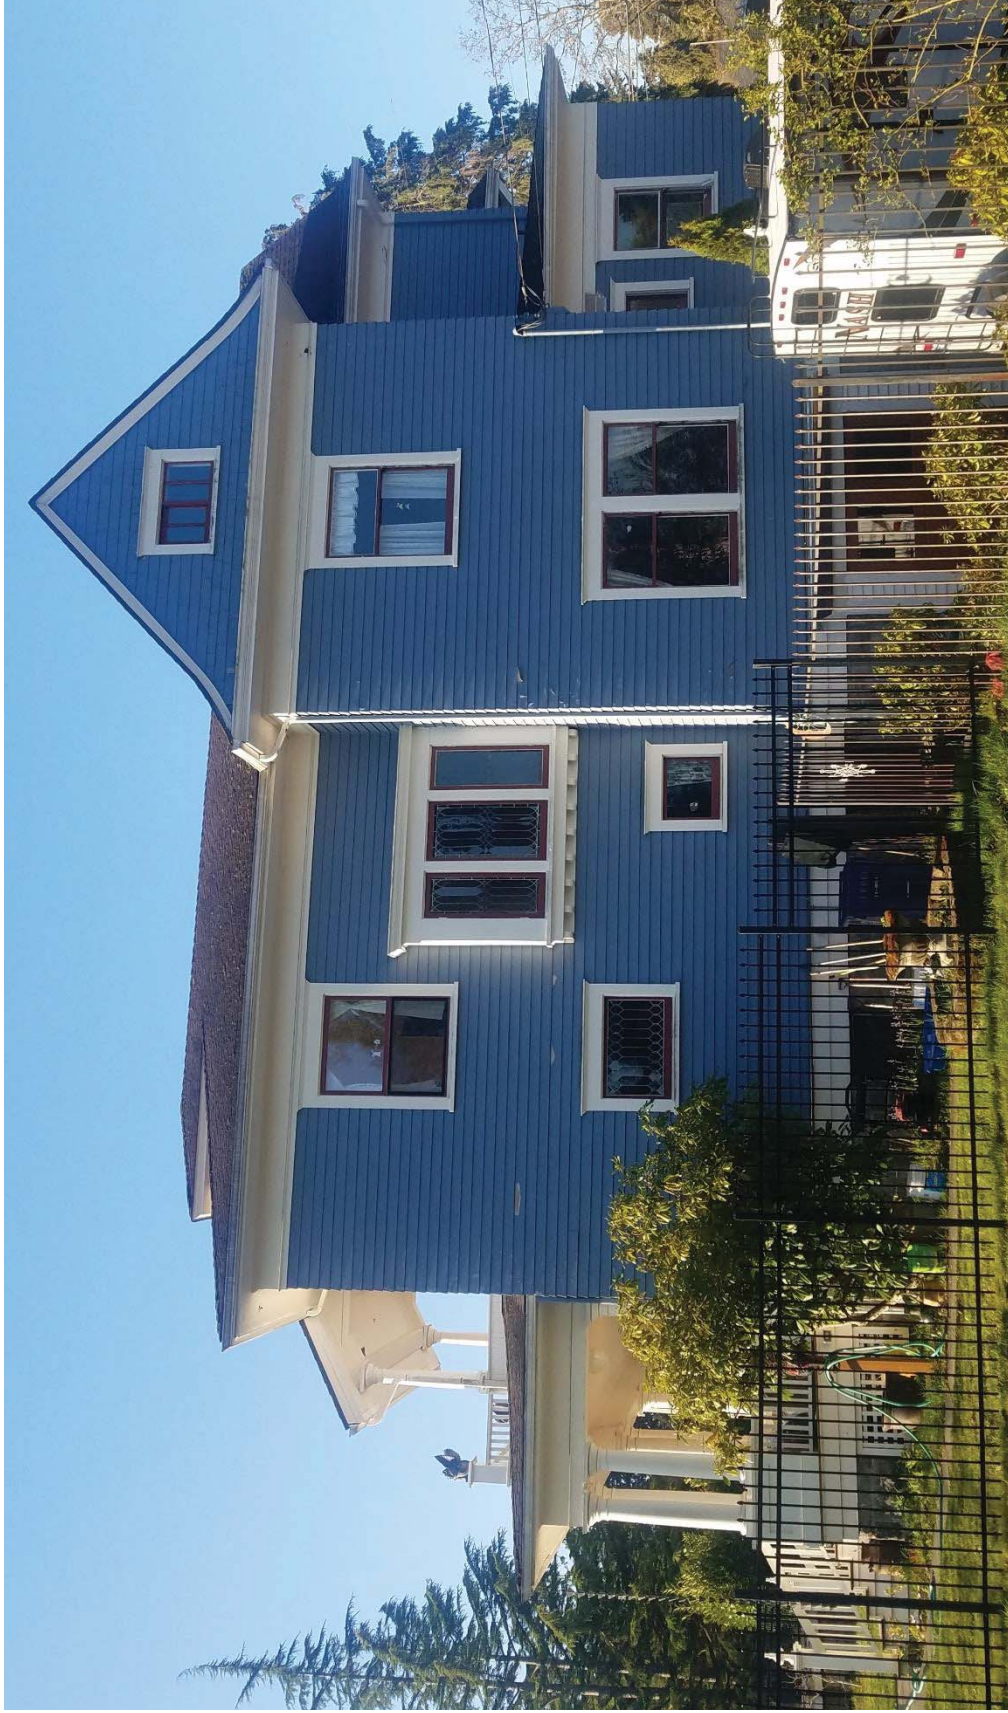
North Side of House – 2020

Note: The set of 3 windows as well as the lower left window are leaded glass

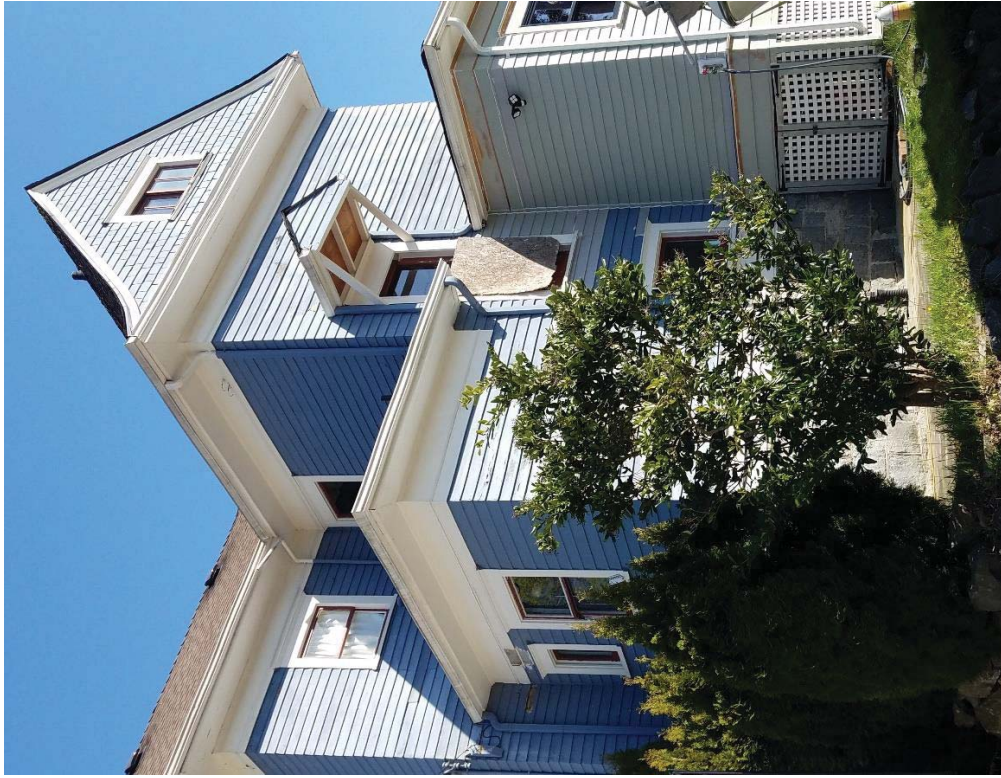
Northwest Corner of House – 2020

Note: The original basement door is hidden by the shrubs

Note: The second-floor exterior door was added when the home was turned into a boarding house (the stairs were removed in the large kitchen/bathroom remodel in 2018-2019)

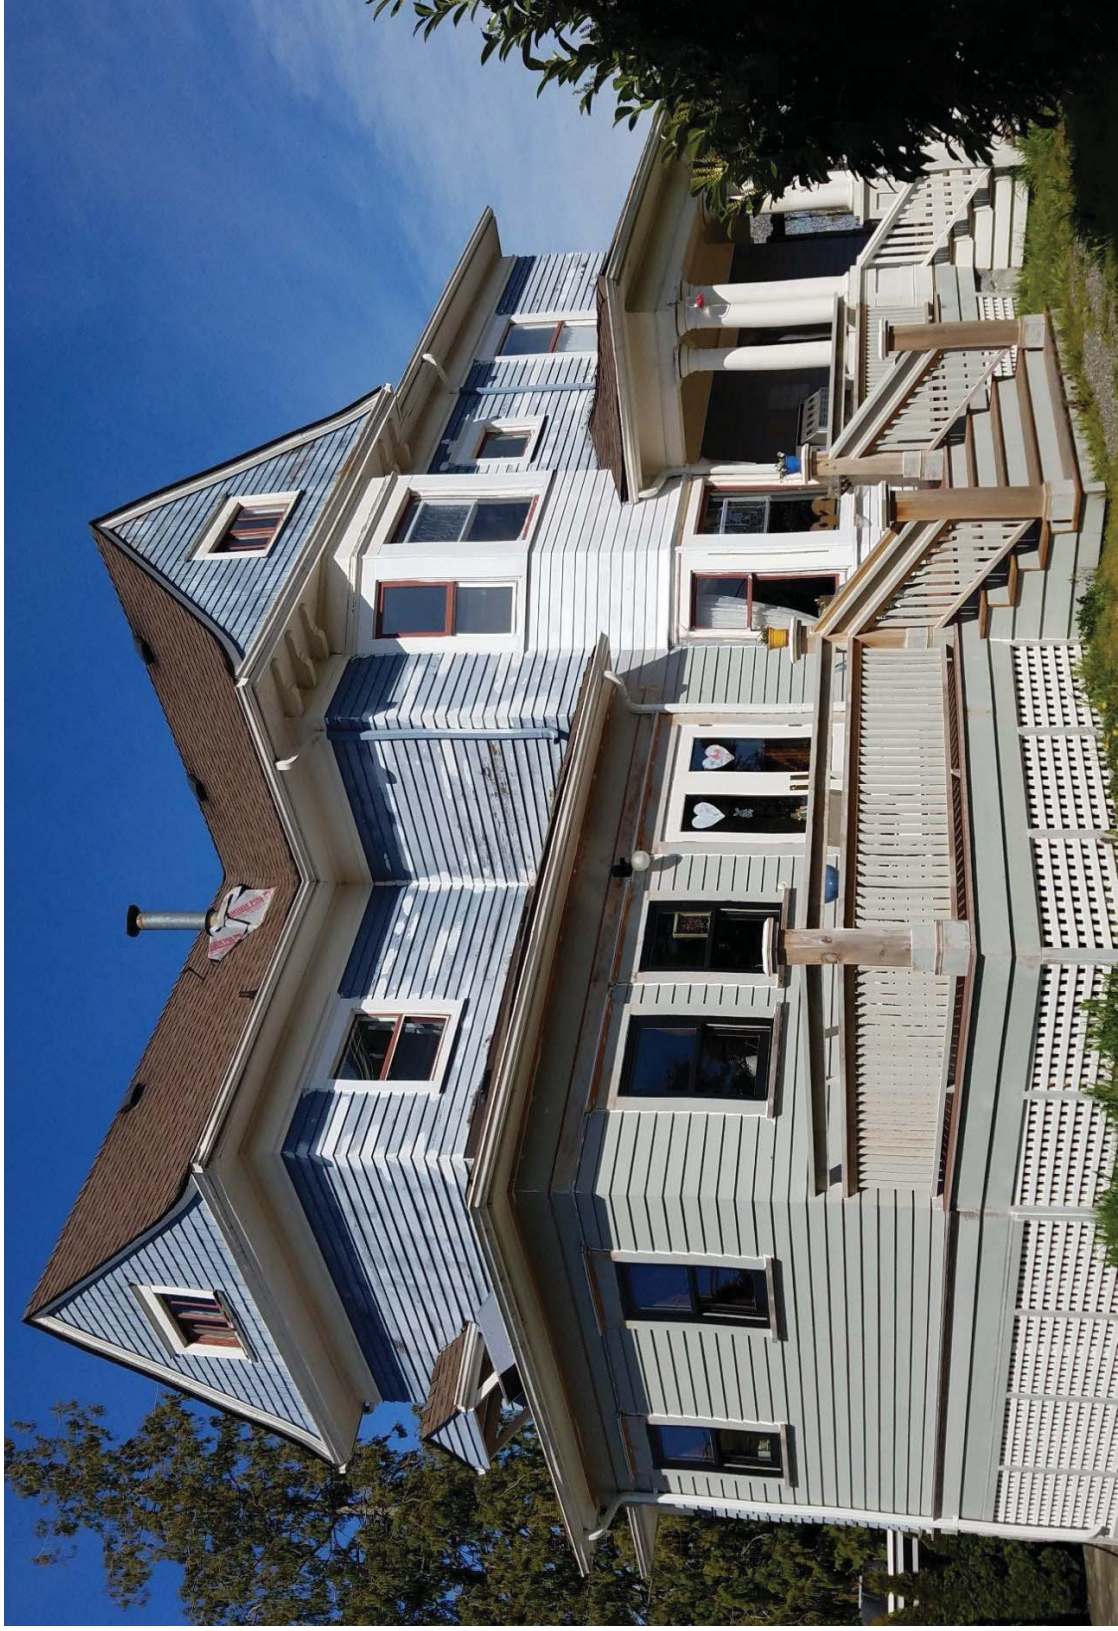
Southwest Corner of House – 2020

Note: The remodeled kitchen added square footage by enclosing the original covered back porch
