HISTORIC BUILDING INVENTORY OF LINCOLN MIXED USE CENTER TACOMA, WASHINGTON

OCTOBER 31, 2022

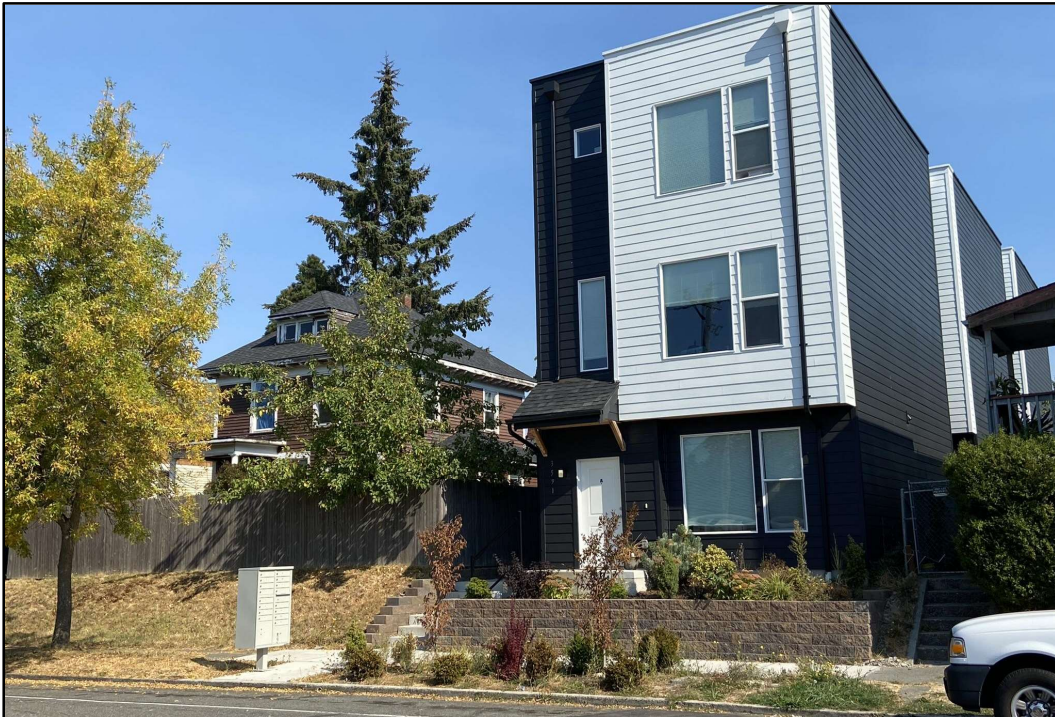
Figure 2. 3589 South G Street, on the left, is dwarfed by its new neighbor to the south, which is not only of a different design but is also built much closer to the street edge. This siting breaks with the pattern of residential development on this block.

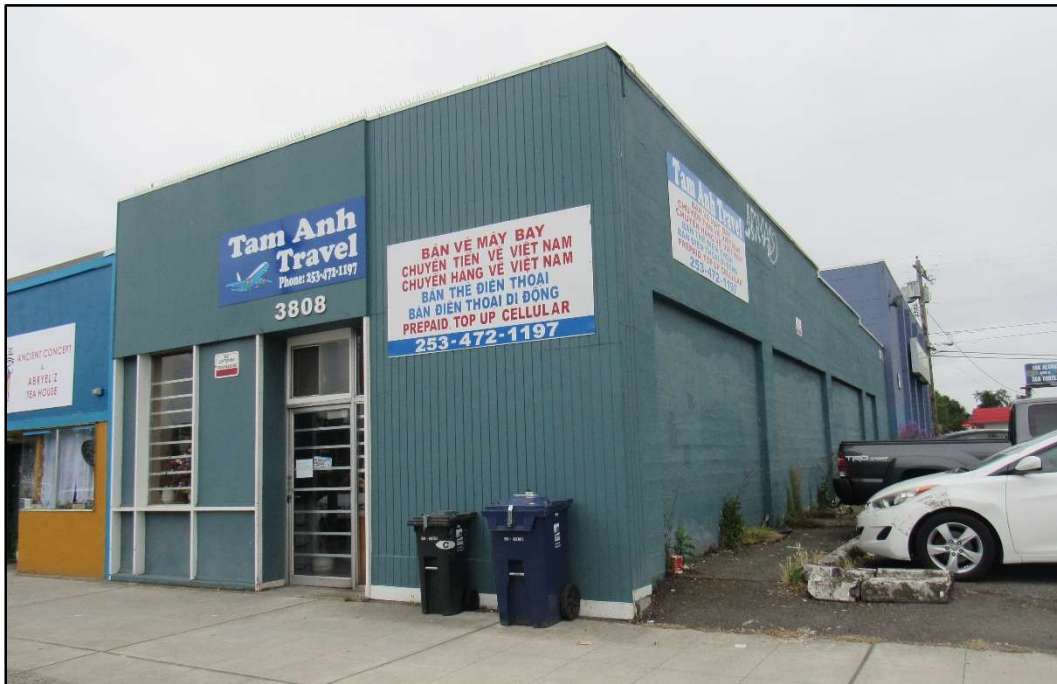
Figure 3. The former Lincoln Bank (3808 South Yakima Avenue), has lost its longtime neighbor, the Model Bakery, which once occupied the space where this surface parking lot is now located (seen on the right). This change has diminished the integrity of setting.

- 3808 South Yakima Avenue (Lincoln Bank) (Figure 3) - The demolition of the historic Model Bakery across next door and its replacement with a surface parking lot has adversely affected the commercial setting of the former Lincoln Bank, which was previously set within a continuous block of businesses. The surface parking lot exposes the north side of the former bank building, which was never intended to be visible.

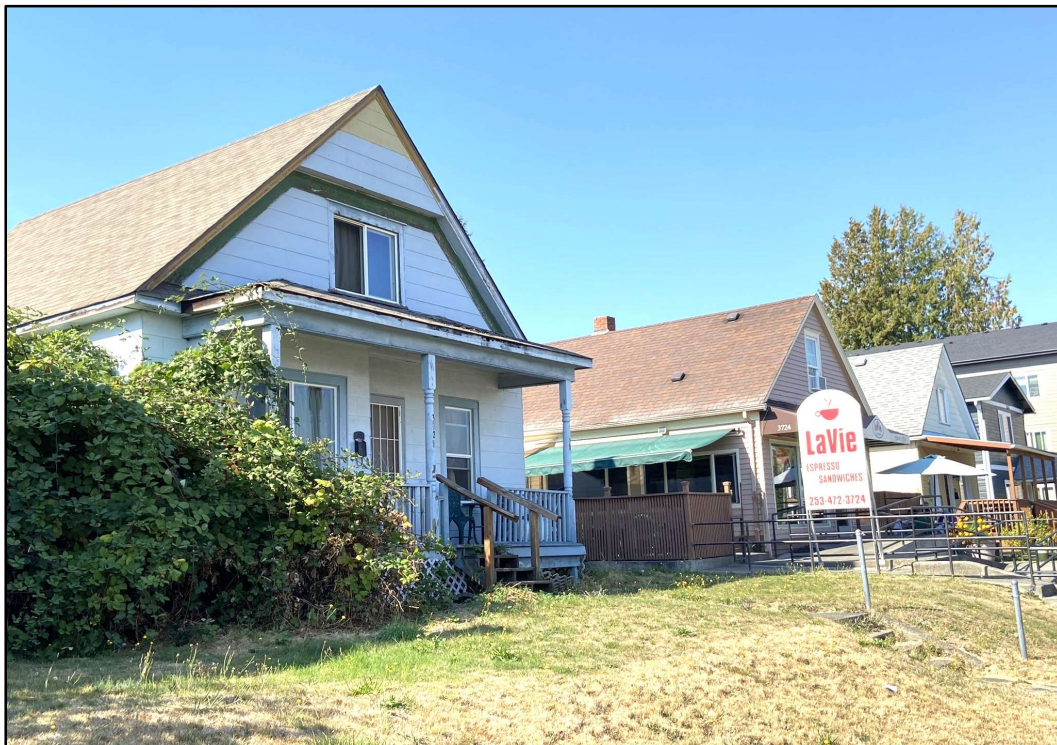
Figure 4. 3728 South Yakima Avenue (left) is part of a string of front-gable buildings that all started out as single-family residences, possibly built by the same developer. The conversion of 3724 South Yakima Avenue has changed the character of the block.

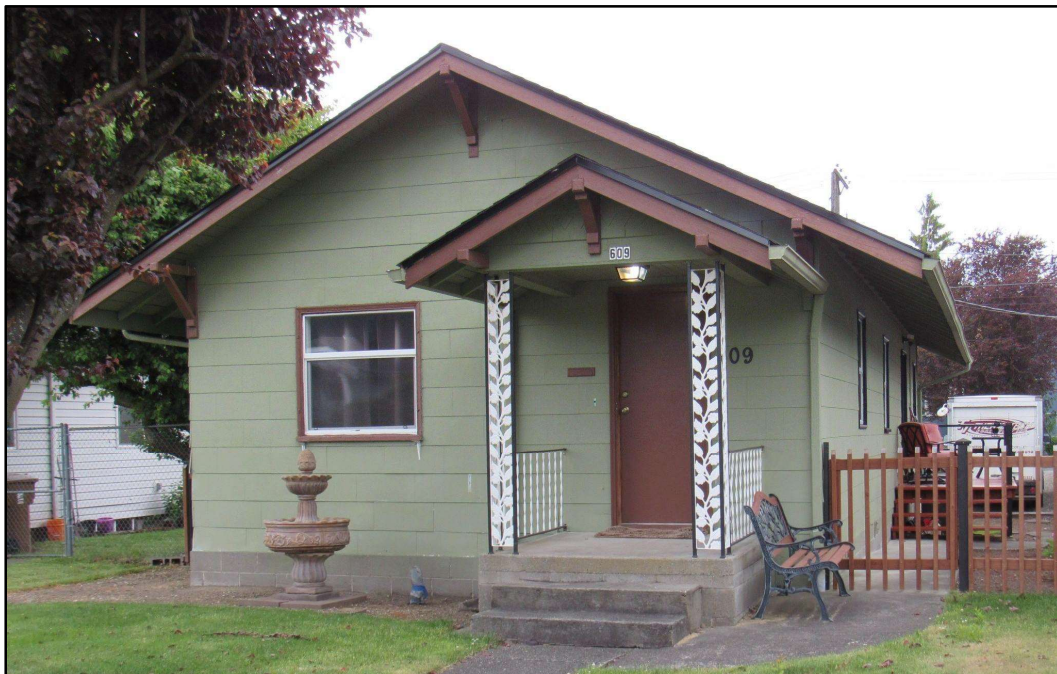
Figure 5. 609 South 34th Street has a porch structure with a design and materials more in keeping with a 1950s house than a Craftsman bungalow.

- 609 South 34th Street (Figure 5) - While this residence is well maintained, the porch has been altered from its historical Craftsman form. Its design integrity is diminished.

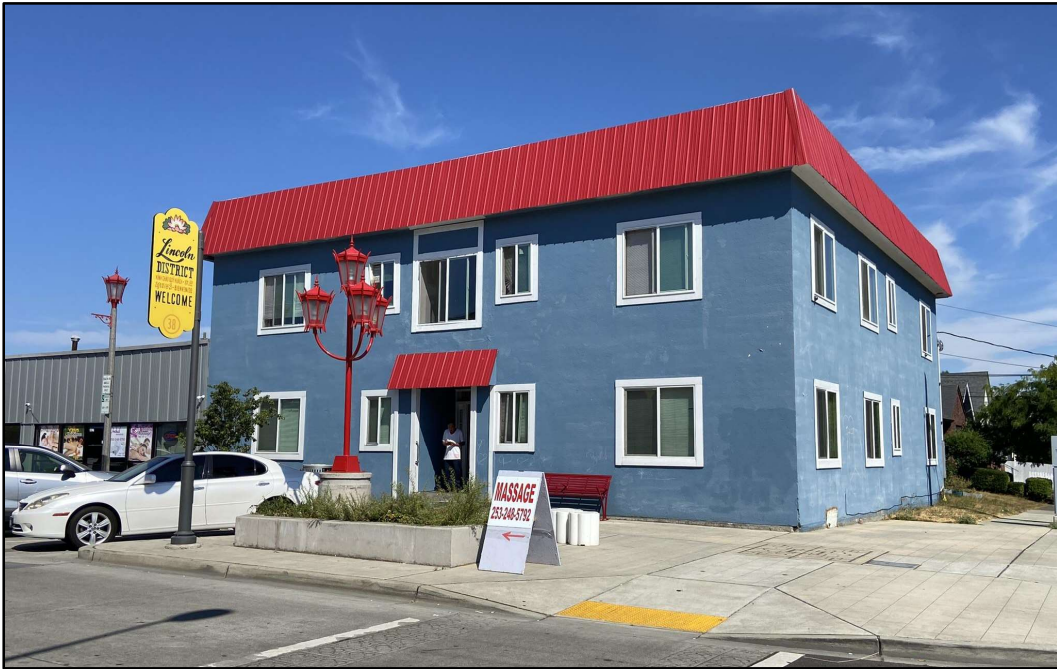
Figure 6. The Vernon Apartments at 3830 Yakima Avenue South has had significant design alterations, including the red, metal-clad mansard-style parapet and front entrance hood.

- 3830 Yakima Avenue South (Vernon Apartments) (Figure 6) - This historic apartment building has been significantly modified, including the addition of a mansard-style parapet clad in red metal sheets and the introduction of window trim. These changes have altered the design that previously was characterized by the stepped parapet and unornamented window surrounds.

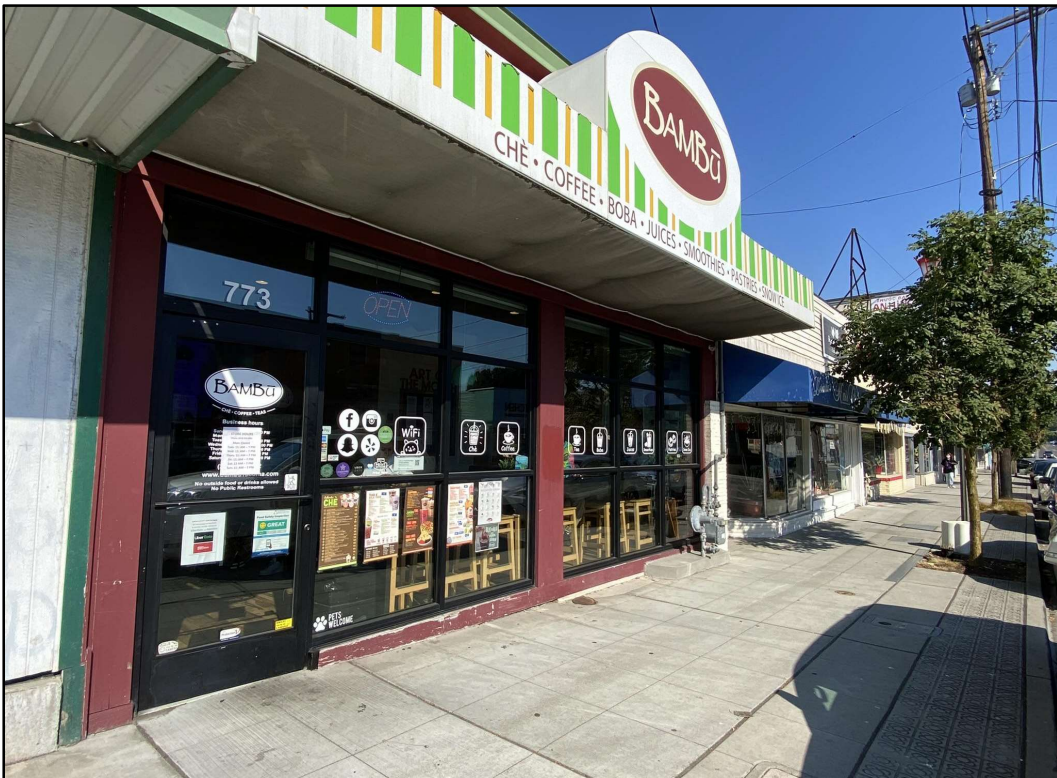
Figure 7. 769 South 38th Street, now known as Bambo restaurant, has recently had its storefront completely replaced with a modern, metal-framed system. This modification has changed its design.

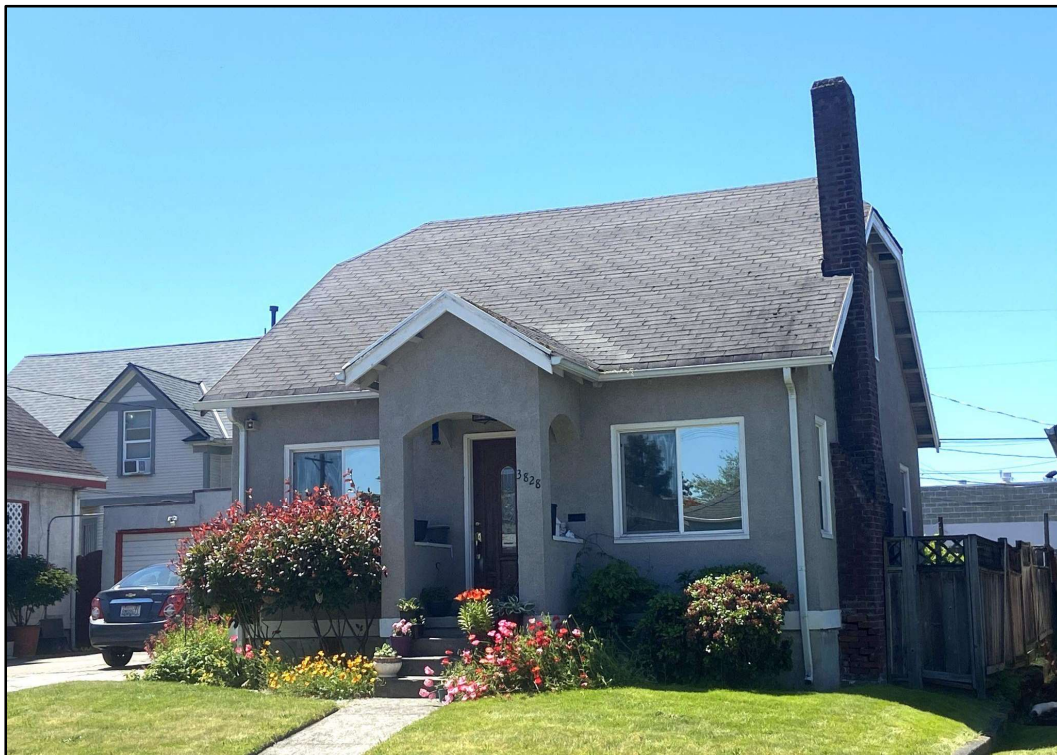
- **Integrity of Materials** - The most common examples of material loss in the Lincoln MUC include replacement of original window and door units as well as the replacement or covering of historical-period siding.
 - 3828 South Park Avenue (Figure 8) - A well-maintained house, its integrity of materials has been diminished by the replacement of the front door and all visible windows with units of incompatible materials and design.
 - 3717 South Yakima Avenue (Figure 9) - This residence has been modified in recent years with all new windows, doors, and siding made of modern materials in designs that contrast with its ca. 1904 origins.
 - 717-723 South 38th Street (Figure 10) - One of the most noticeable changes to this historic movie theater and commercial building is the replacement or covering of the original clapboard siding with incompatible T1-11 cladding.

Figure 8. 3828 South Park Avenue has had all of its visible windows and doors replaced.

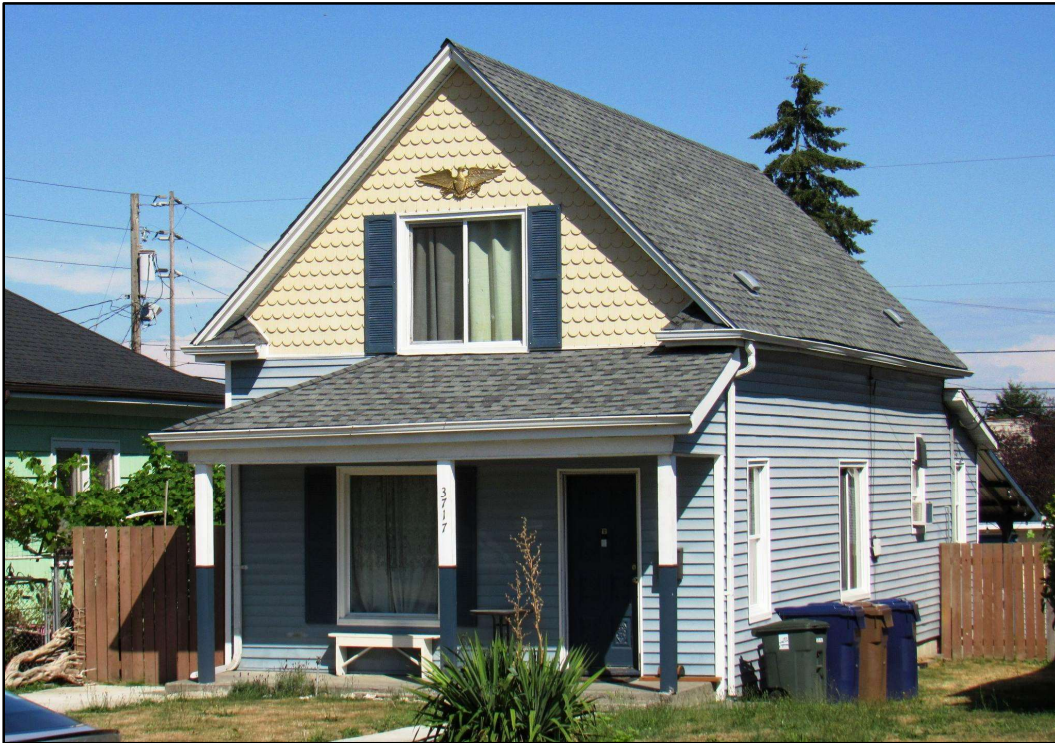
Figure 9. 3717 South Yakima Avenue has had a number of modern alterations, including the introduction of vinyl siding, which is an incompatible material for a building dating to the start of the twentieth century.

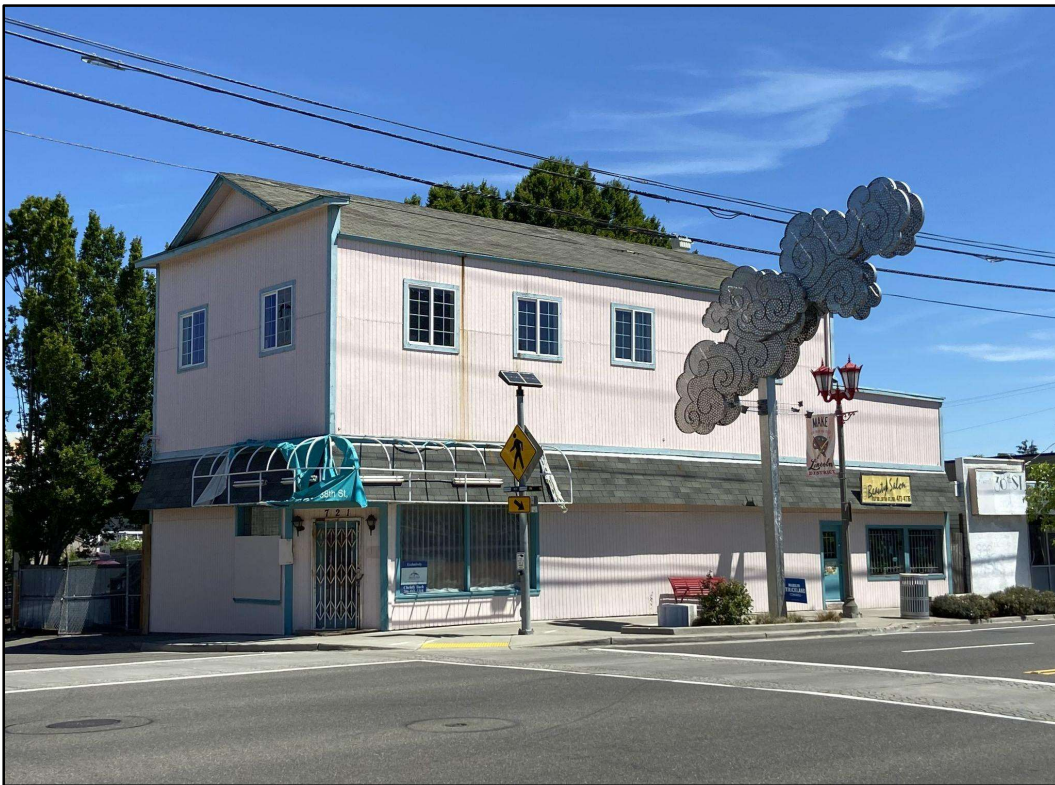
Figure 10. 717-723 South Yakima Avenue's clapboard siding was once a character-defining feature of the building. Now it is clad in T-1-11.

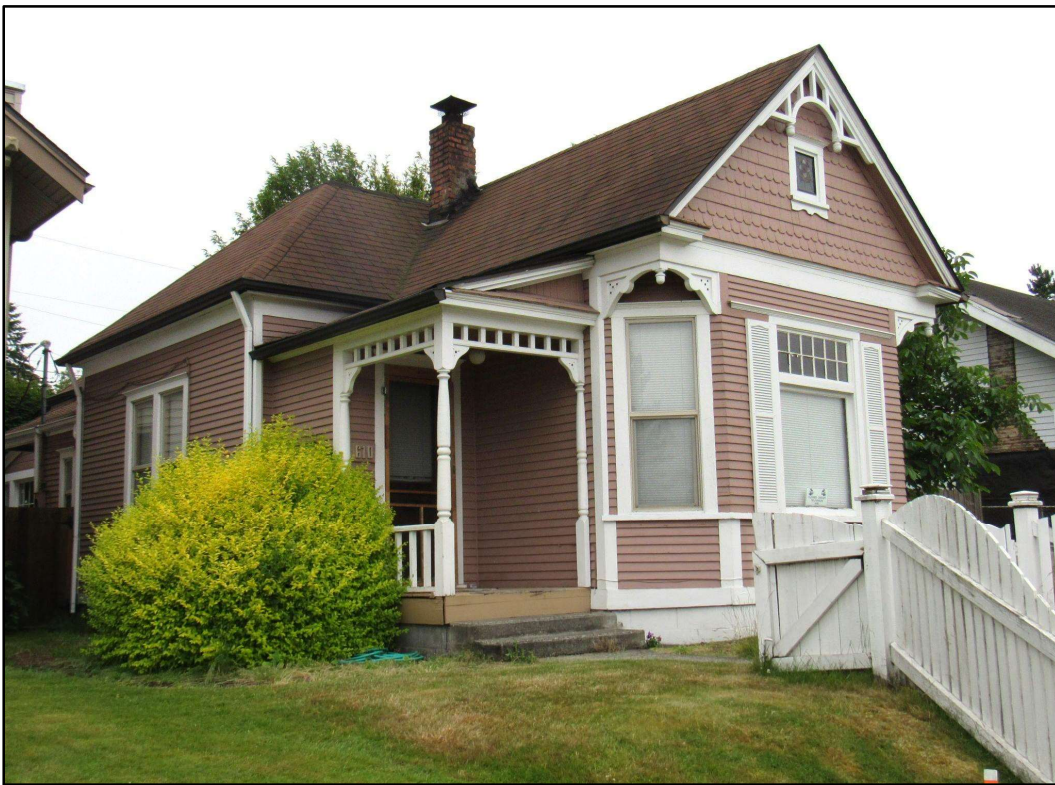
Figure 11. The front (north) and side (west) elevations of Queen Anne style 610 South 38th Street. Note its raised position above the sidewalk.

This building is recommended eligible for listing under Criterion C because, while it has suffered some loss of integrity of materials, it embodies the distinctive characteristics of the late Victorian period of construction.

The residence retains integrity of setting, design, workmanship and feeling. Its material integrity has been somewhat compromised due to the replacement of some windows with vinyl units and the addition of mock (applied) shutters. The introduction of the shutters is a reversible alteration. While the replacement of some windows is a material loss, the simplicity of design of the replacement windows - while incompatible in materials - does not detract from the overall design of the primary facade. The fact that the residence has retained its original or early garage also supports the overall integrity of design of the property as a whole.

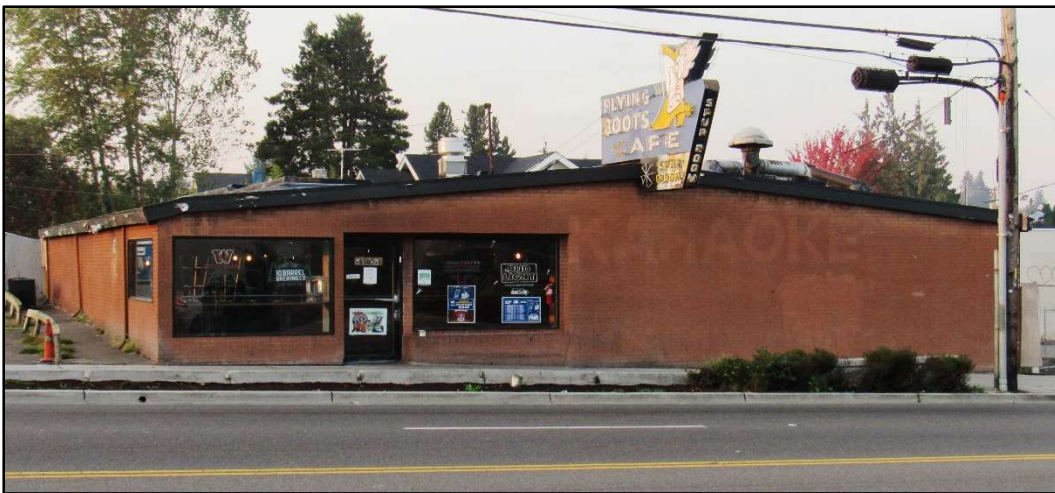
This historic restaurant and tavern presents a challenge when it comes to committing to a date of construction (Figure 12). Records maintained by the Pierce County Assessor date the building to 1960, which is unsupported by other documentary evidence. The recommended construction date is 1955. Tacoma Public Library Tacoma Pierce County Buildings Index and historical permit records show that the Flying Boots Cafe has been in operation on this site since the early 1930s. A small building appears in this location on a 1931 aerial image. However, according to newspaper reports, there was an extensive remodel in 1955, resulting in the building as we see it today.

Figure 12. Flying Boots Café, viewed from the north side of South 38th Street.

This property is recommended eligible for listing in the NRHP under Criterion C because it possesses sufficient integrity to reflect 1950s-era construction of a restaurant with tavern on an important neighborhood thoroughfare. It has integrity of location, design, materials, workmanship, and feeling. The overall integrity is somewhat impacted by the presence of smaller, service structures on the southwest of the site, at least some of which may predate the 1955 revamp of the property. However, these do not affect the building as it is experienced by the public and the overall form is preserved. Integrity of setting is impacted by the loss or alterations of a number of nearby buildings. These setting losses are not sufficient to overshadow the general setting of a busy, neighborhood-commercial district.

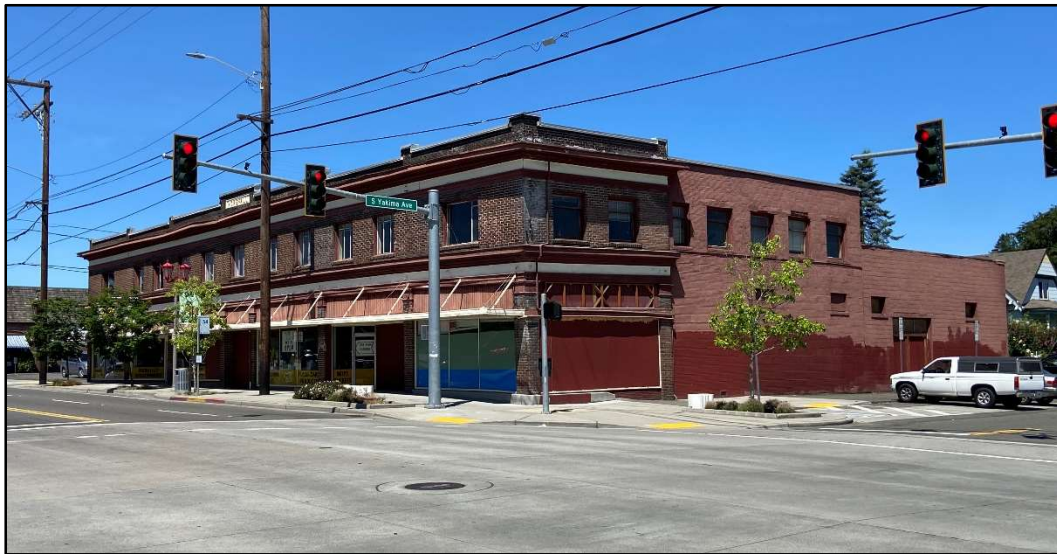
Figure 13. This view of the Horsfall Building was taken from the southeast corner of South 38th Street and South Yakima Avenue, bridging the commercial districts of both streets.

This mixed-use, commercial building was constructed in 1916 and long been an important one on the Lincoln District landscape (Figure 15). Original owner F. H. Horsfall hired Tacoma architect Emanuel “E.J.” Bresemann and contractor M.A. Petrich. According to an article on Historylink, Bresemann was one of Washington State’s first 20 licensed architects. Well known for being a designer of schools and residences, other examples of his commercial work in Tacoma include the Manley-Thompson Ford Agency at 1302-1306 Fawcett Avenue (Property ID 706871) and the former Nalley’s Fine Foods Company Headquarters at 509 Puyallup Avenue (demolished).

Historically the building played host to community events in its Liberty Dance Hall, which included public meetings and other social functions. Past businesses included Haering’s Groceterium, Hogan’s Fine Foods, Ricono’s Bargain Annex, and Hartman’s Furniture. Today it houses Big Vac Janitorial. According to Historic Tacoma, a local preservation advocacy group, the Horsfall Building is now partially vacant and its future is uncertain due to multiple unaddressed maintenance issues.

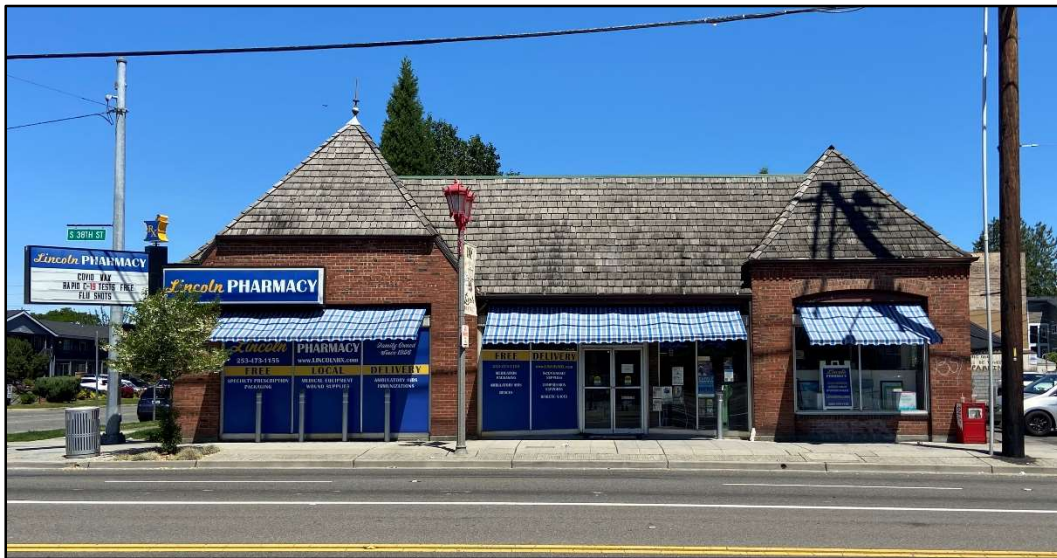
Today serving as Lincoln Pharmacy, this commercial building started out as a branch of the Tacoma-based Totem Foods grocery store chain in 1939 (Figure 15), another example being located at 2501 North Alder Street in Tacoma. Other businesses located here in the past are Safeway and Failor’s Prescription Pharmacy. Its striking character contains some of the hallmarks of French Eclectic style, such as the corner towers, varied roof profiles, and wood-shingle roof.

Figure 14. Today’s Lincoln Pharmacy, originally Totem Foods, as seen from the south side of South 38th Street.

Former Totem Foods Store No. 7 is recommended eligible for listing in the NRHP under Criterion C embodies the characteristics of a branded grocery store chain dating to the late 1930s. It possesses integrity of location, setting, design, materials, workmanship, and feeling. While integrity of design has been compromised by the infill of multiple openings and the installation of modern, metal-framed, door-and-window systems, the overall integrity of design is sufficiently intact to reflect its historical design.

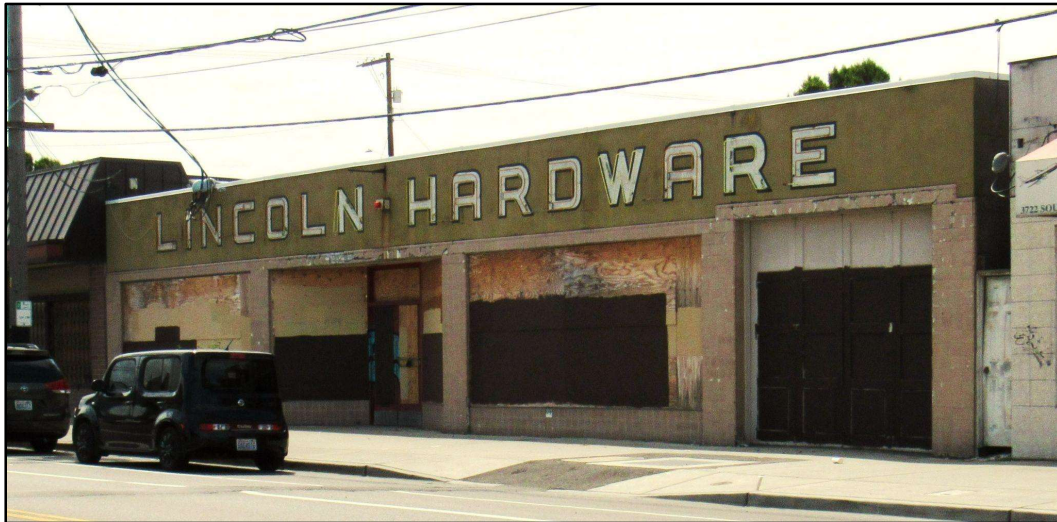
Figure 15. Lincoln Hardware’s historical features appear to have been maintained behind the boards that have shuttered the building since its recent closure.

Former Lincoln Hardware is recommended eligible for listing in the NRHP under Criterion C because it embodies the distinctive characteristics of the post-World War II period of commercial design. Despite the windows and doors being boarded over following recent closure of the business, sufficient evidence suggests that the units are still in place. The building possesses integrity of location, setting, design, materials, workmanship, and feeling.

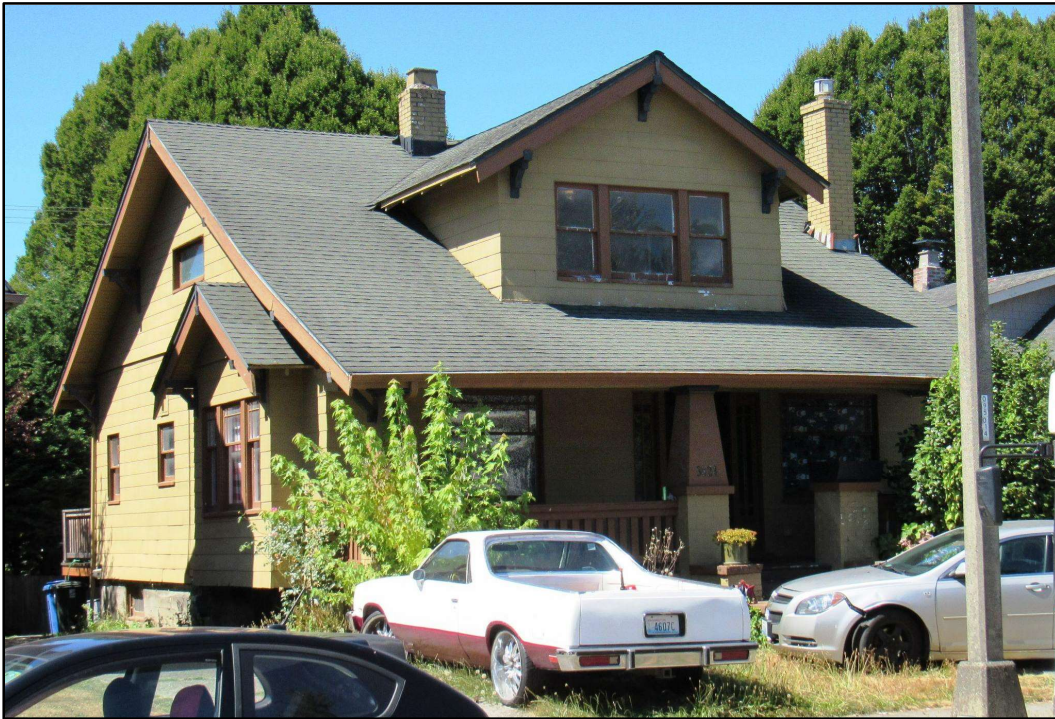
Pierce County Assessor records indicate that this single-family, Craftsman residence was constructed in 1925 (Figure 16). It is recommended eligible for listing in the NRHP under Criterion C because it embodies the distinctive characteristics of 1920s residential architecture. The addition of asbestos siding in 1966 was a common alteration and unlikely to have removed the original cladding. The only identifiable change is the replacement of the front door with a mock-paneled unit. On balance, this does not sufficiently alter the material integrity to eliminate it from consideration for listing in the NRHP

Figure 16. This house at 3824 South G Street has retained almost all original exterior features that characterize it as a Craftsman residence.

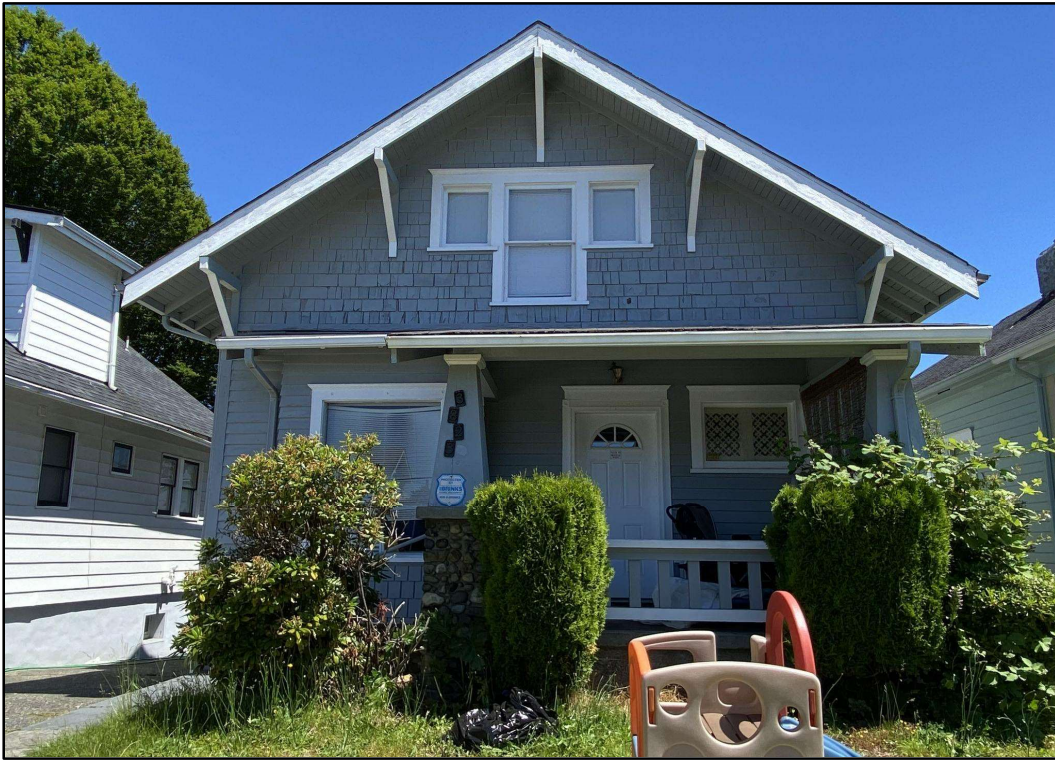
Figure 17. 3823 South Park Avenue is another Craftsman style house that has retained most of its important historical features.

This residence is recommended eligible for listing in the NRHP under Criterion C because it embodies the distinctive characteristics of 1910s residential architecture. While its integrity of materials is somewhat diminished by the loss of original windows to create a picture window and replacement of the front door with an incompatible mock-panel unit, the residence possesses integrity of location, setting, design, materials, workmanship, and feeling. On balance, material losses do not not substantively affect the house's eligibility for listing in the NRHP under Criterion C.

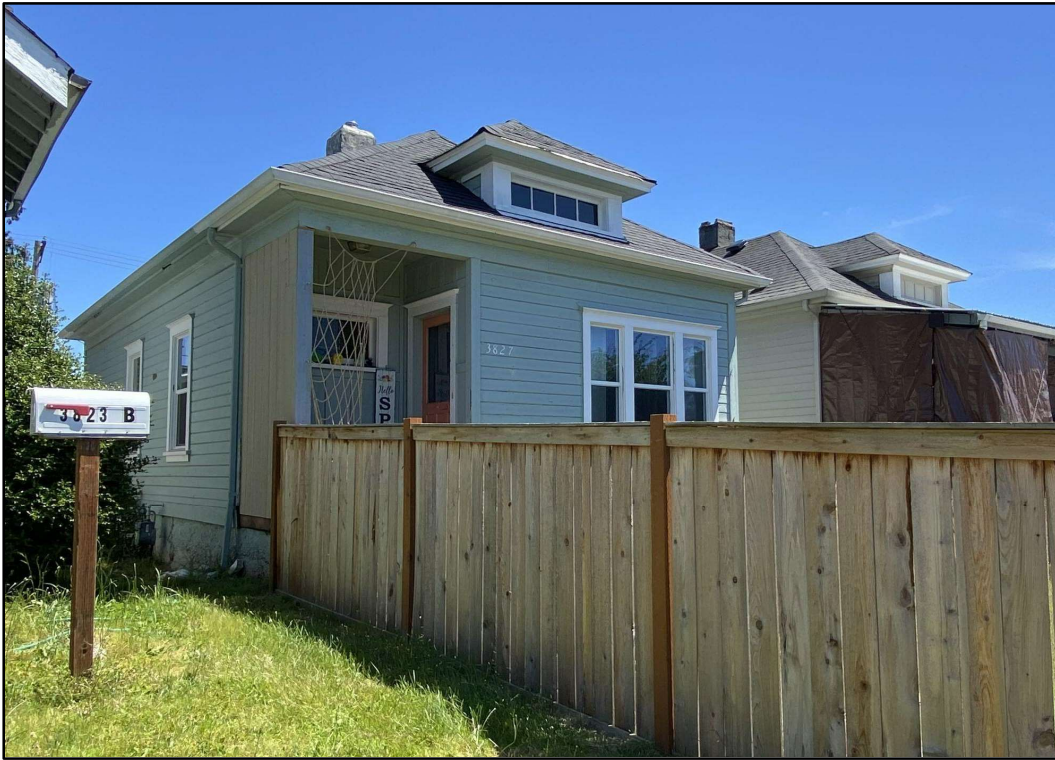
Figure 18. 3827 South Park Avenue was designed as one of a pair with 3829 South Park Avenue. The two residences even share a side porch that appears on the 1912 Sanborn Fire Insurance map.

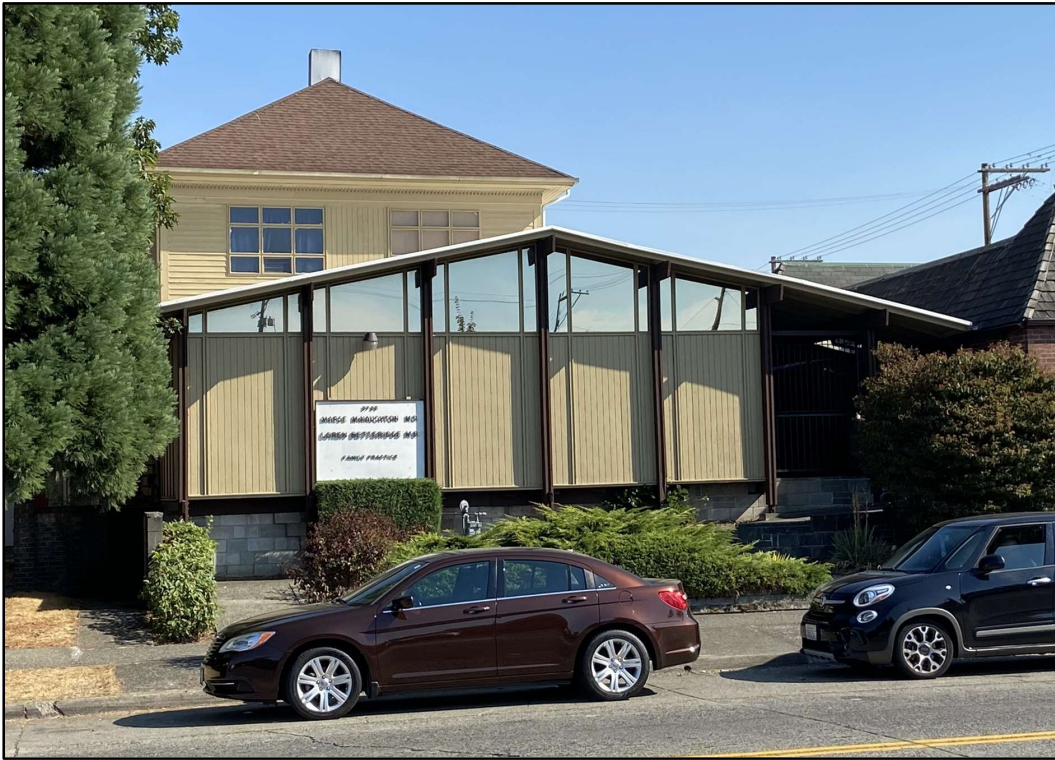
Figure 19. Both the original residence and the 1955 addition that created this medical office at 3733 South Thompson Avenue are visible in this photograph taken from the opposite side of the street.

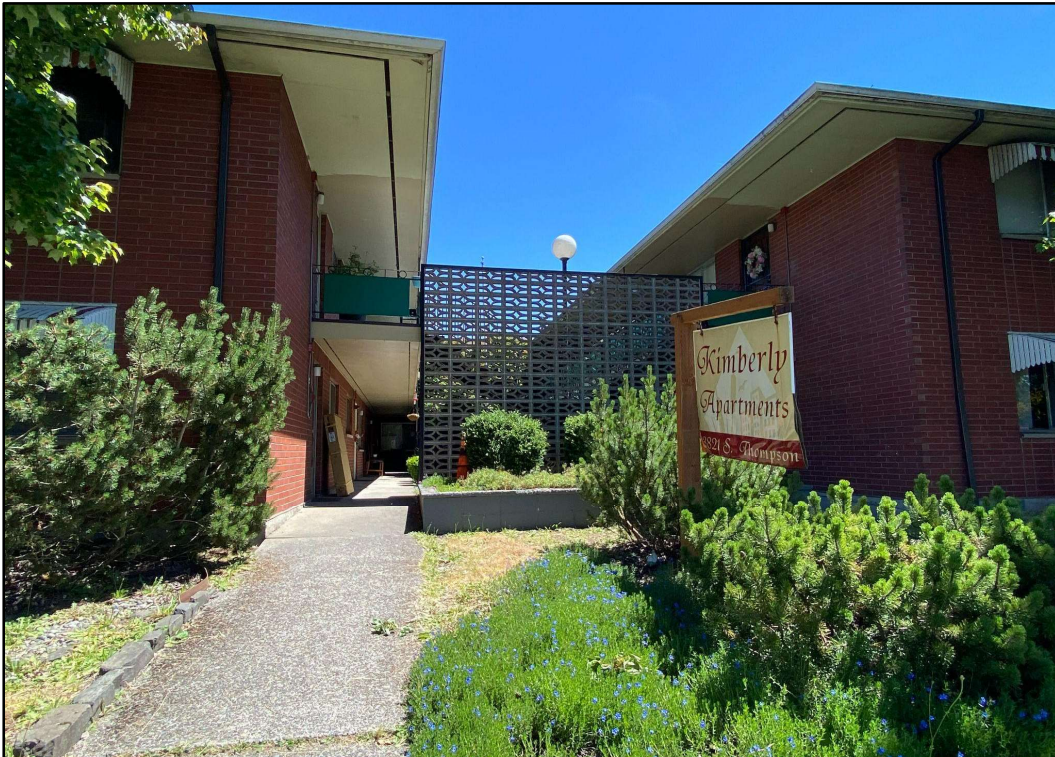
Figure 20. Difficult to photograph in full because of street trees, Kimberly Apartments at 3821 South Thompson Avenue has a character-defining courtyard that provides access to all of the apartments.

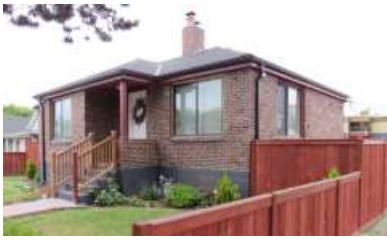
605 S 34th St	524480	1910 (ca)	-Varied roof profile -One story -Multiple additions -Vinyl siding -Vinyl windows	<input checked="" type="checkbox"/> Setting <input checked="" type="checkbox"/> Location <input type="checkbox"/> Design <input type="checkbox"/> Materials <input type="checkbox"/> Workmanship <input type="checkbox"/> Feeling	<input type="checkbox"/> Yes <input checked="" type="checkbox"/> No Fails to possess sufficient integrity for design or construction significance	<input type="checkbox"/> Yes <input checked="" type="checkbox"/> No

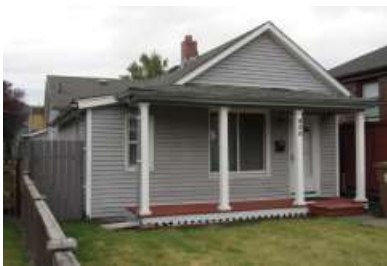
609 S 34th St	524521	1925 (ca) 1952 (ca)	-Single story -Gable roof -Asbestos siding -Concrete-block foundation	<input checked="" type="checkbox"/> Setting <input type="checkbox"/> Location <input type="checkbox"/> Design <input type="checkbox"/> Materials <input type="checkbox"/> Workmanship <input type="checkbox"/> Feeling	<input type="checkbox"/> Yes <input checked="" type="checkbox"/> No Fails to possess sufficient integrity for design or construction significance	<input type="checkbox"/> Yes <input checked="" type="checkbox"/> No

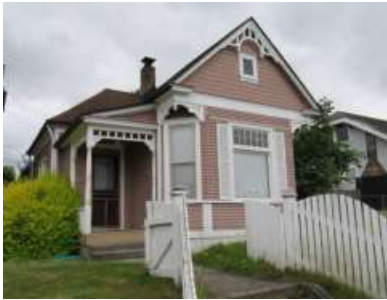
613 S 34th St	728262	1943	-One story -Cross-gable roof	<input type="checkbox"/> Setting <input checked="" type="checkbox"/> Location <input checked="" type="checkbox"/> Design <input type="checkbox"/> Materials <input type="checkbox"/> Workmanship <input type="checkbox"/> Feeling	<input type="checkbox"/> Yes <input checked="" type="checkbox"/> No Fails to possess sufficient integrity to qualify for its design or method of construction	<input type="checkbox"/> Yes <input checked="" type="checkbox"/> No

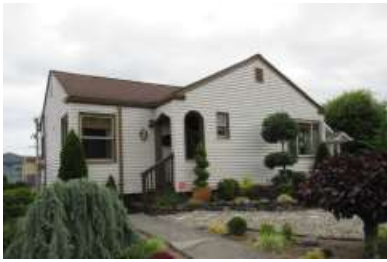
616 S 34th St	512321	1925	-Raised position above sidewalk -Symmetrical front facade -Jerkinhead roof form -Clapboard siding -Eclectic historicist (revival) details on front porch	<input type="checkbox"/> Setting <input checked="" type="checkbox"/> Location <input checked="" type="checkbox"/> Design <input type="checkbox"/> Materials <input checked="" type="checkbox"/> Workmanship <input checked="" type="checkbox"/> Feeling	<input type="checkbox"/> Yes <input checked="" type="checkbox"/> No Fails to possess sufficient integrity to qualify for design or construction significance	<input type="checkbox"/> Yes <input checked="" type="checkbox"/> No

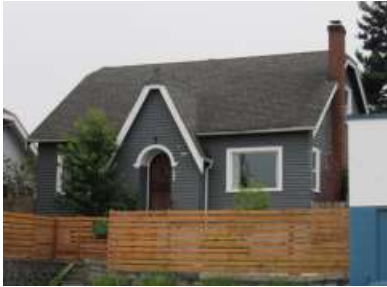
608 S 35th St	536311	1907	-Raised position above sidewalk -Complex hip roof forms -Front porch with Italianate and Alpine details -Incompatible, non-historic windows	<input checked="" type="checkbox"/> Setting <input checked="" type="checkbox"/> Location <input checked="" type="checkbox"/> Design <input type="checkbox"/> Materials <input checked="" type="checkbox"/> Workmanship <input checked="" type="checkbox"/> Feeling	<input type="checkbox"/> Yes <input checked="" type="checkbox"/> No Fails to possess sufficient integrity for significance in design or method of construction.	<input type="checkbox"/> Yes <input checked="" type="checkbox"/> No

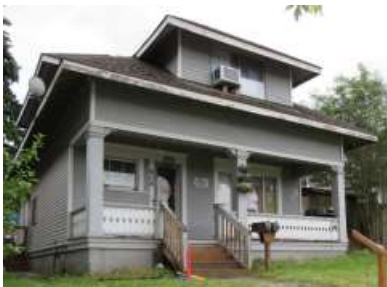
622 S 35th St	503573	1900 (ca)	-Prominent, corner location - Raised position above sidewalk -Varying roof planes -Dominant, non-historic front deck -Modern window and siding materials -Detached garage at street level	<input checked="" type="checkbox"/> Setting <input checked="" type="checkbox"/> Location <input type="checkbox"/> Design <input type="checkbox"/> Materials <input type="checkbox"/> Workmanship <input type="checkbox"/> Feeling	<input type="checkbox"/> Yes <input checked="" type="checkbox"/> No Fails to possess sufficient integrity for significance in design or method of construction	<input type="checkbox"/> Yes <input checked="" type="checkbox"/> No

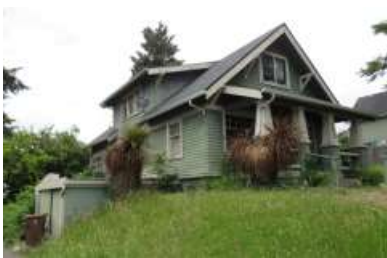
816 S 37th St	502318	1914	-Prominent location on corner lot -Flared gable roof Full-length porch with Craftsman detailing -Knee braces and fascia boards with carved ends -Fiber-cement siding -Vinyl windows	<input type="checkbox"/> Setting <input checked="" type="checkbox"/> Location <input checked="" type="checkbox"/> Design <input type="checkbox"/> Materials <input type="checkbox"/> Workmanship <input checked="" type="checkbox"/> Feeling	<input type="checkbox"/> Yes <input checked="" type="checkbox"/> No Fails to possess sufficient integrity to achieve significance in design or method of construction	<input type="checkbox"/> Yes <input checked="" type="checkbox"/> No

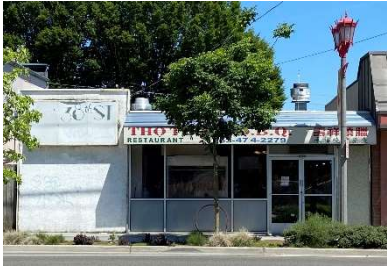
717-723 S 38th St	536199	1914 (ca)	-Two stories -Gable roof with false front -Canted corner entrance -Predominance of T1-11 cladding -Low proportion of display windows for a neighborhood commercial building -Incompatible upstairs windows	<input checked="" type="checkbox"/> Setting <input checked="" type="checkbox"/> Location <input type="checkbox"/> Design <input type="checkbox"/> Materials <input type="checkbox"/> Workmanship <input type="checkbox"/> Feeling	<input type="checkbox"/> Yes <input checked="" type="checkbox"/> No Fails to possess sufficient integrity for significance in design or method of construction	<input type="checkbox"/> Yes <input checked="" type="checkbox"/> No

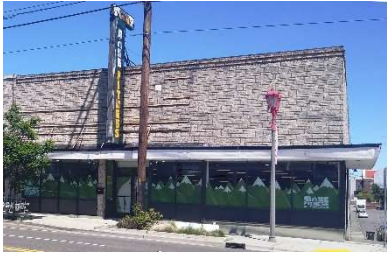
756 S 38th St	536201	1913 (ca)	-Position at sidewalk edge -Single story with flat roof -Two units of different visual aesthetic -Incompatible mix of materials	<input checked="" type="checkbox"/> Setting <input checked="" type="checkbox"/> Location <input type="checkbox"/> Design <input type="checkbox"/> Materials <input type="checkbox"/> Workmanship <input type="checkbox"/> Feeling	<input type="checkbox"/> Yes <input checked="" type="checkbox"/> No Fails to possess sufficient integrity for significance in design or method of construction	<input type="checkbox"/> Yes <input checked="" type="checkbox"/> No

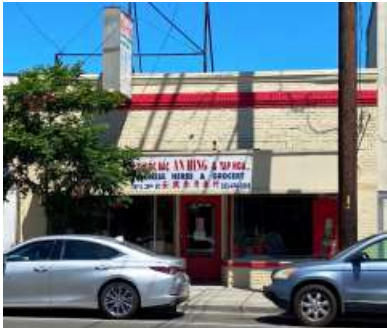
769-769 1/2 S 38th St	536188	1923 (ca)	-Mid-block location in a dense, neighborhood commercial district -Single story with two commercial bays -Historic storefront at 769 South 38th Street, with plate glass windows, inset entrance, and Roman brick cladding -New storefront to 769½ South 38th Street Incompatible mix of siding	<input checked="" type="checkbox"/> Setting <input checked="" type="checkbox"/> Location <input type="checkbox"/> Design <input type="checkbox"/> Materials <input type="checkbox"/> Workmanship <input type="checkbox"/> Feeling	<input type="checkbox"/> Yes <input checked="" type="checkbox"/> No Fails to possess sufficient integrity for significance in design or method of construction	<input type="checkbox"/> Yes <input checked="" type="checkbox"/> No

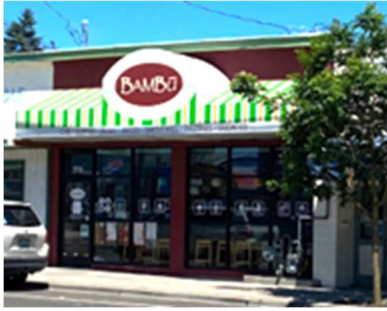
775 S 38th St Harry K. Todd Block	536195	1910	-Prominent corner location -Part of a continuous commercial frontage -Relatively large, single-occupancy business in a neighborhood-commercial district -One story with parapet -Stucco cladding -Contemporary mural	<input checked="" type="checkbox"/> Setting <input checked="" type="checkbox"/> Location <input type="checkbox"/> Design <input checked="" type="checkbox"/> Materials <input type="checkbox"/> Workmanship <input checked="" type="checkbox"/> Feeling	<input type="checkbox"/> Yes <input checked="" type="checkbox"/> No Fails to possess sufficient integrity for significance in design or method of construction	<input type="checkbox"/> Yes <input checked="" type="checkbox"/> No

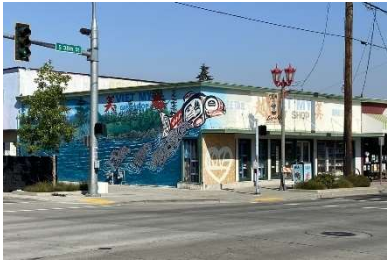
803-809 S 38th St Horsfall Building	536212	1916	-Prominent corner position on historically-important intersection in neighborhood commercial district -Two stories Long frontage along sidewalk -Brick and iron facade -Plate-glass storefronts -Potentially historic signage	<input type="checkbox"/> Setting <input checked="" type="checkbox"/> Location <input checked="" type="checkbox"/> Design <input checked="" type="checkbox"/> Materials <input checked="" type="checkbox"/> Workmanship <input checked="" type="checkbox"/> Feeling	<input checked="" type="checkbox"/> Yes <input type="checkbox"/> No Embodies the distinctive characteristics of a 1910s-era mixed-use building in a neighborhood commercial district	<input checked="" type="checkbox"/> Yes <input type="checkbox"/> No

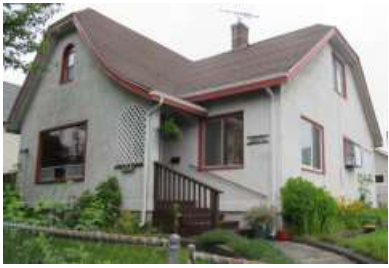
755 S 39th St	536157	1905	-Moderate-pitch, front-gable roof -Patterned shingle and clapboard siding -Full-length front porch -Vinyl windows	<input checked="" type="checkbox"/> Setting <input checked="" type="checkbox"/> Location <input checked="" type="checkbox"/> Design <input type="checkbox"/> Materials <input checked="" type="checkbox"/> Workmanship <input checked="" type="checkbox"/> Feeling	<input type="checkbox"/> Yes <input checked="" type="checkbox"/> No Fails to possess sufficient integrity for significance in design or method of construction	<input type="checkbox"/> Yes <input checked="" type="checkbox"/> No

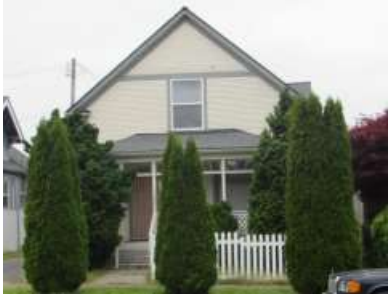
758 S 39th St	536158	1908	-Pyramidal roof -Pedimented door -Cedar cladding -Mix of window materials and styles -Attached secondary residence	<input checked="" type="checkbox"/> Setting <input checked="" type="checkbox"/> Location <input checked="" type="checkbox"/> Design <input type="checkbox"/> Materials <input checked="" type="checkbox"/> Workmanship <input checked="" type="checkbox"/> Feeling	<input type="checkbox"/> Yes <input checked="" type="checkbox"/> No Fails to possess sufficient integrity for significance in design or method of construction	<input type="checkbox"/> Yes <input checked="" type="checkbox"/> No

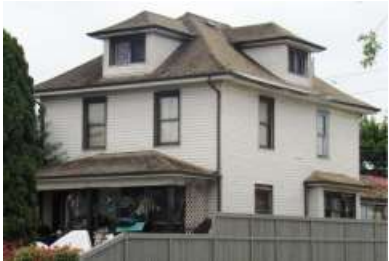
764 S 39th St	536146	1902	-Square profile with flared hip roof -Flared hip dormers -Full-length porch with columns -Wood-framed sliding sash windows -Vinyl siding	<input type="checkbox"/> Setting <input checked="" type="checkbox"/> Location <input checked="" type="checkbox"/> Design <input type="checkbox"/> Materials <input type="checkbox"/> Workmanship <input type="checkbox"/> Feeling	<input type="checkbox"/> Yes <input checked="" type="checkbox"/> No Fails to possess sufficient integrity for significant design or method of construction	<input type="checkbox"/> Yes <input checked="" type="checkbox"/> No

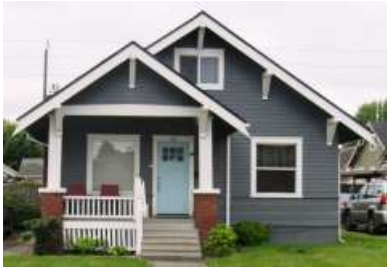
751 S 40th St	506220	1918	-Location on corner lot with detached garage -Low-pitch, cross-gable roof -Offset front porch with wood and river rock materials -True-divided-light, wood-framed windows -River rock chimney	<input checked="" type="checkbox"/> Setting <input checked="" type="checkbox"/> Location <input checked="" type="checkbox"/> Design <input type="checkbox"/> Materials <input type="checkbox"/> Workmanship <input checked="" type="checkbox"/> Feeling	<input type="checkbox"/> Yes <input checked="" type="checkbox"/> No Fails to possess sufficient integrity for design or construction significance	<input type="checkbox"/> Yes <input checked="" type="checkbox"/> No

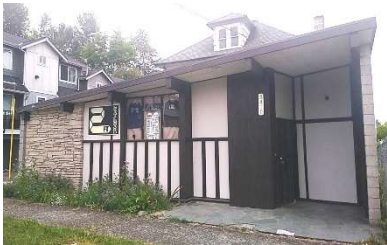
3410 S G St Hope Chest Bridal Shop	728265	1905; 1956	-Juxtaposition of commercial Modernism added to a much-altered, historical residence -Single-story, commercial addition -Nearly-flat, shed roof -Mix of materials on the storefront, including stone, concrete block, and wood beams	<input type="checkbox"/> Setting <input checked="" type="checkbox"/> Location <input checked="" type="checkbox"/> Design <input type="checkbox"/> Materials <input checked="" type="checkbox"/> Workmanship <input type="checkbox"/> Feeling	<input type="checkbox"/> Yes <input checked="" type="checkbox"/> No Fails to possess sufficient integrity for significance in design or method of construction	<input type="checkbox"/> Yes <input checked="" type="checkbox"/> No

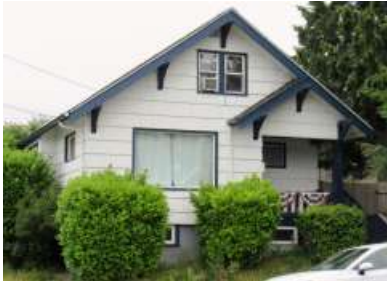
3577 S G St	533421	1900 (ca); 1997	-Raised position above the sidewalk -Large lot with mature tree -Complex, cross-gable roof form -Decorative wood cladding -Wood-framed windows	<input type="checkbox"/> Setting <input checked="" type="checkbox"/> Location <input type="checkbox"/> Design <input checked="" type="checkbox"/> Materials <input checked="" type="checkbox"/> Workmanship <input checked="" type="checkbox"/> Feeling	<input type="checkbox"/> Yes <input checked="" type="checkbox"/> No Fails to possess sufficient integrity for significance in design or method of construction	<input type="checkbox"/> Yes <input checked="" type="checkbox"/> No

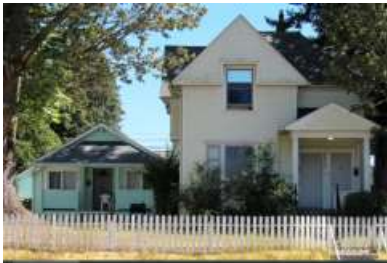
3585 S G St	728412	1907	-Raised position above sidewalk -One-and-one-half stories tall -Front-gable roof with returns -Recently replaced siding, windows, and doors	<input type="checkbox"/> Setting <input checked="" type="checkbox"/> Location <input type="checkbox"/> Design <input type="checkbox"/> Materials <input type="checkbox"/> Workmanship <input type="checkbox"/> Feeling	<input type="checkbox"/> Yes <input checked="" type="checkbox"/> No Fails to possess sufficient integrity for significance in design or method of construction	<input type="checkbox"/> Yes <input checked="" type="checkbox"/> No
