HISTORIC BUILDING INVENTORY OF LINCOLN MIXED USE CENTER TACOMA, WASHINGTON

OCTOBER 31, 2022

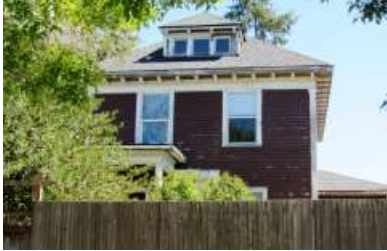
3619 S G St Al's Barber-shop	728270	1912 (ca); 1934	-Residence with on-site, one-room commercial building -Residence set back from sidewalk -Residence characterized by historic joinery -Commercial building characterized by modern materials, notably mansard-style projecting eaves, brick cladding, and replacement doors and windows	<input checked="" type="checkbox"/> Setting <input checked="" type="checkbox"/> Location <input checked="" type="checkbox"/> Design <input type="checkbox"/> Materials <input checked="" type="checkbox"/> Workmanship <input checked="" type="checkbox"/> Feeling	<input type="checkbox"/> Yes <input checked="" type="checkbox"/> No Fails to possess sufficient integrity for significance in design or method of construction	<input type="checkbox"/> Yes <input checked="" type="checkbox"/> No

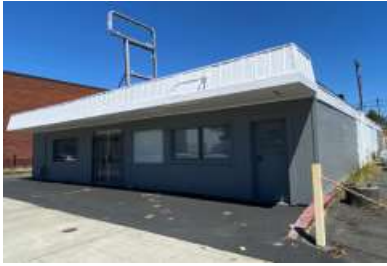
3715 S G St Lincoln Service Station	728272	1949	-Single story Set-back position within parking lot -Canted customer entrance with zig-zag window projections -Flat roof with deep eaves -Mix of cladding materials	<input checked="" type="checkbox"/> Setting <input checked="" type="checkbox"/> Location <input type="checkbox"/> Design <input type="checkbox"/> Materials <input checked="" type="checkbox"/> Workmanship <input type="checkbox"/> Feeling	<input type="checkbox"/> Yes <input checked="" type="checkbox"/> No Fails to possess sufficient integrity for design or construction significance	<input type="checkbox"/> Yes <input checked="" type="checkbox"/> No

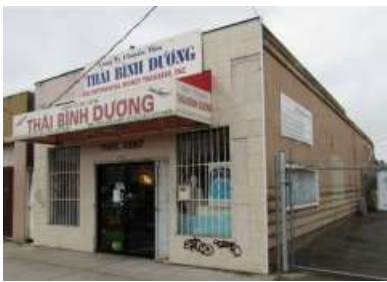
3722 S G St L.A. Hughes Store	728273	1915	-Location on sidewalk edge -Narrow street frontage -Predominance of signage -Degrading cladding	<input type="checkbox"/> Setting <input checked="" type="checkbox"/> Location <input type="checkbox"/> Design <input type="checkbox"/> Materials <input type="checkbox"/> Workmanship <input type="checkbox"/> Feeling	<input type="checkbox"/> Yes <input checked="" type="checkbox"/> No Fails to possess sufficient integrity to reflect design or construction significance	<input type="checkbox"/> Yes <input checked="" type="checkbox"/> No

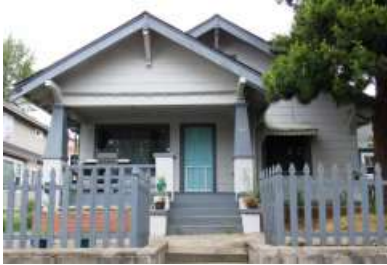
3819 S G St	728276	1925	-A primary and secondary residence on one lot -Raised position of the primary residence above the sidewalk -Front gable roofs with joinery embellishments -Picture windows on the primary residence -Cross-braced garage doors on the secondary residence	<input checked="" type="checkbox"/> Setting <input checked="" type="checkbox"/> Location <input checked="" type="checkbox"/> Design <input type="checkbox"/> Materials <input checked="" type="checkbox"/> Workmanship <input checked="" type="checkbox"/> Feeling	<input type="checkbox"/> Yes <input checked="" type="checkbox"/> No Fails to possess sufficient integrity for significance in design or method of construction	<input type="checkbox"/> Yes <input checked="" type="checkbox"/> No

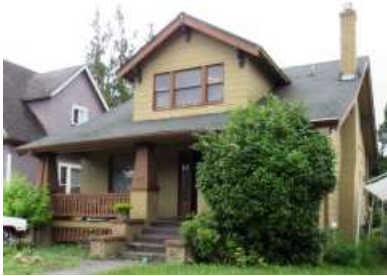
3825 S G St	728278	1915	-Gable roof forms with fascia boards and knee braces -Historic-period garage with alley access -Degrading original joinery -Incompatible door and window replacements	<input checked="" type="checkbox"/> Setting <input checked="" type="checkbox"/> Location <input type="checkbox"/> Design <input type="checkbox"/> Materials <input type="checkbox"/> Workmanship <input type="checkbox"/> Feeling	<input type="checkbox"/> Yes <input checked="" type="checkbox"/> No Fails to possess sufficient integrity for significance in design or method of construction	<input type="checkbox"/> Yes <input checked="" type="checkbox"/> No

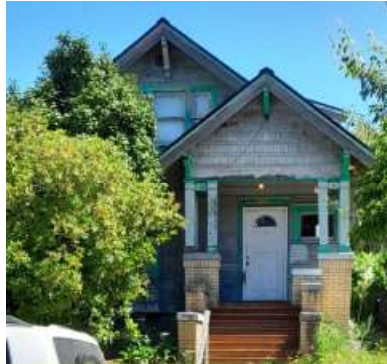
3828 S G St	728279	1905 (ca) 1922 (ca)	-Steeply-pitched, cross-gable roof -Decorative shingles -Decorative feature windows -Inappropriate T1-11 cladding and vinyl windows	<input checked="" type="checkbox"/> Setting <input checked="" type="checkbox"/> Location <input type="checkbox"/> Design <input type="checkbox"/> Materials <input type="checkbox"/> Workmanship <input type="checkbox"/> Feeling	<input type="checkbox"/> Yes <input checked="" type="checkbox"/> No Fails to possess sufficient integrity for significance in design or method of construction	<input type="checkbox"/> Yes <input checked="" type="checkbox"/> No

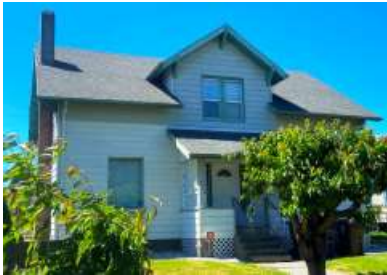
3819 S Park Ave	509987	1910 (ca)	-Location next to a residence of similar design that suggests both were built by the same speculative developer -Front gable roof Wood-framed windows -New carport -Altered siding and porch structure	<input checked="" type="checkbox"/> Setting <input checked="" type="checkbox"/> Location <input type="checkbox"/> Design <input type="checkbox"/> Materials <input type="checkbox"/> Workmanship <input type="checkbox"/> Feeling	<input type="checkbox"/> Yes <input checked="" type="checkbox"/> No Fails to possess sufficient integrity for significance in design or workmanship	<input type="checkbox"/> Yes <input checked="" type="checkbox"/> No

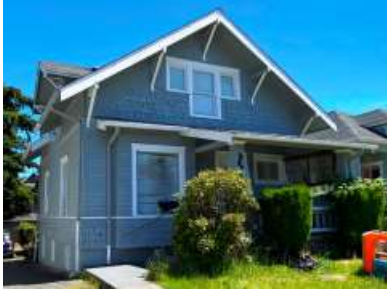
3824 S Park Ave	512985	1914	-Cross-gable roof -Decorative wood siding -Full-length porch -Incompatible replacement windows and doors	<input checked="" type="checkbox"/> Setting <input checked="" type="checkbox"/> Location <input type="checkbox"/> Design <input type="checkbox"/> Materials <input type="checkbox"/> Workmanship <input type="checkbox"/> Feeling	<input type="checkbox"/> Yes <input checked="" type="checkbox"/> No Fails to possess sufficient integrity for significance in design or method of construction	<input type="checkbox"/> Yes <input checked="" type="checkbox"/> No

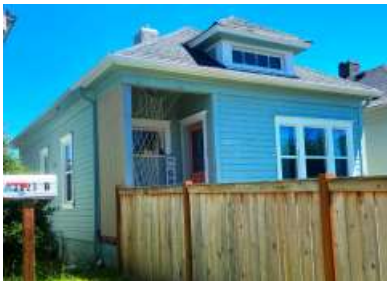
3828 S Park Ave	512602	1928	-Jerkinhead roof -Small front porch -Stucco cladding -Incompatible window and door replacements -Shared two-car garage with neighbor	<input checked="" type="checkbox"/> Setting <input checked="" type="checkbox"/> Location <input checked="" type="checkbox"/> Design <input type="checkbox"/> Materials <input type="checkbox"/> Workmanship <input checked="" type="checkbox"/> Feeling	<input type="checkbox"/> Yes <input checked="" type="checkbox"/> No Fails to possess sufficient integrity for significance in design or method of construction	<input type="checkbox"/> Yes <input checked="" type="checkbox"/> No

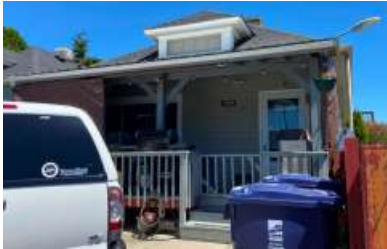
3841 S Park Ave Linnington Court Apartments	501799	1950	-One-story, C-court footprint -Multi-family residence -Brick cladding -Incompatible replacement doors and windows	<input checked="" type="checkbox"/> Setting <input checked="" type="checkbox"/> Location <input checked="" type="checkbox"/> Design <input type="checkbox"/> Materials <input checked="" type="checkbox"/> Workmanship <input checked="" type="checkbox"/> Feeling	<input type="checkbox"/> Yes <input checked="" type="checkbox"/> No Fails to possess sufficient integrity for significance of design or method of construction	<input type="checkbox"/> Yes <input checked="" type="checkbox"/> No

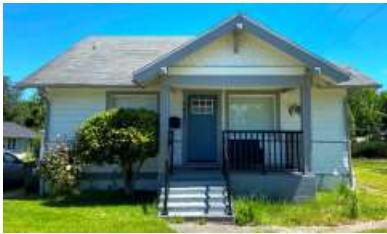
3857 S Park Ave	506223	1925	-Position on corner lot -Variety of roof forms -Decorative wood siding and roof joinery -Mix of window styles, including some original wood-framed units -Incompatible front porch supports and railings	<input checked="" type="checkbox"/> Setting <input checked="" type="checkbox"/> Location <input type="checkbox"/> Design <input checked="" type="checkbox"/> Materials <input checked="" type="checkbox"/> Workmanship <input checked="" type="checkbox"/> Feeling	<input type="checkbox"/> Yes <input checked="" type="checkbox"/> No Fails to possess sufficient integrity for significance in design or method of construction	<input type="checkbox"/> Yes <input checked="" type="checkbox"/> No

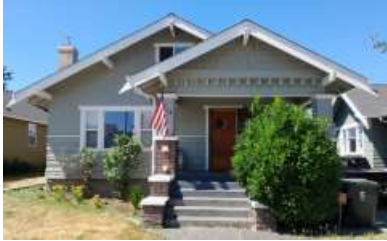
3714-3716 Tacoma Ave S	530246	1921	-Two residences on one parcel, one facing the street, the other the alley -Craftsman style Cladding patterns -Decorative details on main residence at 3714 Tacoma Avenue South -Simplicity of design for secondary residence at 3716 Tacoma Avenue South	<input checked="" type="checkbox"/> Setting <input checked="" type="checkbox"/> Location <input checked="" type="checkbox"/> Design <input type="checkbox"/> Materials <input checked="" type="checkbox"/> Workmanship <input checked="" type="checkbox"/> Feeling	<input type="checkbox"/> Yes <input checked="" type="checkbox"/> No Fails to possess sufficient integrity to reflect significance in design or method of construction	<input type="checkbox"/> Yes <input checked="" type="checkbox"/> No

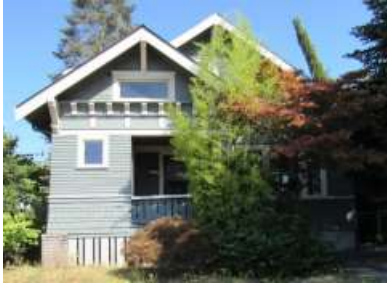
3719 S Thompson Ave	513100	1916 1957 1958	-Residence with detached garage accessed via the alley -Gambrel roof -Prominent 2-story addition between gambrel-roof projections -Asbestos siding -Vinyl windows	<input checked="" type="checkbox"/> Setting <input checked="" type="checkbox"/> Location <input type="checkbox"/> Design <input type="checkbox"/> Materials <input type="checkbox"/> Workmanship <input type="checkbox"/> Feeling	<input type="checkbox"/> Yes <input checked="" type="checkbox"/> No Fails to possess sufficient integrity for significance in design or method of construction	<input type="checkbox"/> Yes <input checked="" type="checkbox"/> No

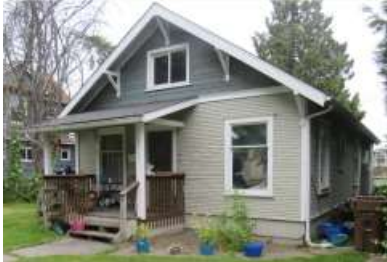
Address / Historical Business Name	WISAARD Property ID	Built Date	Character-Defining Features	NRHP Integrity Analysis	WAC Recommends NRHP-Eligible under Criterion C (Federal Register)?	City HPO Recommends TRHP-Eligible under Criterion C (Local Register)?	Photograph
3707 S Yakima Ave	523955	1908	-Front gable roof with fascia boards and knee braces -Wood siding in different styles -One-over-one, wood-framed windows -Modern porch structure	<input checked="" type="checkbox"/> Setting <input checked="" type="checkbox"/> Location <input type="checkbox"/> Design <input checked="" type="checkbox"/> Materials <input checked="" type="checkbox"/> Workmanship <input checked="" type="checkbox"/> Feeling	<input type="checkbox"/> Yes <input checked="" type="checkbox"/> No Fails to possess sufficient integrity for significance in design or method of construction	<input type="checkbox"/> Yes <input checked="" type="checkbox"/> No

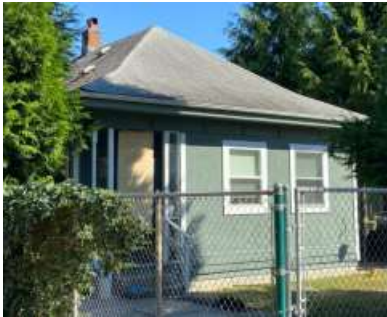
3709 S Yakima Ave	511985	1905 (ca)	-Bellcast roof -Location adjacent to another ca. 1905 house with bellcast roof -Grooveless T1-11 cladding -Vinyl windows	<input checked="" type="checkbox"/> Setting <input checked="" type="checkbox"/> Location <input type="checkbox"/> Design <input type="checkbox"/> Materials <input type="checkbox"/> Workmanship <input type="checkbox"/> Feeling	<input type="checkbox"/> Yes <input checked="" type="checkbox"/> No Fails to possess sufficient integrity for significance in design or method of construction	<input type="checkbox"/> Yes <input checked="" type="checkbox"/> No

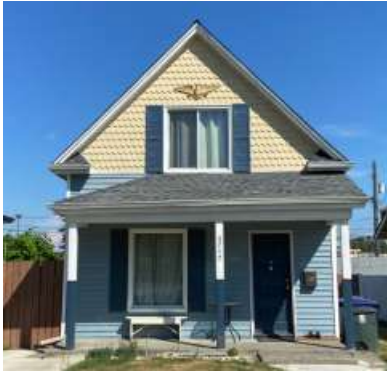
Address / Historical Business Name	WISAARD Property ID	Built Date	Character-Defining Features	NRHP Integrity Analysis	WAC Recommends NRHP-Eligible under Criterion C (Federal Register)?	City HPO Recommends TRHP-Eligible under Criterion C (Local Register)?	Photograph
3717 S Yakima Ave	527304	1904 (ca)	-Front gable roof -New porch structure -Vinyl siding imitating shingles and clapboard -Incompatible windows and doors	<input checked="" type="checkbox"/> Setting <input checked="" type="checkbox"/> Location <input type="checkbox"/> Design <input type="checkbox"/> Materials <input type="checkbox"/> Workmanship <input type="checkbox"/> Feeling	<input type="checkbox"/> Yes <input checked="" type="checkbox"/> No Fails to possess sufficient integrity for significance in design or method of construction	<input type="checkbox"/> Yes <input checked="" type="checkbox"/> No

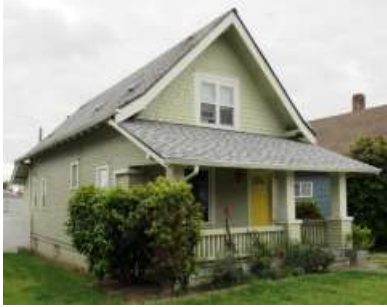
3719 S Yakima Ave	511157	1905 (ca)	-Steeply-pitched, front-gable, bellcast roof -Full-length porch with extended shed roof -Decorative mixture of wood cladding -Vinyl windows and incompatible replacement door	<input checked="" type="checkbox"/> Setting <input checked="" type="checkbox"/> Location <input type="checkbox"/> Design <input type="checkbox"/> Materials <input checked="" type="checkbox"/> Workmanship <input checked="" type="checkbox"/> Feeling	<input type="checkbox"/> Yes <input checked="" type="checkbox"/> No Fails to possess sufficient integrity for significance in design or method of construction	<input type="checkbox"/> Yes <input checked="" type="checkbox"/> No

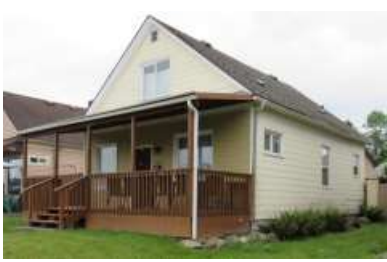
3720 S Yakima Ave	527302	1905 (ca)	-Single-family residence with commercial parking to the rear -Part of a row of houses with front-gable roofs -Dominant, modern front porch -Replacement siding, windows, and door	<input type="checkbox"/> Setting <input checked="" type="checkbox"/> Location <input type="checkbox"/> Design <input type="checkbox"/> Materials <input type="checkbox"/> Workmanship <input type="checkbox"/> Feeling	<input type="checkbox"/> Yes <input checked="" type="checkbox"/> No Fails to possess sufficient integrity for significance in design or method of construction	<input type="checkbox"/> Yes <input checked="" type="checkbox"/> No

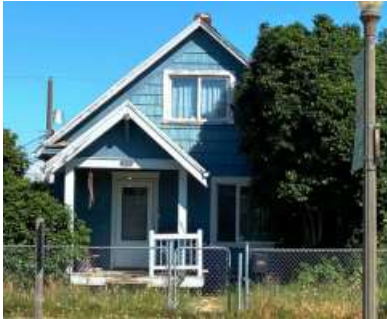
Address / Historical Business Name	WISAARD Property ID	Built Date	Character-Defining Features	NRHP Integrity Analysis	WAC Recommends NRHP-Eligible under Criterion C (Federal Register)?	City HPO Recommends TRHP-Eligible under Criterion C (Local Register)?	Photograph
3723 S Yakima Ave	511728	1905 (ca)	-Front gable roof -Mix of styles suggesting multiple phases of construction -Shingle siding -Incompatible windows and doors	<input checked="" type="checkbox"/> Setting <input checked="" type="checkbox"/> Location <input type="checkbox"/> Design <input type="checkbox"/> Materials <input type="checkbox"/> Workmanship <input type="checkbox"/> Feeling	<input type="checkbox"/> Yes <input checked="" type="checkbox"/> No Fails to possess sufficient integrity for significance in design or method of construction	<input type="checkbox"/> Yes <input checked="" type="checkbox"/> No

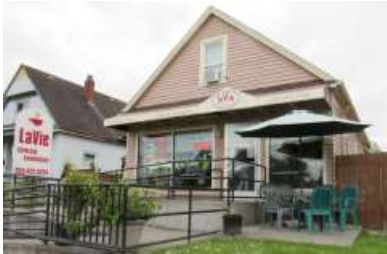
3724 S Yakima Ave	529560	1903	-Former house converted into a cafe (Cafe La Vie) -Part of a row of houses with front-gable roofs -Modern awnings -Snaking, concrete access ramp -Extensive modern signage	<input type="checkbox"/> Setting <input checked="" type="checkbox"/> Location <input type="checkbox"/> Design <input type="checkbox"/> Materials <input type="checkbox"/> Workmanship <input type="checkbox"/> Feeling	<input type="checkbox"/> Yes <input checked="" type="checkbox"/> No Fails to possess sufficient integrity for significance in design, setting, materials, workmanship and feeling	<input type="checkbox"/> Yes <input checked="" type="checkbox"/> No

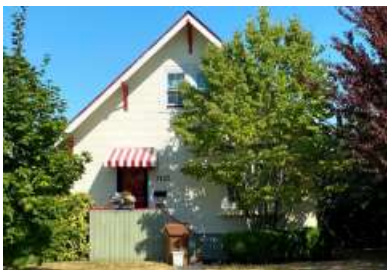
3727 S Yakima Ave	529608	1906 (ca)	-Steeply-pitched, front gable roof -Front stoop with steps running parallel to the house -Asbestos siding -Detached garage to the rear of the property	<input type="checkbox"/> Setting <input checked="" type="checkbox"/> Location <input checked="" type="checkbox"/> Design <input type="checkbox"/> Materials <input type="checkbox"/> Workmanship <input checked="" type="checkbox"/> Feeling	<input type="checkbox"/> Yes <input checked="" type="checkbox"/> No Fails to possess sufficient integrity for significance in materials or method of construction	<input type="checkbox"/> Yes <input checked="" type="checkbox"/> No

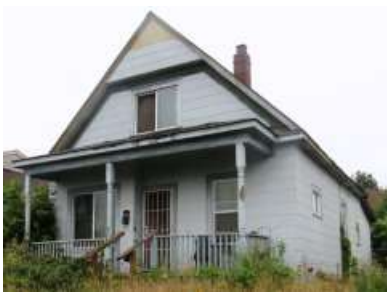
Address / Historical Business Name	WISAARD Property ID	Built Date	Character-Defining Features	NRHP Integrity Analysis	WAC Recommends NRHP-Eligible under Criterion C (Federal Register)?	City HPO Recommends TRHP-Eligible under Criterion C (Local Register)?	Photograph
3728 S Yakima Ave	526435	1906	-Raised position above sidewalk -Part of a row of houses with front-gable roofs -Full-length front porch -Asbestos siding -Incompatible windows and front door	<input type="checkbox"/> Setting <input checked="" type="checkbox"/> Location <input checked="" type="checkbox"/> Design <input type="checkbox"/> Materials <input type="checkbox"/> Workmanship <input type="checkbox"/> Feeling	<input type="checkbox"/> Yes <input checked="" type="checkbox"/> No Fails to possess sufficient integrity for significance in materials and method of construction	<input type="checkbox"/> Yes <input checked="" type="checkbox"/> No

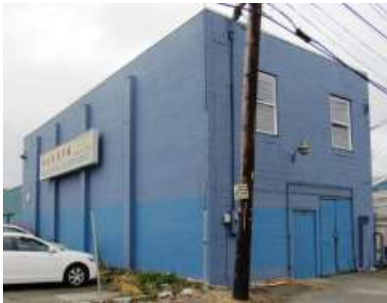
3802 S Yakima Ave Model Bakery Annex	529671	1947	-Alley access only -Built to alley edge -Flat roof with low parapet -Two stories Concrete block construction -Altered door openings	<input type="checkbox"/> Setting <input checked="" type="checkbox"/> Location <input type="checkbox"/> Design <input type="checkbox"/> Materials <input type="checkbox"/> Workmanship <input type="checkbox"/> Feeling	<input type="checkbox"/> Yes <input checked="" type="checkbox"/> No Fails to possess sufficient integrity for significance in design or method of construction	<input type="checkbox"/> Yes <input checked="" type="checkbox"/> No

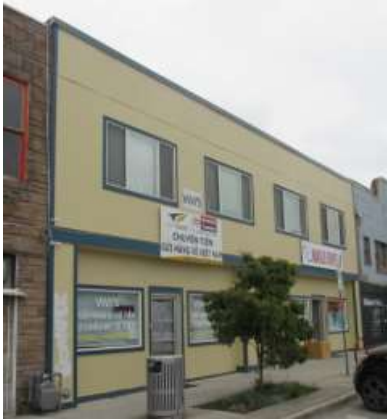
Address / Historical Business Name	WISAARD Property ID	Built Date	Character-Defining Features	NRHP Integrity Analysis	WAC Recommends NRHP-Eligible under Criterion C (Federal Register)?	City HPO Recommends TRHP-Eligible under Criterion C (Local Register)?	Photograph
3803 S Yakima Ave	728844	1920 (ca)	-Continuous frontage with neighboring commercial properties -Engineered wood surface treatment -Modern windows and storefront designs presenting a horizontal orientation rather than vertical commercial bays -Modern stairwell and balcony providing access to rear of second-floor unit(s) via the alley	<input checked="" type="checkbox"/> Setting <input checked="" type="checkbox"/> Location <input type="checkbox"/> Design <input type="checkbox"/> Materials <input type="checkbox"/> Workmanship <input type="checkbox"/> Feeling	<input type="checkbox"/> Yes <input checked="" type="checkbox"/> No Fails to possess sufficient integrity for significance in design or method of construction	<input type="checkbox"/> Yes <input checked="" type="checkbox"/> No

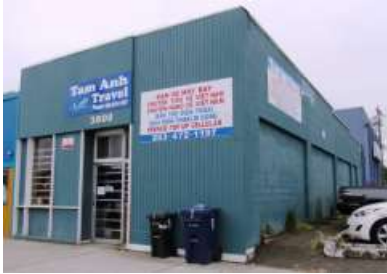
3808 S Yakima Ave Lincoln Bank	529662	1925	-One-story, three-bay street frontage -Position between commercial business and surface parking lot -T-1-11 and plywood siding -Metal-framed front door system -Minimal visual penetration into the interior	<input type="checkbox"/> Setting <input checked="" type="checkbox"/> Location <input checked="" type="checkbox"/> Design <input type="checkbox"/> Materials <input type="checkbox"/> Workmanship <input checked="" type="checkbox"/> Feeling	<input type="checkbox"/> Yes <input checked="" type="checkbox"/> No Fails to possess sufficient integrity for significance in design or method of construction	<input type="checkbox"/> Yes <input checked="" type="checkbox"/> No

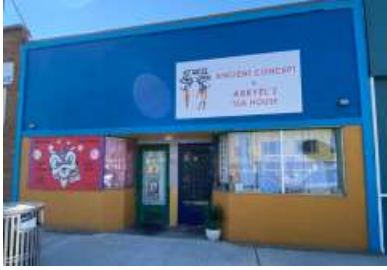
3810 S Yakima Ave Preston-Strobel Realtors & Daisy Beauty Shop	529663	1945	-One-story commercial building with two retail units -Location mid-block within continuous retail frontages -Inset, mirrored entrances -Display windows with frameless, canted corners	<input checked="" type="checkbox"/> Setting <input checked="" type="checkbox"/> Location <input checked="" type="checkbox"/> Design <input type="checkbox"/> Materials <input type="checkbox"/> Workmanship <input checked="" type="checkbox"/> Feeling	<input type="checkbox"/> Yes <input checked="" type="checkbox"/> No Fails to possess sufficient integrity for significance in design or method of construction	<input type="checkbox"/> Yes <input checked="" type="checkbox"/> No

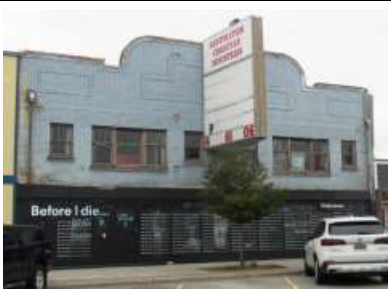
Address / Historical Business Name	WISAARD Property ID	Built Date	Character-Defining Features	NRHP Integrity Analysis	WAC Recommends NRHP-Eligible under Criterion C (Federal Register)?	City HPO Recommends TRHP-Eligible under Criterion C (Local Register)?	Photograph
3811 S Yakima Ave Rex Theater	529687	1919	-Two-story theater with decorative parapet -Painted brick cladding -Historic, wood windows in a state of some disrepair -Boarded-over first floor -Non-historic, internally-lit marquee	<input checked="" type="checkbox"/> Setting <input checked="" type="checkbox"/> Location <input type="checkbox"/> Design <input type="checkbox"/> Materials <input checked="" type="checkbox"/> Workmanship <input checked="" type="checkbox"/> Feeling	<input type="checkbox"/> Yes <input checked="" type="checkbox"/> No Fails to possess sufficient integrity for significance in design or method of construction	<input type="checkbox"/> Yes <input checked="" type="checkbox"/> No

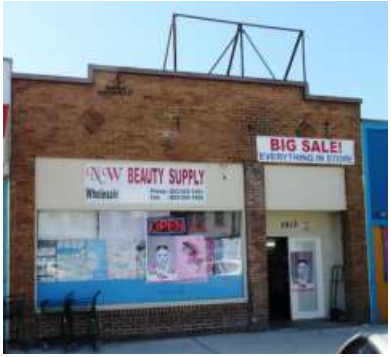
3812 S Yakima Ave Post Office, Golden City Cafe	529672	1932	-One-story commercial building -Location mid-block within continuous retail frontages -Brick cladding -Flat roof with stepped parapet -Three-bay vertical division with two bays dominated by large display window	<input checked="" type="checkbox"/> Setting <input checked="" type="checkbox"/> Location <input type="checkbox"/> Design <input checked="" type="checkbox"/> Materials <input checked="" type="checkbox"/> Workmanship <input checked="" type="checkbox"/> Feeling	<input type="checkbox"/> Yes <input checked="" type="checkbox"/> No Fails to possess sufficient integrity for significance in design or method of construction	<input type="checkbox"/> Yes <input checked="" type="checkbox"/> No

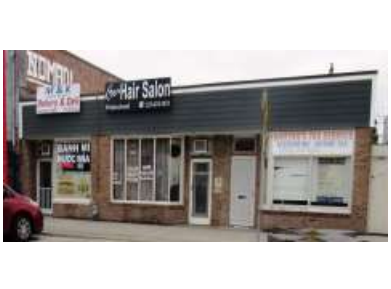
3813-3815 S Yakima Ave	529667	1946	-Mid-block position with narrow side alley to south -Built to sidewalk edge -Single-story, three-bay commercial building -Mirrored layout of storefronts -Red-brick cladding Inset entrances	<input checked="" type="checkbox"/> Setting <input checked="" type="checkbox"/> Location <input type="checkbox"/> Design <input type="checkbox"/> Materials <input type="checkbox"/> Workmanship <input type="checkbox"/> Feeling	<input type="checkbox"/> Yes <input checked="" type="checkbox"/> No Fails to possess sufficient integrity for significance in design or method of construction	<input type="checkbox"/> Yes <input checked="" type="checkbox"/> No

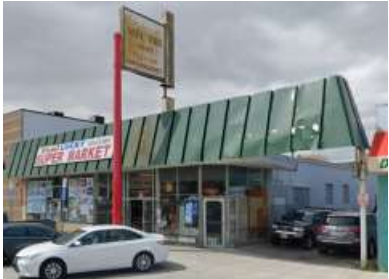
3820 S Yakima Ave Fashion Cleaners	529692	1946	-Position along two alleys filling the parcel -Single story Mostly glazed storefront -Dominant, oversized mansard awning -Profusion of signage	<input type="checkbox"/> Setting <input checked="" type="checkbox"/> Location <input type="checkbox"/> Design <input type="checkbox"/> Materials <input type="checkbox"/> Workmanship <input type="checkbox"/> Feeling	<input type="checkbox"/> Yes <input checked="" type="checkbox"/> No Fails to possess sufficient integrity for significance in design or method of construction	<input type="checkbox"/> Yes <input checked="" type="checkbox"/> No

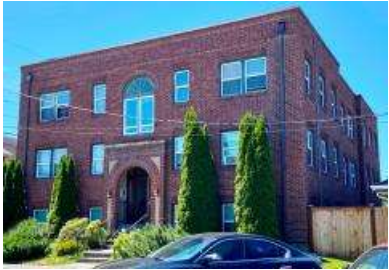
Address / Historical Business Name	WISAARD Property ID	Built Date	Character-Defining Features	NRHP Integrity Analysis	WAC Recommends NRHP-Eligible under Criterion C (Federal Register)?	City HPO Recommends TRHP-Eligible under Criterion C (Local Register)?	Photograph
3910 S Yakima Ave Hutchinson Apartments	511066	1926	-Two-and-a-half-story, apartment building on corner lot on mostly residential block -Daylight basement -Flat roof with parapet -Red brick cladding -Second-story fanlight window that echoes the arched entrance vestibule	<input checked="" type="checkbox"/> Setting <input checked="" type="checkbox"/> Location <input checked="" type="checkbox"/> Design <input type="checkbox"/> Materials <input checked="" type="checkbox"/> Workmanship <input checked="" type="checkbox"/> Feeling	<input type="checkbox"/> Yes <input checked="" type="checkbox"/> No Fails to possess sufficient integrity for significance in design or method of construction	<input type="checkbox"/> Yes <input checked="" type="checkbox"/> No
