# Salmon Beach

## Activities and Monitoring Report

### 2020/2021

**Prepared by City of Tacoma**

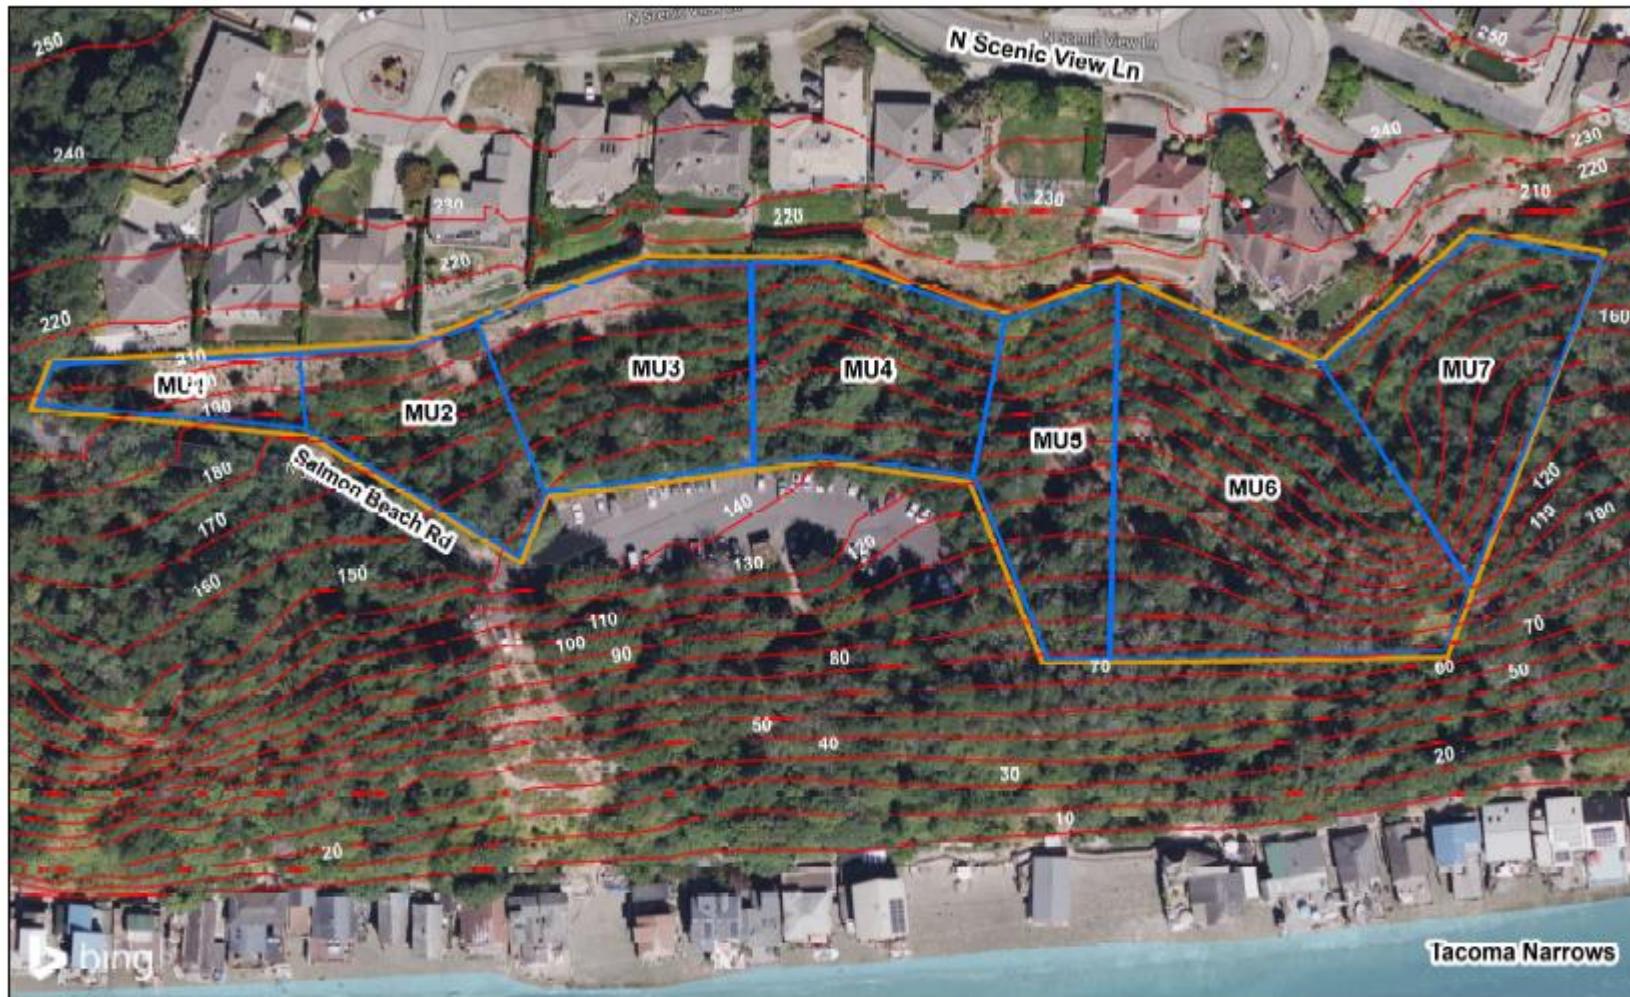
Figure 1. Salmon Beach Elevation

There are seven Management Units (MUs) at Salmon Beach that span the site consecutively (1-7) from North to South (Figure 1). Over 90% of the open space has slopes greater than 25%, and the majority of that area includes slopes greater than 40% (Figures 1 & 2).

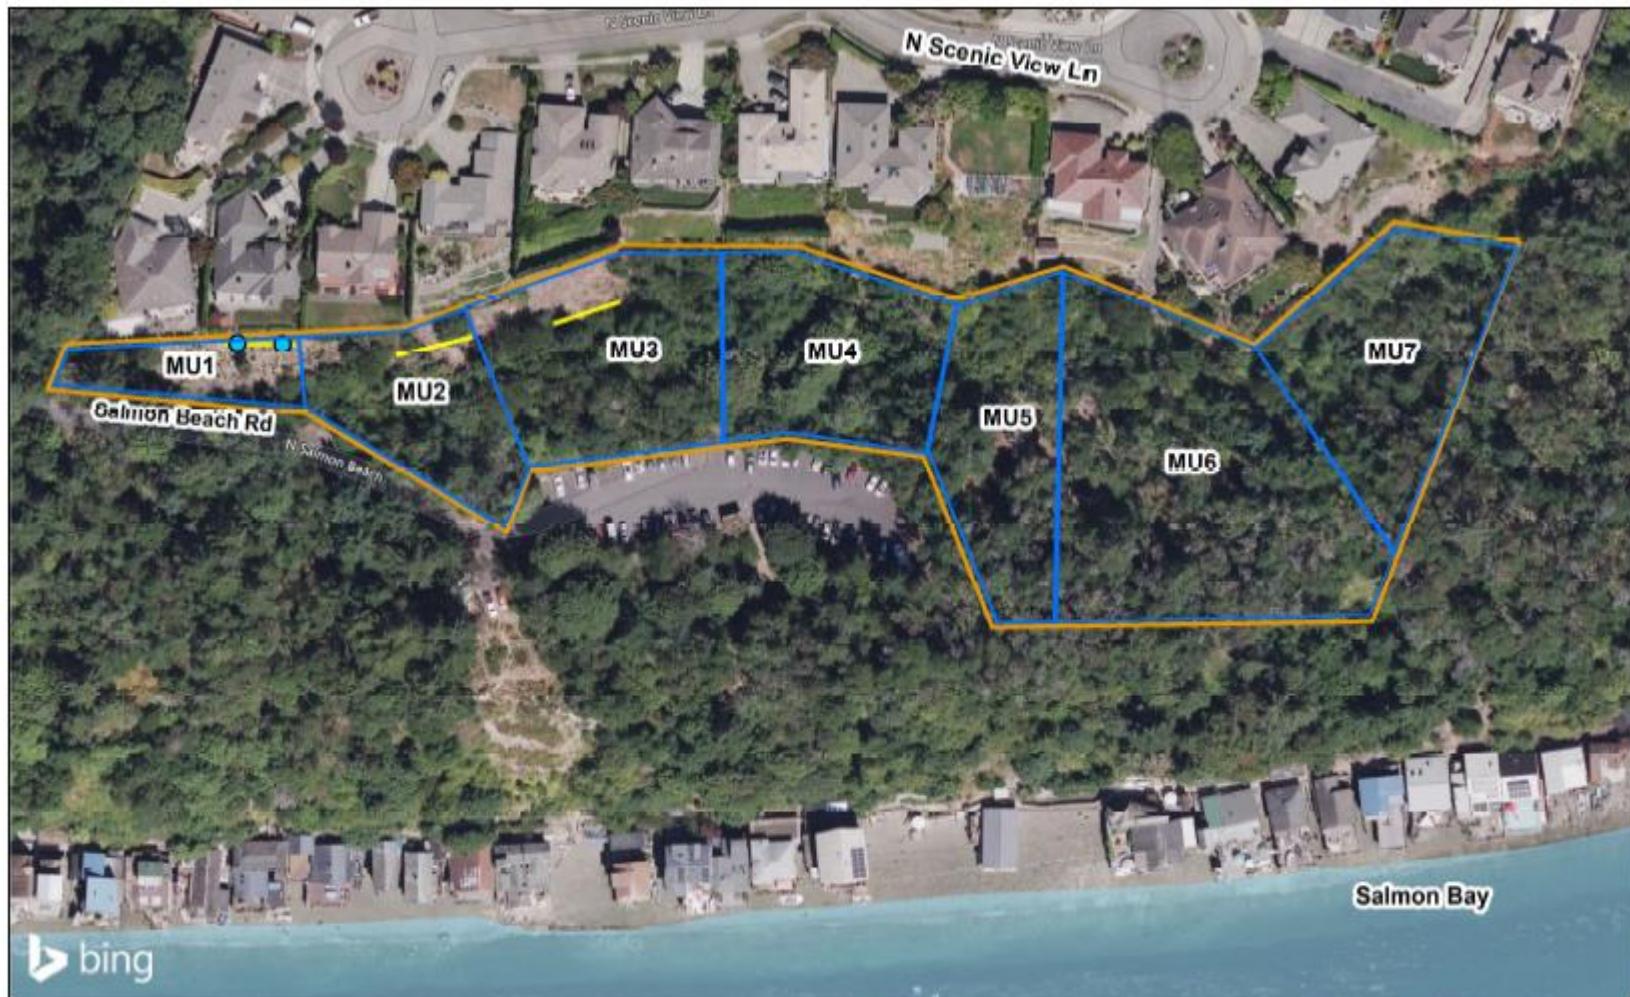
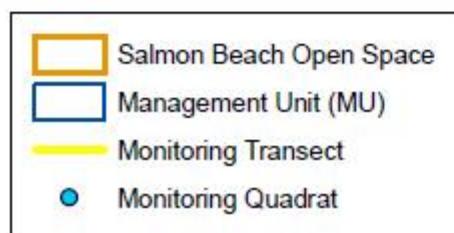
Figure 3. Salmon Beach Monitoring Areas 2020/2021

All MUs have areas of invasive species, however they are most dense in the eastern half and upper elevations (>180 ft, Figure 3) of MUs 1-5, and completely dominated MU1 prior to restoration. These areas coincide with those that had the most tree topping and removals. Management Units 3 and 4 have areas of healthy native vegetation cover near the lower elevations of the slope consisting of bigleaf maple (*Acer macrophyllum*), madrone (*Arbutus menziesii*) and Douglas fir (*Pseudotsuga menziesii*). Management Units 6 and 7 also have a healthier tree cover and fewer invasive species. Areas with more native vegetation cover still have significant numbers of dead and dying trees.

The number of transects needed within MU1 was only one 50 ft transect as the area was less than a quarter acre at 0.16 acres or 7,090 sq ft (Figure 1). Management Units 2 and 3 were restored together, with the total restoration area being 0.18 acres or 7,817 sq ft, requiring only 1 transect. However, it has been observed by field staff that monitoring quadrats result in more damage than monitoring transects as they usually encompass multiple contours and require staff to move up and down the slope multiple times to see the entire quadrat. It was decided that quadrats would no longer be used for new monitoring at Salmon Beach, and the numbers of transects would be doubled. Thus, two transects were used to monitor MUs 2 and 3 collectively.
