FIRE FACILITIES MASTER PLAN

CITY OF TACOMA

FEBRUARY 2024

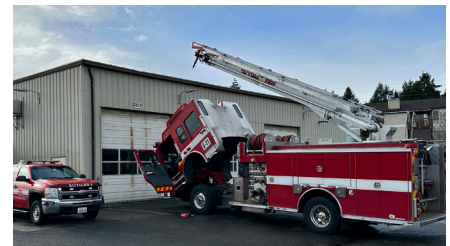
TFD facilities, particularly support facilities, are undersized to meet future needs; see Figure 4. Increased population and resulting demand for services will further strain over-capacity facilities.

Figure 4. Fire Garage is undersized for modern apparatus

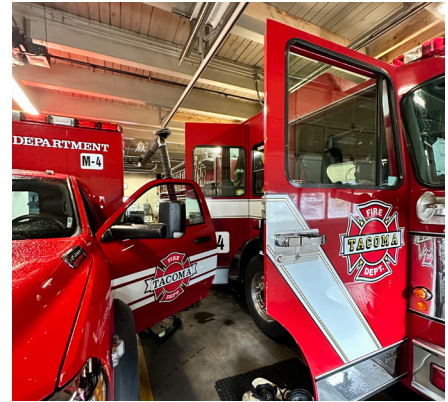
Figure 41. Tight clearance in Station 4 apparatus bay

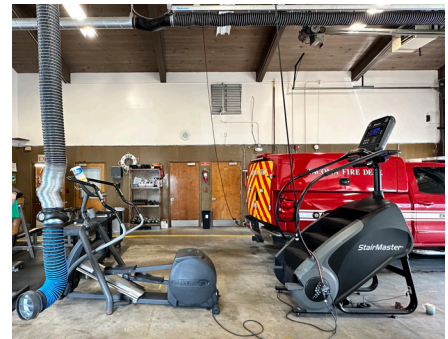
- Workout area is located in apparatus bay, which exposes firefighters to vehicle exhaust
- Repeated break-ins at non-secure staff parking lot
- Common restroom areas are not adequate or gender neutral; only one shower for the entire station
- Bunk room windows are not operable and do not meet egress requirements
- Turnout storage is located in apparatus bay

Figure 43. Fitness equipment in Station 6 apparatus bay

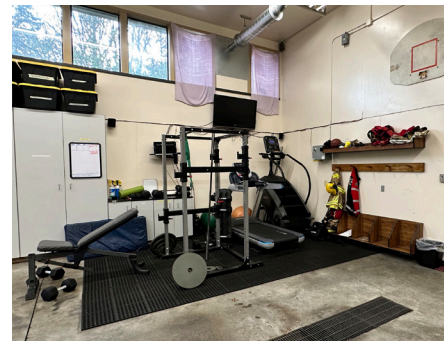
Figure 55. Fitness area in Station 3 apparatus bay

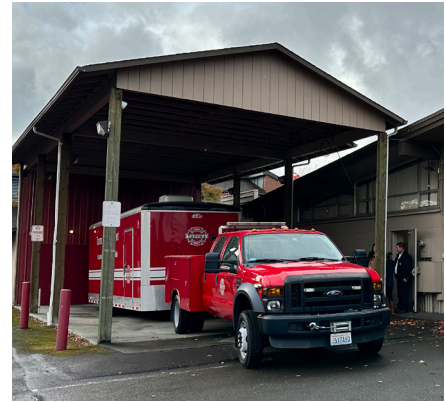
- Minimal natural light
- Lacks secure staff parking
- Apparatus bays are not large enough to store the station's vehicles and equipment, leaving them susceptible to vandalism and unprotected from harsh weather, which increases maintenance needs and shortens replacement cycles; see Figure 58

Figure 58. Hazmat unit parked outside and unsecured at Station 12

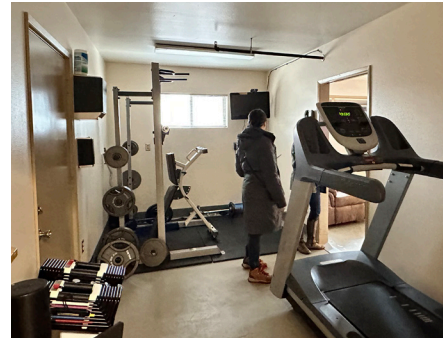
Figure 70. Station 7 front entry and fitness room

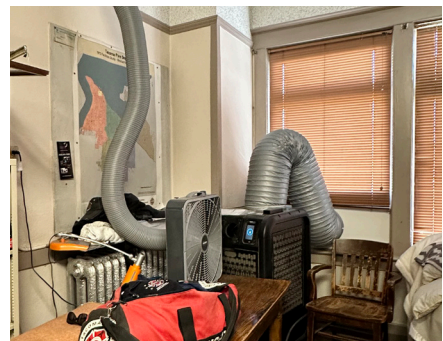
Figure 75. HVAC system in Station 11 dormitory

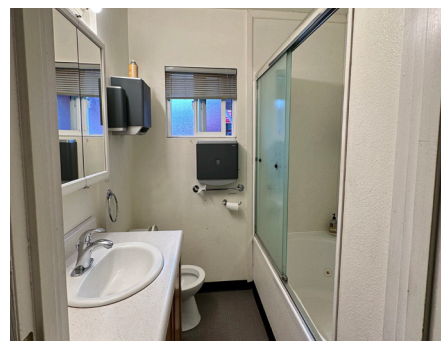
Figure 76. Station 15 residential-grade bathroom
