Mason Gulch

Activities and Monitoring Report

2019/2020

**Prepared by City of
Tacoma Passive Open
Space Program
Permit # LU16-0272**

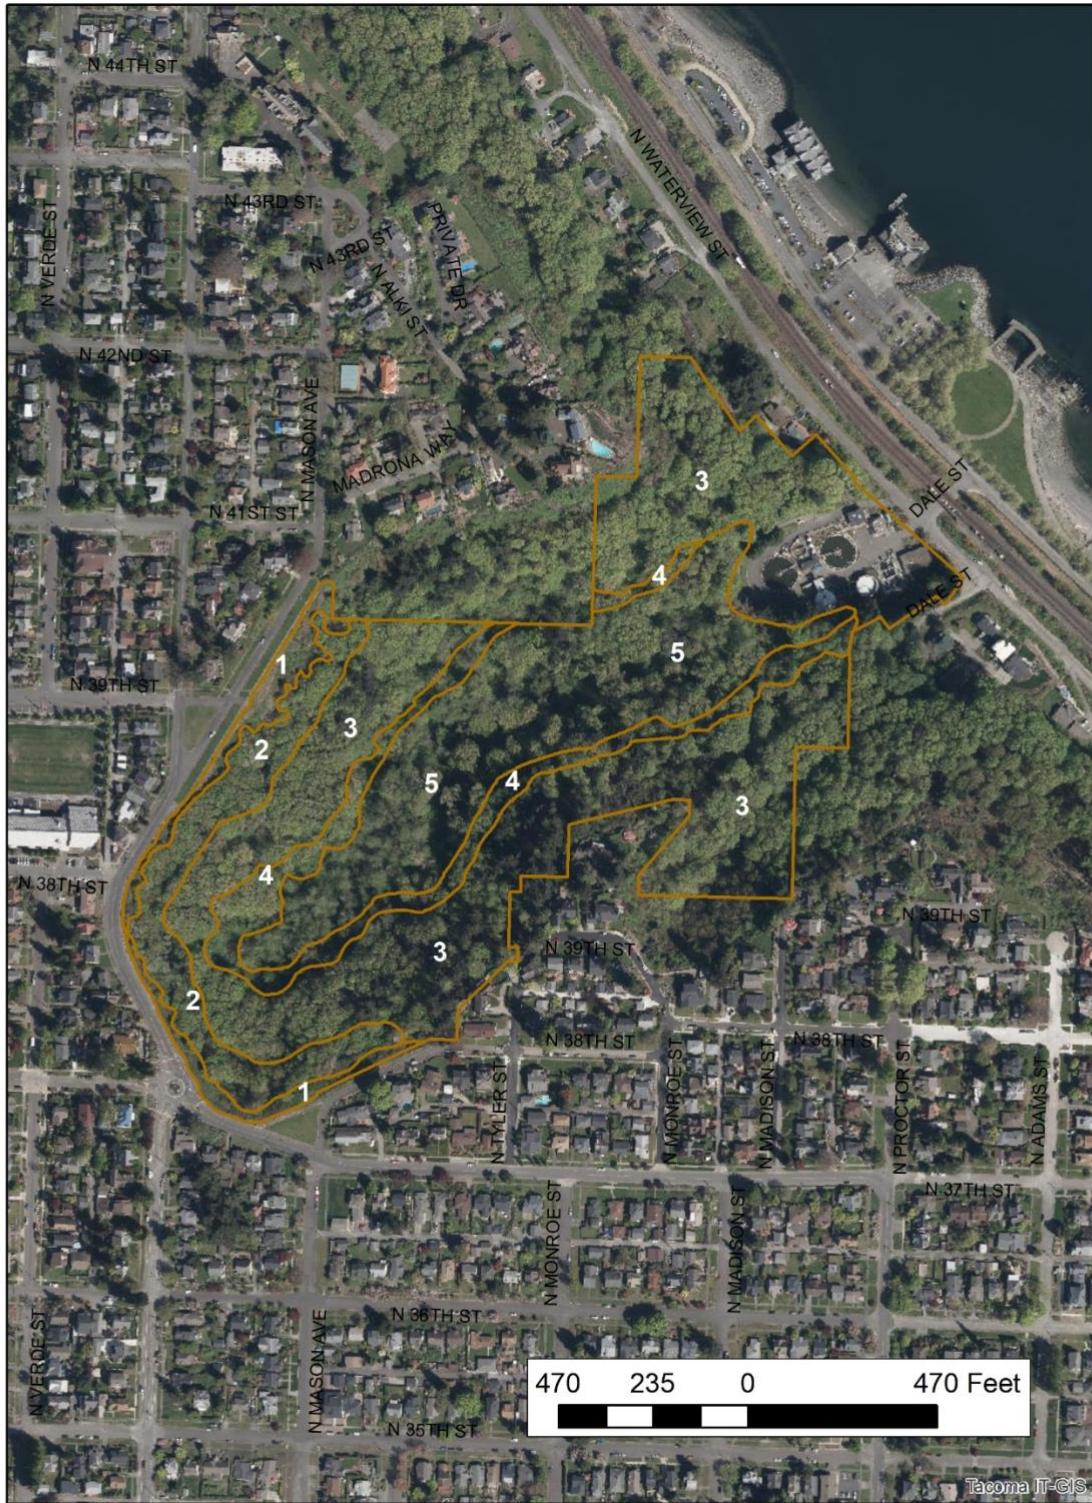
Figure 2. Mason Gulch Landscape Management Units

Open Space Management Units
