FIRE FACILITIES MASTER PLAN

CITY OF TACOMA

FEBRUARY 2024

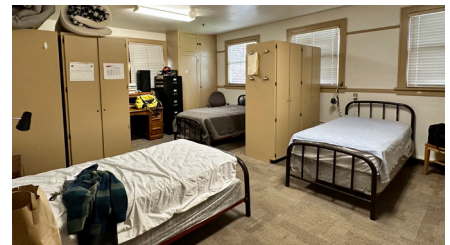
Facilities lack decontamination space and adequate delineation between contaminated zones and living quarters. Communal dorms are outmoded and do not allow for adequate respite and privacy; see Figure 5.

Figure 5. Station 10’s dormitory lacks privacy and does not support adequate rest

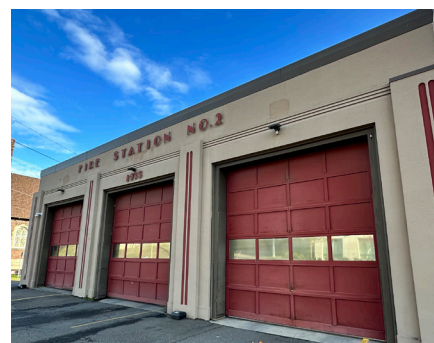
Figure 11. Built in 1907, historic Station 2 is TFD’s oldest operating fire station

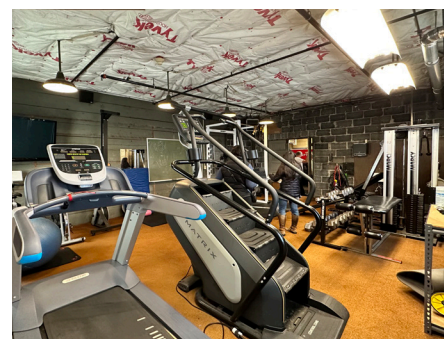
- Historic station is not seismically reinforced based on Tier 1 screening; further analysis will be required to determine extent of seismic retrofit needed
- Security measures added in response to recent break-ins
- Common sleeping areas are not adequate or gender neutral
- Basement has extra space and could be reconfigured
- Flooding and mold issues in basement
- Skylight in apparatus bay leaks
- Lacks secure onsite parking and security cameras
- Not ADA accessible
- Apparatus bay lacks trench drains
- Fitness room is of poor quality and lacks adequate ventilation

Figure 40. Station 2 fitness room

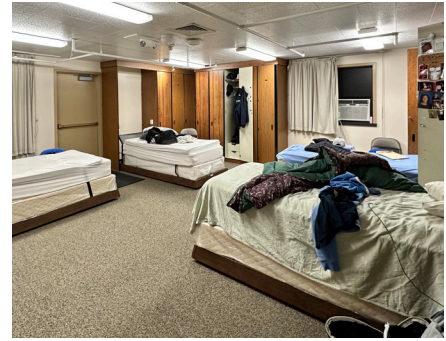
Figure 54. Station 3 shared dormitory

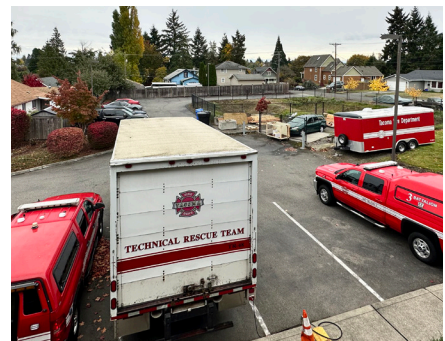
Figure 71. Vehicles parked uncovered at Station 8

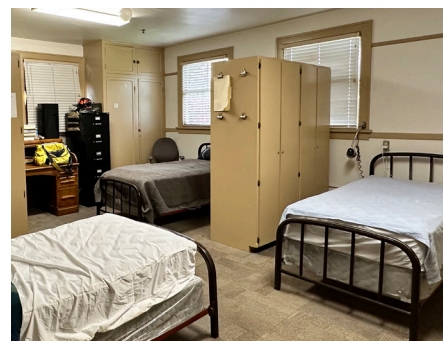
Figure 72. Shared dormitory at Station 10

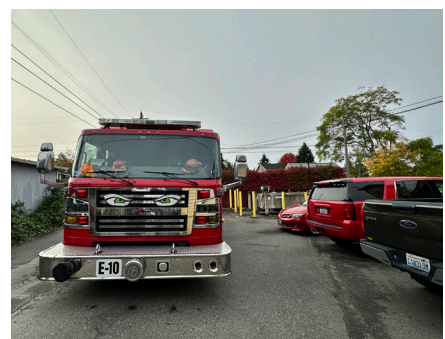
Figure 73. Engine 10 must be washed in alley behind Station 10

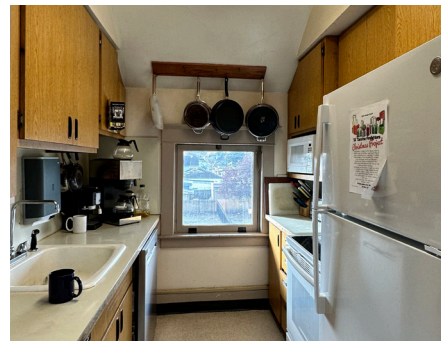
Figure 74. Up to eight staff share small kitchen in Station 11
